Treatment of old disused mine openings

TREATMENT OF OLD DISUSED MINE OPENINGS

EXAMPLE OF A SPECIFIC STUDY - THE SAINT-JOSEPH MINE CASE

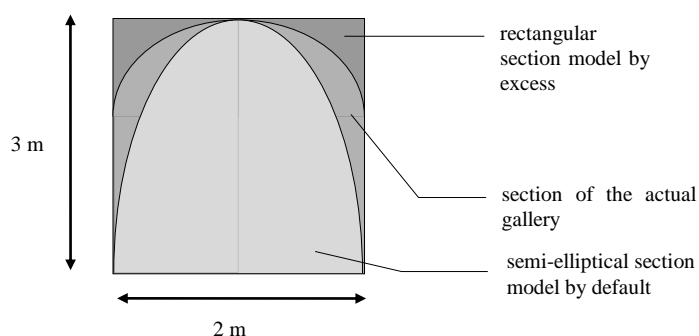
Fig 1 showing the models used for the actual section of Saint-Joseph Gallery

The models used were those of a rectangular and a semi-elliptic gallery to frame the actual result. Calculations showed that the maximum height of a chimney would be between 44 m and 49 m. These yielded quite accurate value and it has been possible to decide from which point no backfill would be required to ensure safety on surface. The same calculations were computed with backfill corresponding to 80% of void volume and to 50% void.

Percentage of void volume backfilled	maximum height of a sinkhole development
0%	44 m - 49 m
50%	23 m - 26 m
80%	10 m

A factor of safety has been chosen taking into consideration the lack of information on parameters as well as the damage potential of surface structures. As two sensitive structures are located above the mine and the thickness of covering materials has been found not to be sufficient, a backfill of the full gallery volume is recommended. As shown on figure 2, it has been possible to propose a « by step » backfilling procedure, each zone backfilled separated from the other by a wall to limit fill dispersion.

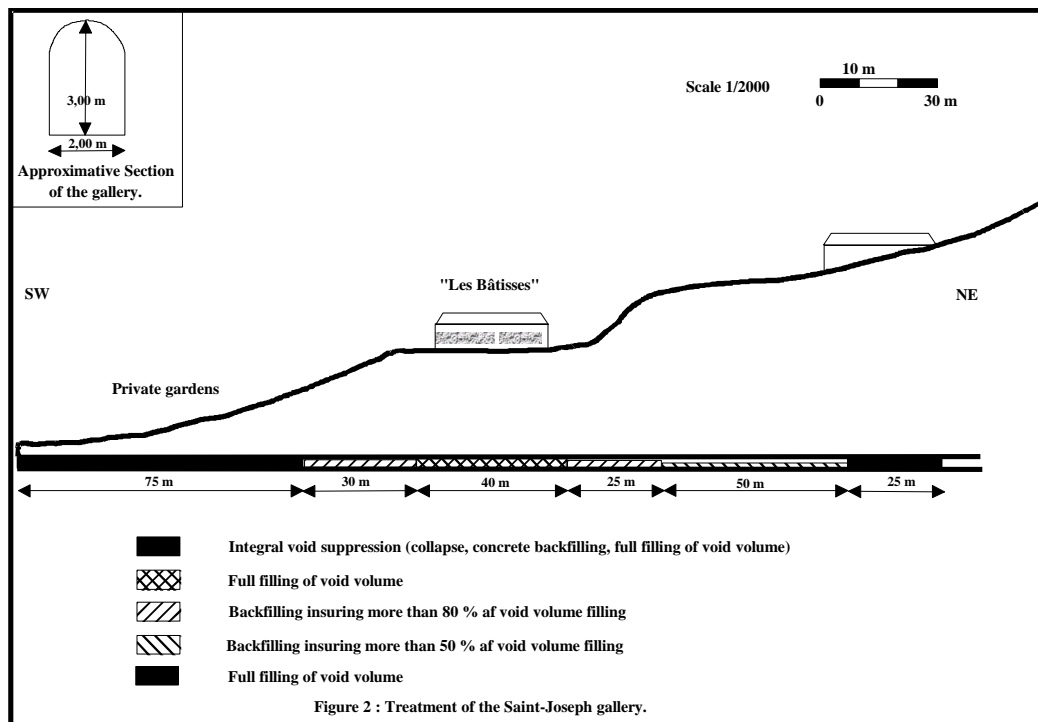
- in the gardens located close to buildings called « Les Bâtisses », one can notice the presence of sandstone with soil. Because of dense vegetation making any visual observation very difficult, it has been assumed that the opening of the gallery was situated within this formation ;
- « Les Bâtisses » were founded on fill made of mining materials. If we assume the height of the fillslope being approximately equal to the thickness of the in-situ layer, it is around 5 m thick (fig 2).
