## **CNG buses fire safety : learnings from recent accidents in France and Germany**

Lionel Perrette, Helmut K. Wiedemann

# CNG buses fire safety: learnings from recent accidents in France and Germany

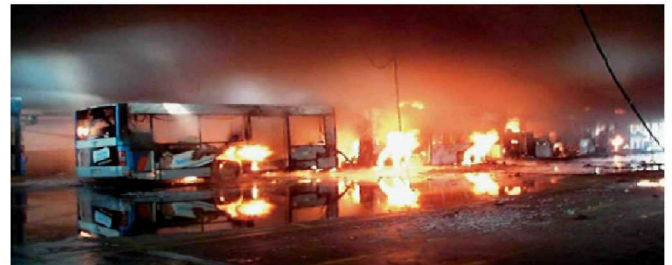
The fire propagated from the back of the first bus to another articulated bus parked in a row at 1.5 meters behind. At 3:09 pm the fire is well developed inside the depot and violent explosions occur. These explosions are caused by the release through actuated PRDs, mixing and later combustion of natural gas inside the depot. Both buses have been burnt out whereas the other ones have been extracted from the depot before they caught fire. The first bus burnt from the back to the front. The second bus burnt the opposite way.

Figure 3: View of the fire once it was under control (from [6])

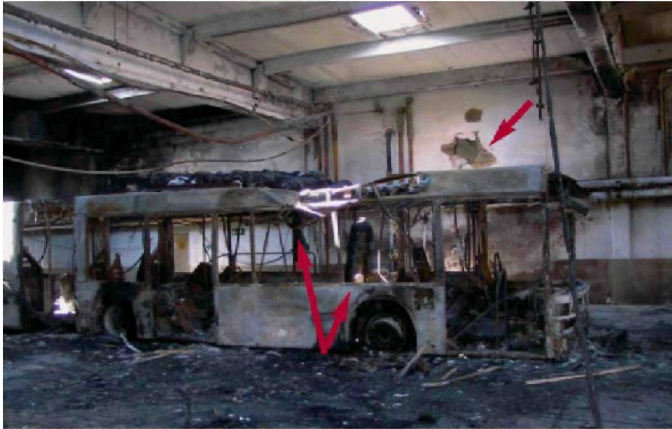
It went a different way for one of the tanks mounted on the second bus whereas the fire was “under control”. The tank burst about 15 minutes after the fire started. A large tank fragment was propelled in the tank axial direction. It broke through a nearby wall (hole at 3 meters from ground level) flew through the air and damaged another wall located 25 meters further and ended up its journey on the roof of a bus parked in a nearby depot. The tank that burst was the first in the row

Figure 4: Destroyed bus with red arrows pointing (from right to left), tank n°3, hanging tank n°2 and hole through which tank n°1 flew (from [6])

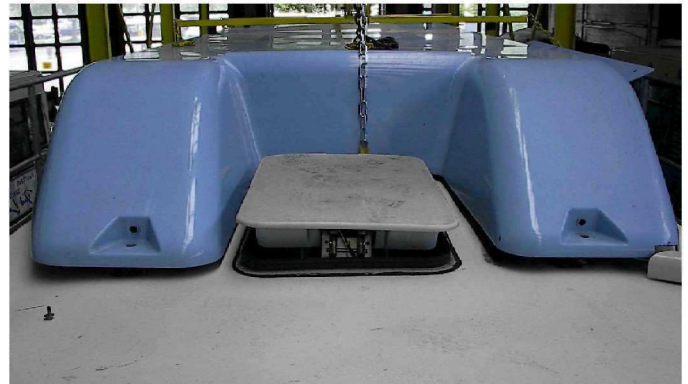
Figure 6: Roof opening ahead of tank n°1 (from [6])

- on one hand it suffered a local fire stress when a fire-induced short-circuit triggered the opening of a roof door mounted nearby tank n°1 (Picture 6). Flame broke through this opening and heated up tank n°1 in its middle part,
- on the other hand, PRDs mounted on tank n°1 did fail to open, hence preventing the tank from depressurising. Investigation concluded that failure to open was caused by an insufficient heat up of the PRDs that did not melt completely. The protective cover mounted on the top of tanks contributed to prevent sufficient heat to reach the PRDs.

Further developments of the current “bonfire test” are necessary in order to consider the entire vehicle as suggested also by [7] & [8]. Besides, any opening underneath or nearby the tank must be avoided (or be sealed and fire resistant). Finally, PRD performance and potential failures should be further investigated including

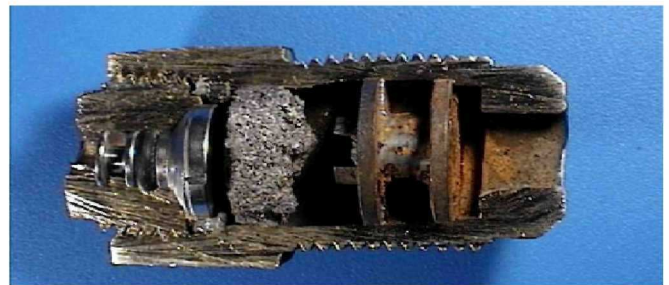
Figure 7: Example of one closed PRD from tank n°1. Picture shows that the metal fuse did not have time to melt completely (from [6])

In that case PRDs did not fail because they froze<sup>3</sup> but because flames heat did not reach them fast enough. Therefore, a tank system that survives a bonfire test may not survive in a real life situation, similarly a fuse that works correctly in test condition may operate differently in real life conditions. Indeed, as the bonfire test only focuses on the tank system and does not consider the entire vehicle, it misses synergetic effects induced by the association of tank system and the vehicle. This remark underlines that tank fire protection and bus fire safety can not rely only on the performance of isolated protected tank systems.

appropriate location that does not shield them from heat or allow them to freeze. As far as freezing is concerned, new PRDs exist with fuse made of glass-cylinders containing expanding liquids. Glass breaks up at 110°C and completely free the release orifice with no possibility of PRD reclosure.

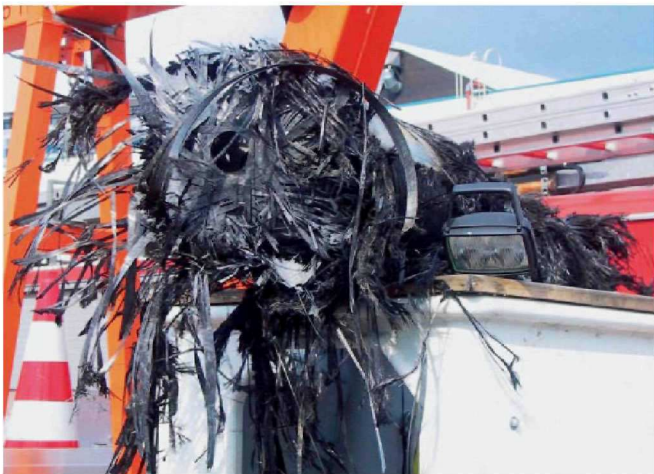
Figure 5: Remains of tank n°1 after it landed (from [6])

Investigation lead to the following explanations. Tank n°1 burst for two concomitant reasons:

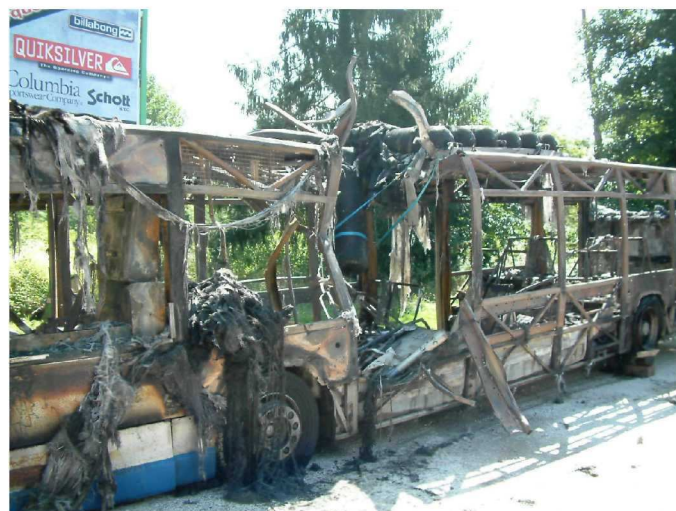
Firemen stood at a safe distance in front of the bus and tried to cool down the tank system with water spray. 10 minutes later at 6:51 am, the front cylinder exploded causing slight and directional damages to the environment within a distance of 100 m. Damages were caused by tank debris (tank n°1 damaged the roof of an adjacent house after a 30 m fly) and overpressure (poster frame unhooked and damaged sliding shutters 60 m away from explosion). As it burst, tank n°1 also propelled the adjacent tank to the other side of the road (10 m away). The tank n°1 ruptured in large pieces whereas carbon fiber could be found as far as 150 m away. Tank n°1 valve and associated fuse have not been found after the accident. Bursting noise could be heard at a 5 km distance. Firemen did not report any noticeable fireball though they felt a transient heat. Nobody was injured.

Figure 9: Side view of the bus with tank n°3 hanging (Courtesy SDIS 25)

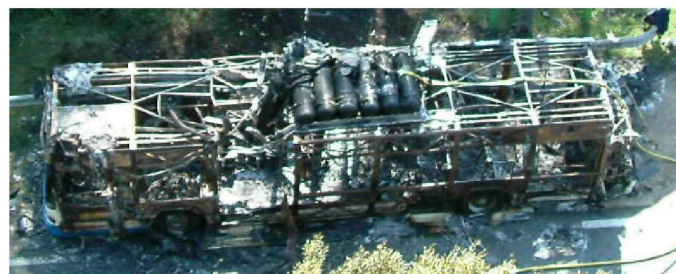
Figure 10: Top view of the bus (Courtesy SDIS 25)

2. Localised thermal aggression that caused tank mechanical strength to weaken and tank to burst:
  - The fire broke through the roof opening located 20 cm ahead of tank n°1 and caused a severe localised thermal stress in the middle part of tank n°1,
  - A horizontal jet flame may have come from tank n°2 PRD release and also caused a severe localised thermal stress to the bottom of tank n°1. This abnormal horizontal jet flame is a possibility since on one hand firemen witnessed horizontal jet flames and on the other hand PRD outlet deviators (on even tanks) have been found pointing horizontally when investigating bus remains. Deviators may have collapsed during the fire or some times before due to vibrations or other operational constraints.

Some learnings are common with the German case and some others are specific. First of all, it is advisable to avoid roof openings unless they can offer a fire resistance at least equivalent to that of the roof as well as any design that may cause tanks to suffer from localised thermal stress in a fire scenario.

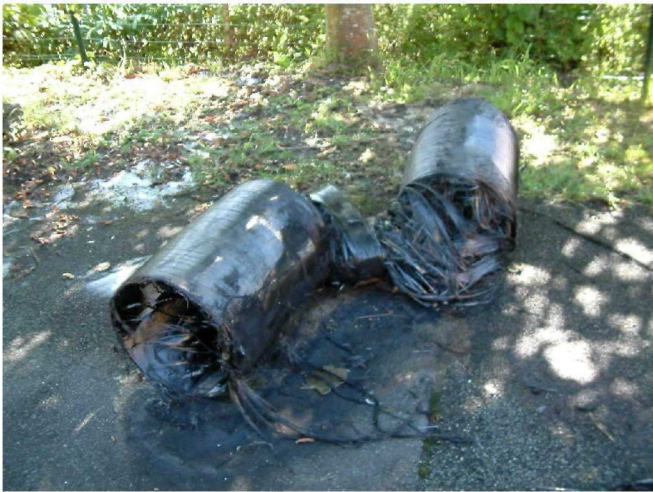
Figure 11: Tank n°1 after burst (Courtesy SDIS 25)

1. Excessive depressurisation time or no depressurisation at all for tank n°1:
  - PRDs which were mounted on the bus were not of a fast release type since they were fitted with a 1.5 mm flow limiter orifice in order to comply with an ancient French draft regulation dated from 1996 (before ECE R110 took over) that required emptying time to be comprised between 25 to 35 minutes. This surprising timeframe which is not compatible with bus fire kinetics was deemed to mitigate gas releases through PRDs in confined spaces like tunnels or parking structures,
  - Since tanks are not isolated one from the others the pressure drops evenly in the entire tank system. However, if one tank is manually isolated from the others, its internal pressure will not drop unless its sole thermal fuse is actuated (single thermal fuse located upstream from manual valve for odd tanks like tank n°1 and

located on the bottom boss of the tank for even tanks). The tank n°1 manual valve may have been voluntarily shut off in order to use its gas content as a back up.

Then, it is advisable that tank complete emptying take place within few minutes after the PRD opened. In that case, detailed study should be undertaken for accidental release of natural gas inside confined spaces like tunnel or parking structures as explosion may occur.

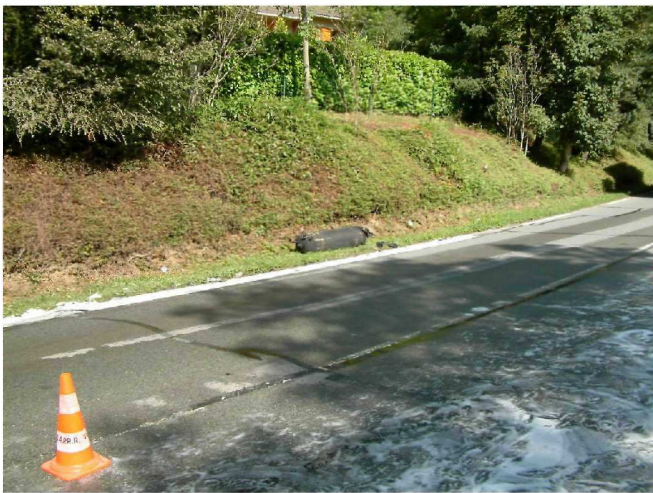
Figure 12: Tank n°2 propelled on the other side of the road (Courtesy SDIS 25)

Out of the 11 PRDs mounted directly on tanks, 3 have been lost during the accident: the one mounted ahead of tank n°1, the one mounted on tank n°1 (plus its manual valve) as well as the thermal fuse of tank n°2. It is therefore not possible to conclude on any failure of these thermal fuses<sup>4</sup> such as:

The PRD outlet must be so designed that the fire jet can only point upward and can not in any circumstances impinge a nearby tank.

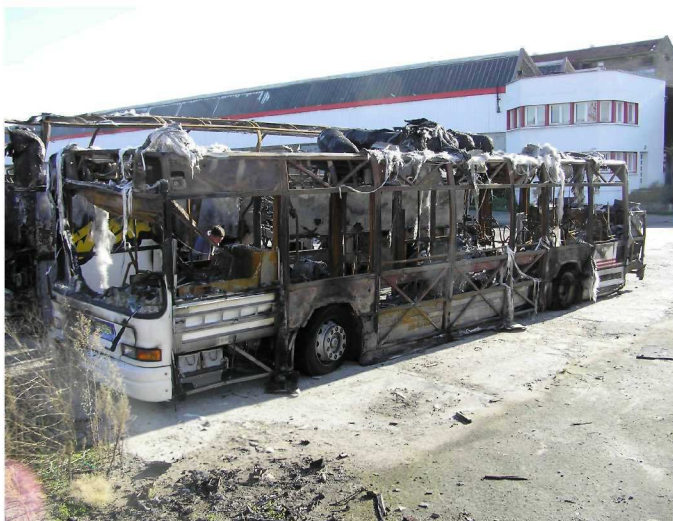
The bus concerned by this later accident is exactly of the same type as the one we have just presented in the Montbeliard case though accidental circumstances are different. On the 8th of November 2005, at 6:50 pm, vandals deliberately threw a Molotov cocktail inside the passenger compartment at the rear of the bus. At that time the remaining pressure inside the storage system was estimated between 100 and 70 bar. Witnesses reported that the fire propagated rapidly and soon broke through the roof panel mounted 20 cm ahead of tank n°1. Tank n°1 burst within 10 minutes after fire broke out and before the fire brigade arrived. Horizontal jet flames were also witnessed meaning that PRD release deviators did also collapsed. Finally, firemen reported various moderate deflagrations. Damages were limited and nobody was injured as a result of this accident.

Figure 13: View of the bus after the fire (courtesy bus manufacturer)

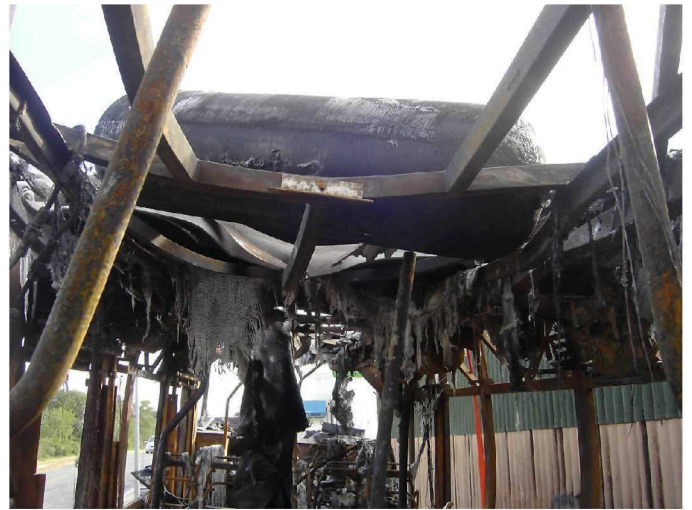
Figure 14: View of tank n°1 that exploded (one half)

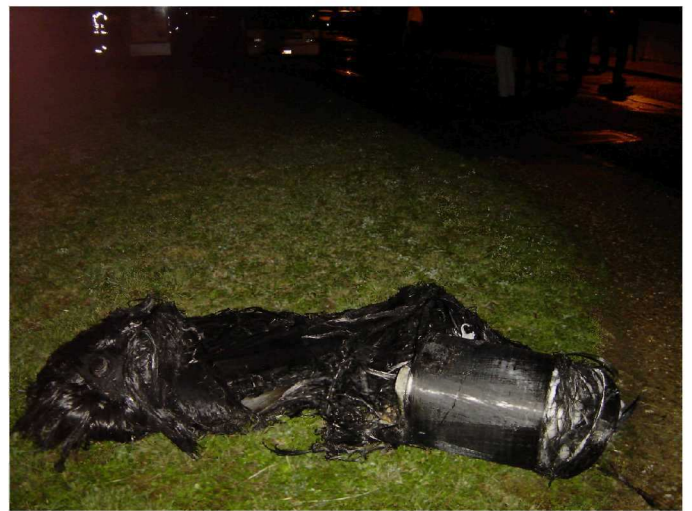
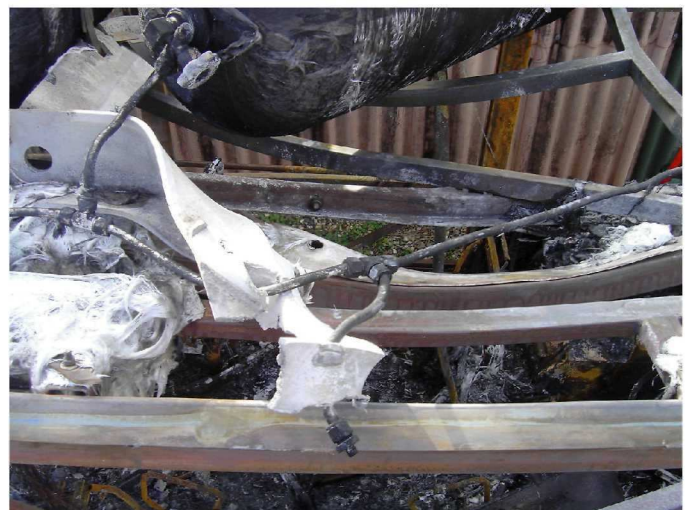
Figure 15: View of the bus from the inside (tank n°2)

Figure 16: View of the bus from the inside (tank n°2)

Learnings from the Montbéliard and Saarbrücken cases also fully apply to this one. However, we can also, in that specific case, underline the vulnerability of buses when submitted to vandalism as fire propagates very rapidly: tank n°1 exploded before the fire brigade arrived. A fire suppression system located in the engine room as suggested above would have been of no use in this specific case. Therefore, additional fire safety measures should be thought of as discussed in the next paragraph.
