## **CNG buses fire safety : learnings from recent accidents in France and Germany**

Lionel Perrette, Helmut K. Wiedemann

Institut National de l'Environnement Industriel et des Risques (INERIS) / France

TÜV Saarland Holding, Sulzbach Saar / Germany

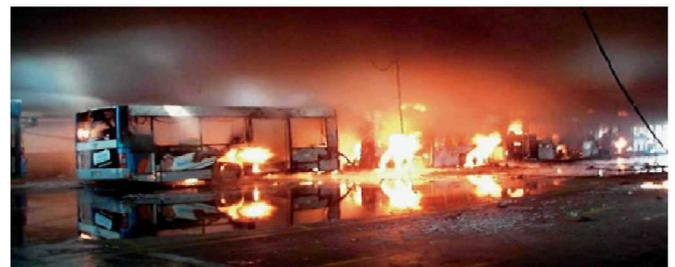
The fire propagated from the back of the first bus to another articulated bus parked in a row at 1.5 meters behind. At 3:09 pm the fire is well developed inside the depot and violent explosions occur. These explosions are caused by the release through actuated PRDs, mixing and later combustion of natural gas inside the depot. Both buses have been burnt out whereas the other ones have been extracted from the depot before they caught fire. The first bus burnt from the back to the front. The second bus burnt the opposite way.

Figure 3: View of the fire once it was under control (from [6])

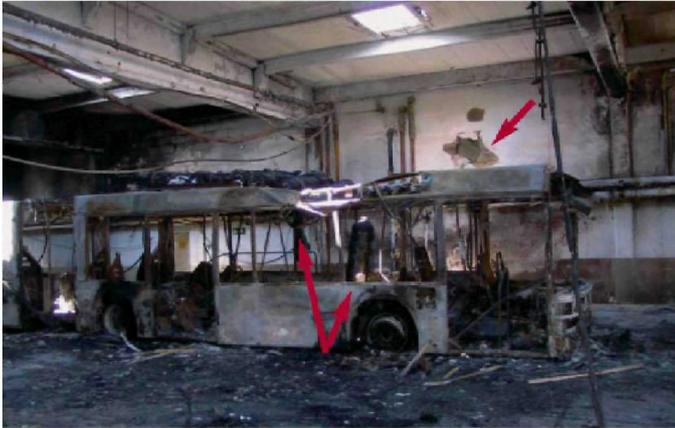
It went a different way for one of the tanks mounted on the second bus whereas the fire was “under control”. The tank burst about 15 minutes after the fire started. A large tank fragment was propelled in the tank axial direction. It broke through a nearby wall (hole at 3 meters from ground level) flew through the air and damaged another wall located 25 meters further and ended up its journey on the roof of a bus parked in a nearby depot. The tank that burst was the first in the row

Figure 4: Destroyed bus with red arrows pointing (from right to left), tank n°3, hanging tank n°2 and hole through which tank n°1 flew (from [6])

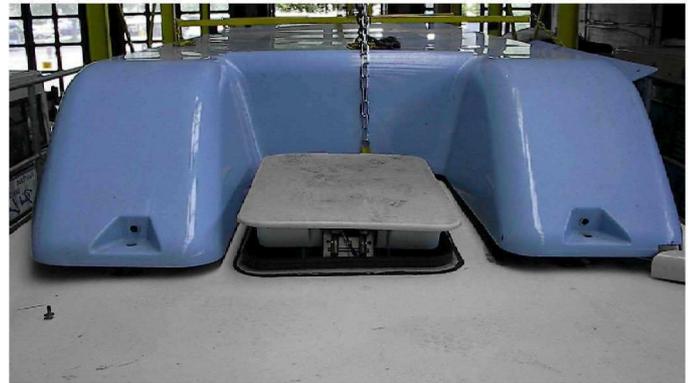
Figure 6: Roof opening ahead of tank n°1 (from [6])

- on one hand it suffered a local fire stress when a fire-induced short-circuit triggered the opening of a roof door mounted nearby tank n°1 (Picture 6). Flame broke through this opening and heated up tank n°1 in its middle part,
- on the other hand, PRDs mounted on tank n°1 did fail to open, hence preventing the tank from depressurising. Investigation concluded that failure to open was caused by an insufficient heat up of the PRDs that did not melt completely. The protective cover mounted on the top of tanks contributed to prevent sufficient heat to reach the PRDs.

Some learnings are common with the German case and some others are specific. First of all, it is advisable to avoid roof openings unless they can offer a fire resistance at least equivalent to that of the roof as well as any design that may cause tanks to suffer from localised thermal stress in a fire scenario.

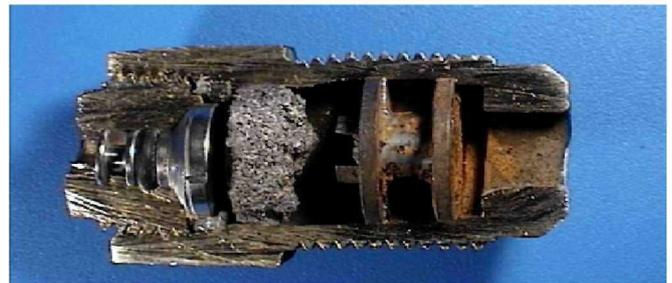
Figure 7: Example of one closed PRD from tank n°1. Picture shows that the metal fuse did not have time to melt completely (from [6])

In that case PRDs did not fail because they froze<sup>3</sup> but because flames heat did not reach them fast enough. Therefore, a tank system that survives a bonfire test may not survive in a real life situation, similarly a fuse that works correctly in test condition may operate differently in real life conditions. Indeed, as the bonfire test only focuses on the tank system and does not consider the entire vehicle, it misses synergetic effects induced by the association of tank system and the vehicle. This remark underlines that tank fire protection and bus fire safety can not rely only on the performance of isolated protected tank systems.

Further developments of the current “bonfire test” are necessary in order to consider the entire vehicle as suggested also by [7] & [8]. Besides, any opening underneath or nearby the tank must be avoided (or be sealed and fire resistant). Finally, PRD performance and potential failures should be further investigated including

appropriate location that does not shield them from heat or allow them to freeze. As far as freezing is concerned, new PRDs exist with fuse made of glass-cylinders containing expanding liquids. Glass breaks up at 110°C and completely free the release orifice with no possibility of PRD reclosure.

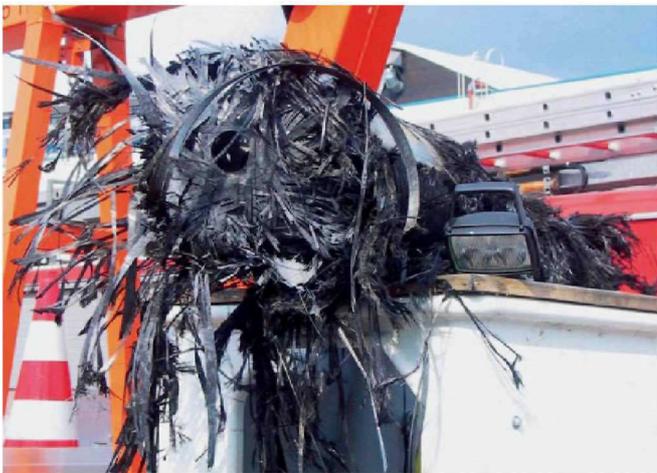
Figure 5: Remains of tank n°1 after it landed (from [6])

Investigation lead to the following explanations. Tank n°1 burst for two concomitant reasons:

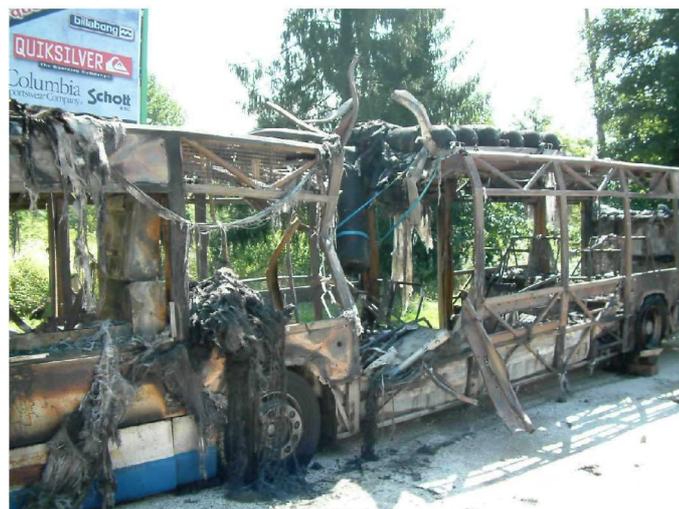
Firemen stood at a safe distance in front of the bus and tried to cool down the tank system with water spray. 10 minutes later at 6:51 am, the front cylinder exploded causing slight and directional damages to the environment within a distance of 100 m. Damages were caused by tank debris (tank n°1 damaged the roof of an adjacent house after a 30 m fly) and overpressure (poster frame unhooked and damaged sliding shutters 60 m away from explosion). As it burst, tank n°1 also propelled the adjacent tank to the other side of the road (10 m away). The tank n°1 ruptured in large pieces whereas carbon fiber could be found as far as 150 m away. Tank n°1 valve and associated fuse have not been found after the accident. Bursting noise could be heard at a 5 km distance. Firemen did not report any noticeable fireball though they felt a transient heat. Nobody was injured.

Figure 9: Side view of the bus with tank n°3 hanging (Courtesy SDIS 25)

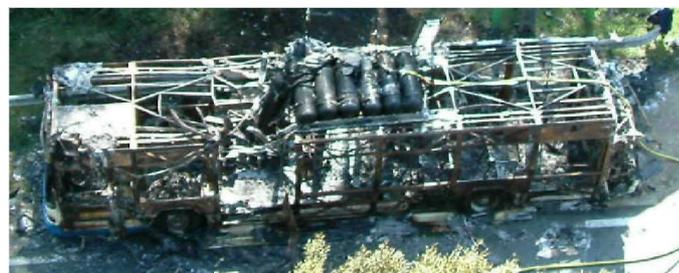
Figure 10: Top view of the bus (Courtesy SDIS 25)

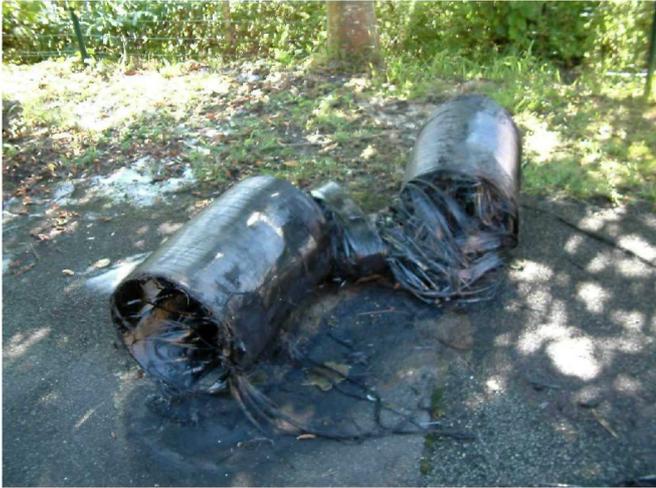
Figure 11: Tank n°1 after burst (Courtesy SDIS 25)

1. Excessive depressurisation time or no depressurisation at all for tank n°1:
  - PRDs which were mounted on the bus were not of a fast release type since they were fitted with a 1.5 mm flow limiter orifice in order to comply with an ancient French draft regulation dated from 1996 (before ECE R110 took over) that required emptying time to be comprised between 25 to 35 minutes. This surprising timeframe which is not compatible with bus fire kinetics was deemed to mitigate gas releases through PRDs in confined spaces like tunnels or parking structures,
  - Since tanks are not isolated one from the others the pressure drops evenly in the entire tank system. However, if one tank is manually isolated from the others, its internal pressure will not drop unless its sole thermal fuse is actuated (single thermal fuse located upstream from manual valve for odd tanks like tank n°1 and

2. Localised thermal aggression that caused tank mechanical strength to weaken and tank to burst:
  - The fire broke through the roof opening located 20 cm ahead of tank n°1 and caused a severe localised thermal stress in the middle part of tank n°1,
  - A horizontal jet flame may have come from tank n°2 PRD release and also caused a severe localised thermal stress to the bottom of tank n°1. This abnormal horizontal jet flame is a possibility since on one hand firemen witnessed horizontal jet flames and on the other hand PRD outlet deviators (on even tanks) have been found pointing horizontally when investigating bus remains. Deviators may have collapsed during the fire or some times before due to vibrations or other operational constraints.

Then, it is advisable that tank complete emptying take place within few minutes after the PRD opened. In that case, detailed study should be undertaken for accidental release of natural gas inside confined spaces like tunnel or parking structures as explosion may occur.

The PRD outlet must be so designed that the fire jet can only point upward and can not in any circumstances impinge a nearby tank.

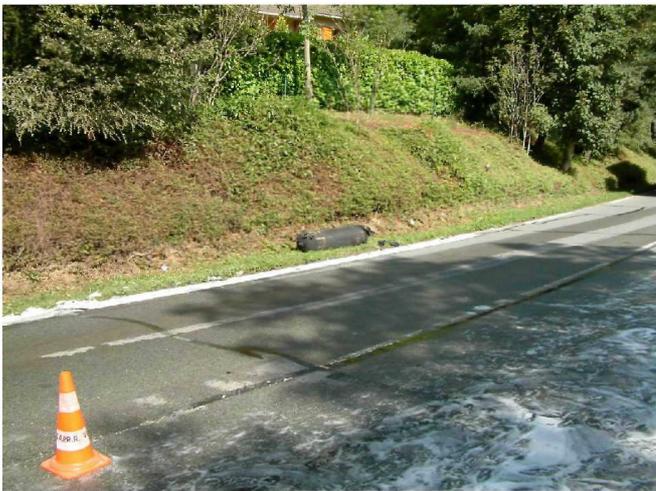
Figure 12: Tank n°2 propelled on the other side of the road (Courtesy SDIS 25)

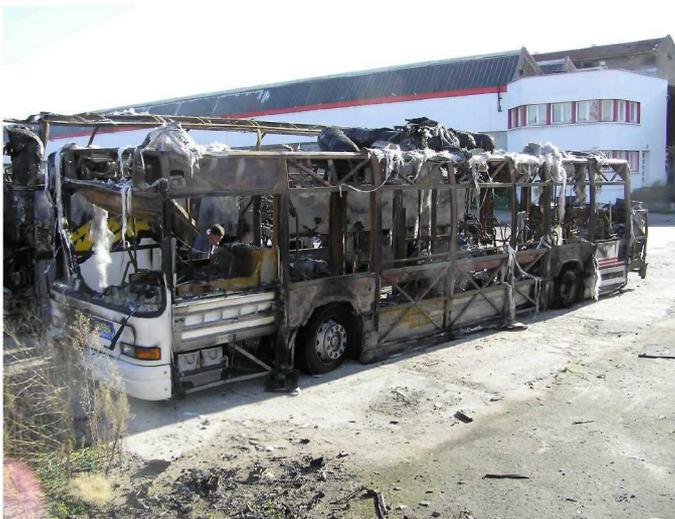
The bus concerned by this later accident is exactly of the same type as the one we have just presented in the Montbeliard case though accidental circumstances are different. On the 8th of November 2005, at 6:50 pm, vandals deliberately threw a Molotov cocktail inside the passenger compartment at the rear of the bus. At that time the remaining pressure inside the storage system was estimated between 100 and 70 bar. Witnesses reported that the fire propagated rapidly and soon broke through the roof panel mounted 20 cm ahead of tank n°1. Tank n°1 burst within 10 minutes after fire broke out and before the fire brigade arrived. Horizontal jet flames were also witnessed meaning that PRD release deviators did also collapsed. Finally, firemen reported various moderate deflagrations. Damages were limited and nobody was injured as a result of this accident.

Figure 13: View of the bus after the fire (courtesy bus manufacturer)

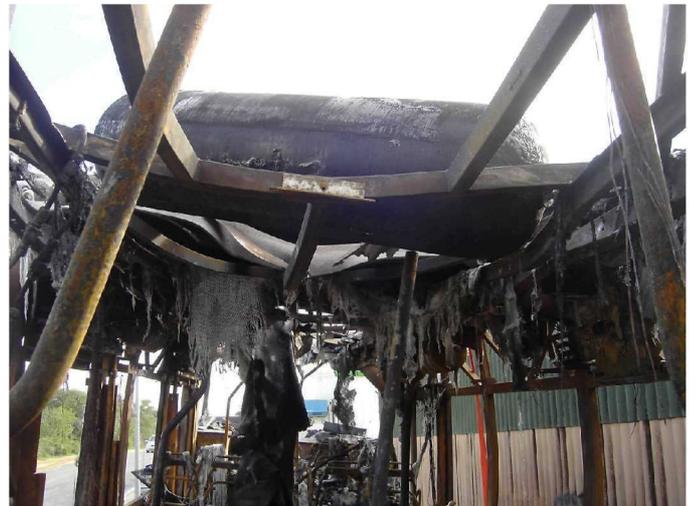
Figure 14: View of tank n°1 that exploded (one half)

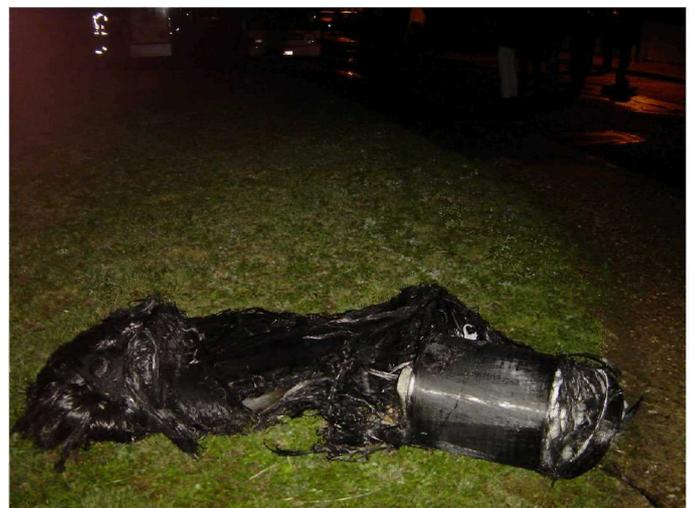
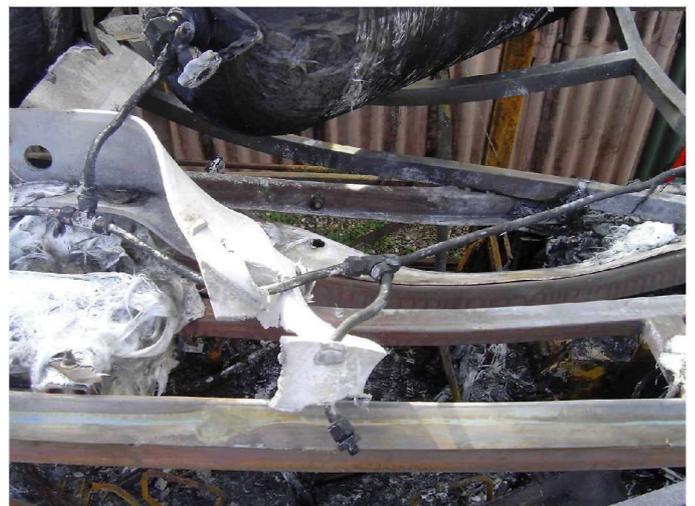
Figure 15: View of the bus from the inside (tank n°2)

Figure 16: View of the bus from the inside (tank n°2)
