# Back-analysis of the collapse of the Clamart chalk underground quarry – Paris (France)

M. Al Heib<sup>\*1</sup>, C. Duval<sup>1</sup>, J.-M. Watelet<sup>1</sup> and P. Gombert<sup>1</sup>

<sup>1</sup> *INERIS, Verneuil-en-Hallate, France*

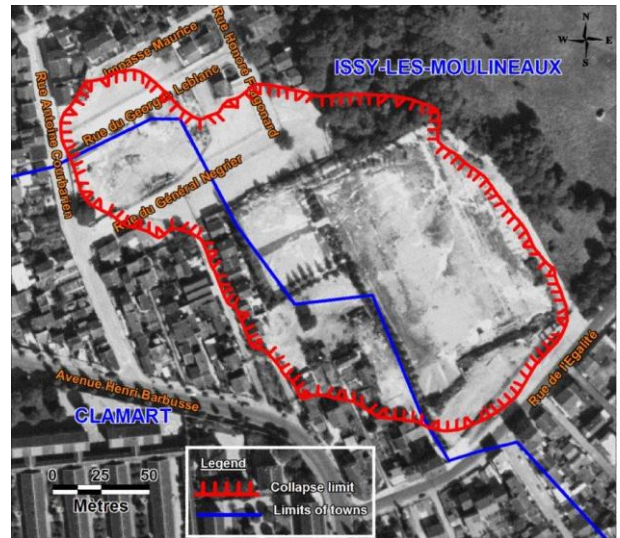
Clamart underground quarry, where mining ceased in the 1880s, caused the abrupt subsidence of three hectares of ground surface and the destruction of a whole urban district, including residential buildings, several roads and sports facilities (Figure 3). Twenty-one people died and more than fifty people were injured.

According to seismographic reports, the ground collapsed in two stages. The southern part, underneath the football stadium (Figure 3), collapsed first, followed by the northern part about half an hour later. The centre of the southern zone suffered the greatest subsidence, at 6 metres. The centre of the northern zone has dropped by 4 metres. Large cracks of about 1 metre wide developed on the edges of the area of the collapse and between the southern and northern zones. As a result of the subsidence, some buildings in the area suffered major damage or were totally destroyed. All buildings shown in black on the figure had to be demolished for safety reasons.

**Figure 3.** The districts of Clamart and Issy-les-Moulineaux after the ground collapse (IGN, August 1961).

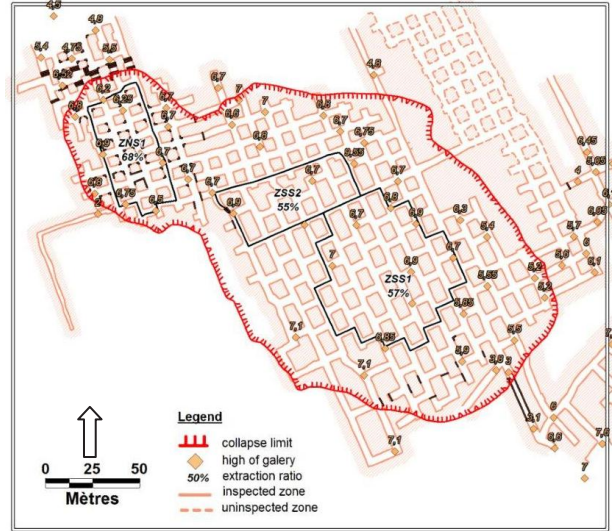
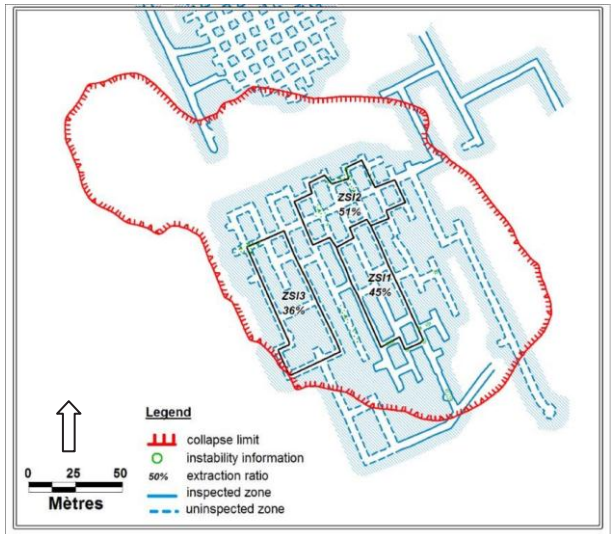
The rooms on the lower level were about 4 metres high and existed only in the southern part, as shown in Figure 5. On the two levels, the area between the northern and southern zones was probably situated on a property line. The interlayer bed (immediate roof of the lower level) was about 4 metres high, and the two levels were perfectly superimposed. The geometrical characteristics of the different underground quarry areas shown in Figure 5 can be found in Table 1. The extraction rate ranges from 36% to 68%. The pillar width/height ratio varies between 0.75 and 1.4.

**Figure 5.** The upper and lower levels of the underground quarry (left and right, respectively, from IGC report).

The minimum pillar stress calculated out of the 6 zones of interest is 1.75 MPa (Zone ZSS1 on Figure 5). This corresponds to the area of maximum subsidence, thus reinforcing the initial hypothesis of the initiation of the collapse.

According to our observations and the known relationship between the underground quarry opening and the subsidence, the maximum subsidence was located in ZSI1 (Figure 5); one can assume that the collapse of the pillars started there. In order to have an idea of the pillars' strength, we assume the factor of safety (FoS) of zone ZSI1 (lower level) to be 1. It must be noted that the safety factor may have been lower (meaning a lower strength of the pillars), but the underground quarry stabilized temporarily for an unknown reason (the resistant limestone roof and/or the local confining pillars by backfilling). Anyhow, given that the pillars were doubtlessly unstable (since they eventually collapsed), the safety factor is 1 at the most and the ultimate strength of the pillars is 1.75 MPa. Considering this value as the failure criterion:

- the failure criterion is exceeded in zones ZSS1, ZSS2, ZSI2, all of which also collapsed;
- the failure criterion is not reached in zone ZSI3, which is still standing;
- the failure criterion is far exceeded in zone ZNS.
