Analysis of failure in a salt room and pillar mine

Institut National de l'Environnement Industriel et des Risques- INERIS, F-60550 Verneuil-en-Halate, France

Failure mechanisms have been investigated in a salt mine (Alsace Potash mines, Esat of France) excavated by the room and pillar method, a part of which is under study for chemical waste storage. This part is located at a depth of about 550 meters. Some singular failure modes appear in the roof mine. These modes are perpendicular to the axis of the gallery and are created by tensile stresses. Such a failure mode is rarely observed in classical mines (coal, construction stones, etc.). 3D modelling of the site has been required for accurate description of the physical mechanisms. The results show that the failures and more generally the roof behaviour are controlled by the deformation of the pillars inducing tensile forces in the roof. The results also show that the creep or the viscoplastic behaviour of the salt is a key element that explains the existence of such failure and their evolution over time. A parametric analysis of the properties of overburden, geometrical pillar features slenderness, confirm the conclusion. Namely

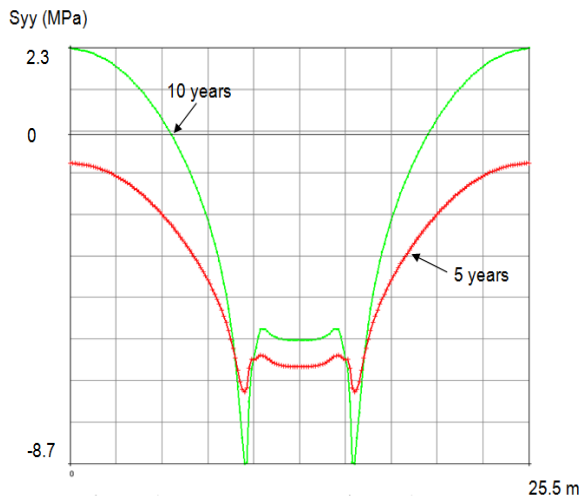
Figure 12 shows the distribution of horizontal stress S_{yy} along Line L at two moments: 5 and 10 years. Initially (all structures in virgin state), S_{yy} equals around -13 MPa (negative due to compression).

The redistribution of the stresses due to the works (here modelled with no phasing and virtually instantaneous) at $t=0$ changes continually over time. Note, for example, that 5 years after the works, S_{yy} stress is still under compression but gradually comes under traction domain.

Figure 12: Distribution of horizontal stress S_{yy} along line L at 5 and 10 years (computed using the reference model). The horizontal-axis represents the distance in m and the vertical-axis the stress in MPa. The sign convention is that of continuum mechanics (stress positive in traction and negative in compression).
