# Analysis of failure in a salt room and pillar mine

Farid Laouafa, Mehdi Ghoreychi

Institut National de l'Environnement Industriel et des Risques- INERIS, F-60550 Verneuil-en-Halate, France

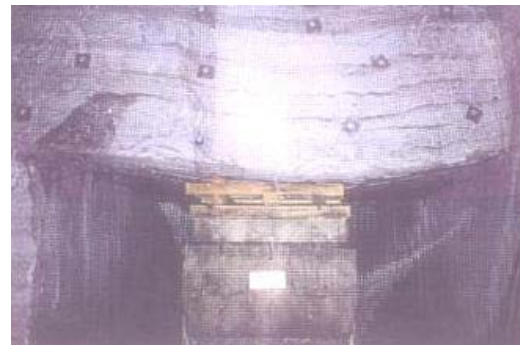
Figure 5: Example of separation of roof (source, MDP A 2015).

As for bed separation (Figure 5), this affects the bed of rock salt in the roof immediately above the

tracks at the marly-anhydrite insoluble interlayers that are frequent at MDPA site.
