## Analysis of failure in a salt room and pillar mine

Farid Laouafa, Mehdi Ghoreychi

# Analysis of failure in a salt room and pillar mine

Institut National de l'Environnement Industriel et des Risques- INERIS, F-60550 Verneuil-en-Halate, France

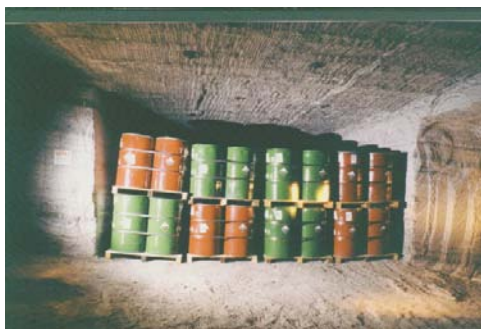
Figure 1: Example of waste storage.

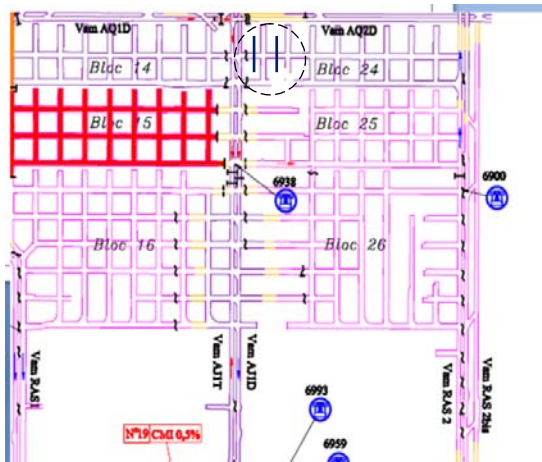
The site examined by this study covers an area of about 4 hectares, 700 m x 600 m. It is located at a depth of approximately 550 m and exploited by the classical abandoned room and pillar method. The pillars are 20 m x 20 m square. The chambers are 5.5 m wide and 2.8 m high (Figures 2 and 3). The worked proportion (ratio of excavated surface to total surface) is 38%. Storage is accessible through aisles called double tracks, 4m wide, separated by 3m-wide pillars.

Figure 2: Section through Storage Area and location of cracks (blue) (MDPA, 2015) (Key: Bloc – Block).

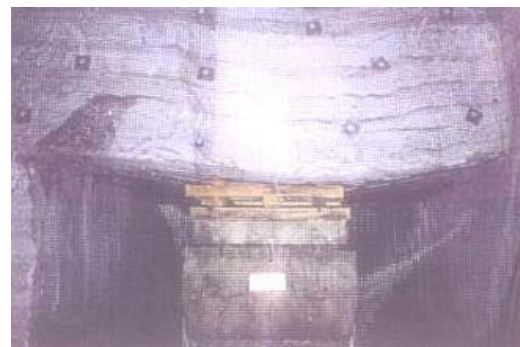
Figure 5: Example of separation of roof (source, MDP A 2015).

As for bed separation (Figure 5), this affects the bed of rock salt in the roof immediately above the

tracks at the marly-anhydrite insoluble interlayers that are frequent at MDPA site.

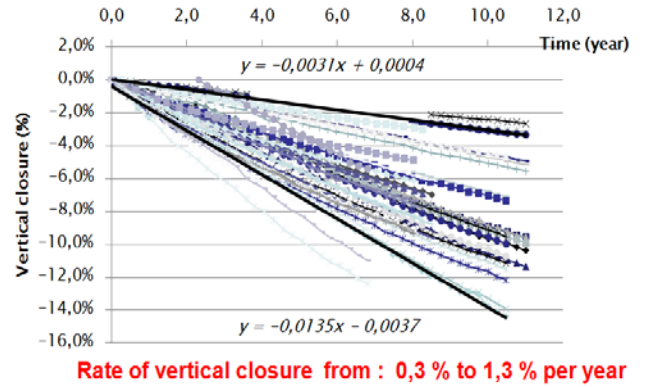
Figure 6: Rate of vertical closure, at different points of the mine (MDPA 2015).

Figure 6 clearly shows the linearity of convergence as a function of time, hence the use of the Norton model described below. For this model, the rate of viscoplastic strain  $\underline{\underline{\dot{\epsilon}}}^{vp}$  is expressed as follows (in tensor form):

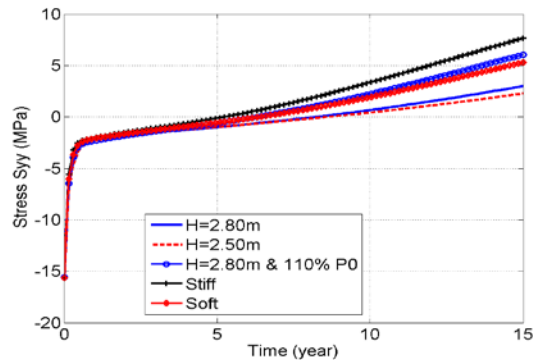
Figure 14: Temporal evolution of horizontal  $S_{yy}$  stress at point B, as a function of time, since excavations began and for the different configurations.

These results show that the creep of the salt pillars is the main factor responsible for these significant variations in stress in the immediate roof area of gallery. The combined effect of this mode of failure and cracking occurred in two perpendicular directions (longitudinal and related roof separation) threatens the security of the site.

This result is confirmed in Figures 13 and 14, which focus solely on the time evolution of the

horizontal stress  $S_{yy}$  at point B and for different configurations (hard or soft roof, slenderness, or excess-load roof).
