## **An underground research laboratory at Château-Landon (France) to study the impact of climate change on the stability of abandoned mines**

Nathalie Conil, Philippe Gombert, Marwan Al Heib, Nicolas Spitzenteder, Roxane Muller, Fabrice Gaumet, Danielle Pajiep

In January 1910, a chalk mine at Château-Landon in the Paris basin brutally collapsed, causing 7 fatalities. This dramatic event was related to the centennial flood of the Seine River and one of its tributaries, the Loing River, which invaded the lower parts of the mine and eventually weakened the entire structure. To understand the conditions that triggered the disaster and anticipate other catastrophic event of this kind elsewhere, the Royer mine, located in the same area, was chosen to host an underground scientific observatory. Its goal is to study water-rock interactions and in particular water circulation and unusual ground saturation conditions on the behaviour of chalk. The Royer chalk mine is shallow, above the water-table, easily accessible and globally stable. It has been equipped with a high resolution multiparameter monitoring network in 2019; all the sensors are connected to The French National Monitoring Cen

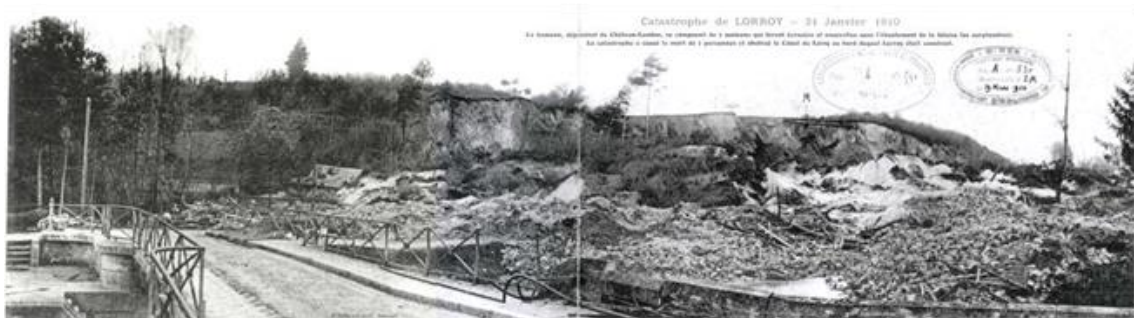
**Figure 4. View of the area after the collapse (source: DRIEE IdF archives) The tear-off surface can be seen at the far end.**

The catastrophic collapse of the Beaulieu mine on 21 January 1910 is the only one that has been documented among the 4 collapses that occurred in the Château-Landon municipality. The sudden collapse of the hillside excavated by the mine and the ensuing landslide (**Figure 4**) took several housings located along the Loing canal and caused the death by burial of 7 people. The volume of material suddenly set in motion is estimated at 100,000 m<sup>3</sup>. The collapse extended over a line of around one hundred meters and the tear-off surface, around twenty metres high, was located about forty metres back from the original edge of the hill.

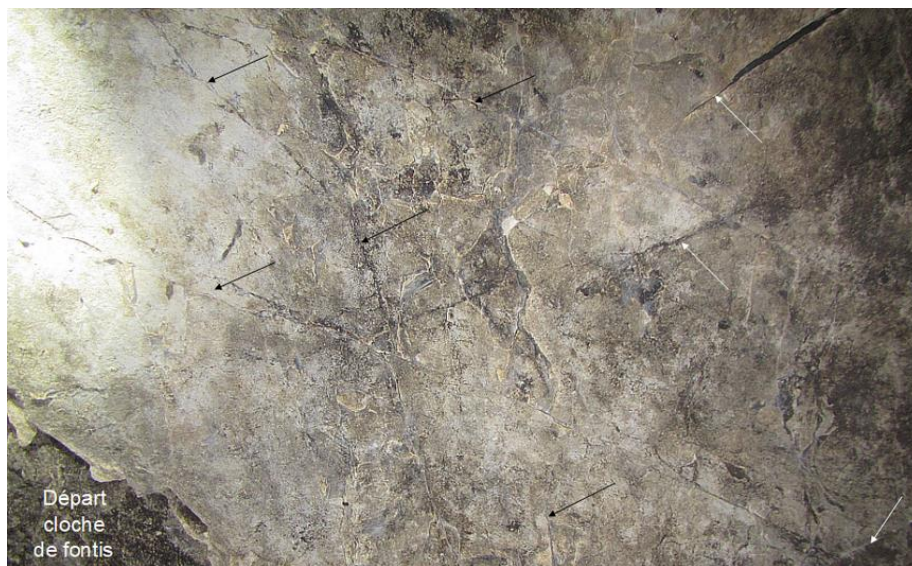
**Figure 13. Photos of the roof of one of the galleries. The multiple conjugate fractures (arrows) testify to the intense fracturing of the galleries (Cerema, 2020).**

In general, the entire gallery is heavily fractured, as is shown by the photos taken from the roof of the gallery (Figure 13), and it is currently difficult to account for this fracturing density using the cartographic surveys, which are not exhaustive. This intense fracturing affects the pillars as well as the roofs of the galleries, with the embankments on the ground hiding the fracturing at the base of the walls. More than three quarters of fractures are without displacement (diaclasses), the majority being closed. Split-level fractures are normal, radial or stepped flaws, showing openings and level differences of a few mm to a few cm. Apart from a few fractures enlarged by karst dissolution processes, the others are open and either dry or filled with brown or ochre clays or a siliceous vein. This latter observation indicates the existence of a fracturing prior to the diagenetic precipitation of silica which may be of tectonic origin. The dip of the fractures is essentially large (> 65 °) to subvertical, which could favour large masses of chalk remaining intact during pillar failure events, without spalling or shearing.

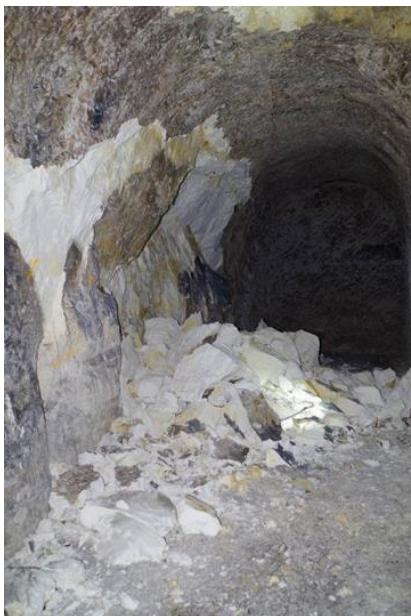
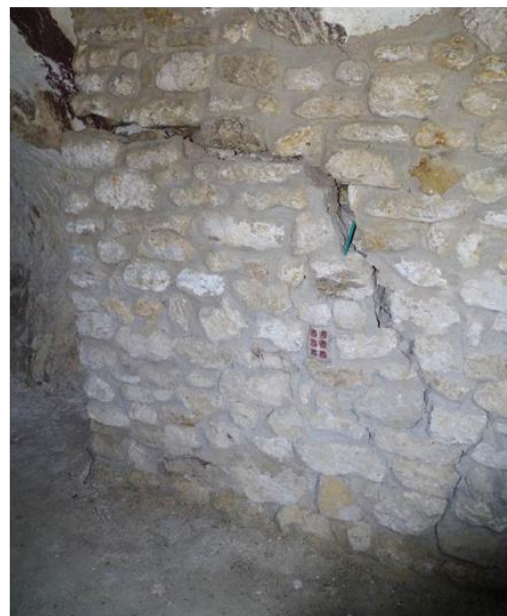
**Figure 15. View of the disorders observed after the extreme hydroclimatic event of June 2016, affecting a fault (on the left) and packing down the brickwork through the remobilisation of the embankments at the base of the galleries (on the right)**

Following the extreme hydroclimatic event of June 2016, although no significant disorder of the structure had been seen previously, spalling on the facings and a collapse along the large identified fault had been observed, as well as movements of the embankment near the entrance (**Figure 15**). This attests to the active character of the deterioration, under the influence of heavy rainfalls which caused more than a once-in-a-century flooding of the Loing.
