An underground research laboratory at Château-Landon (France) to study the impact of climate change on the stability of abandoned mines

Abstract

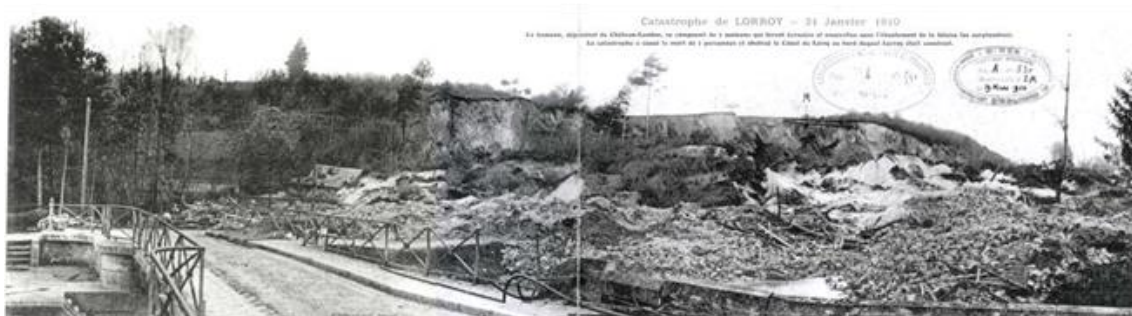
Figure 4. View of the area after the collapse (source: DRIEE IdF archives) The tear-off surface can be seen at the far end.

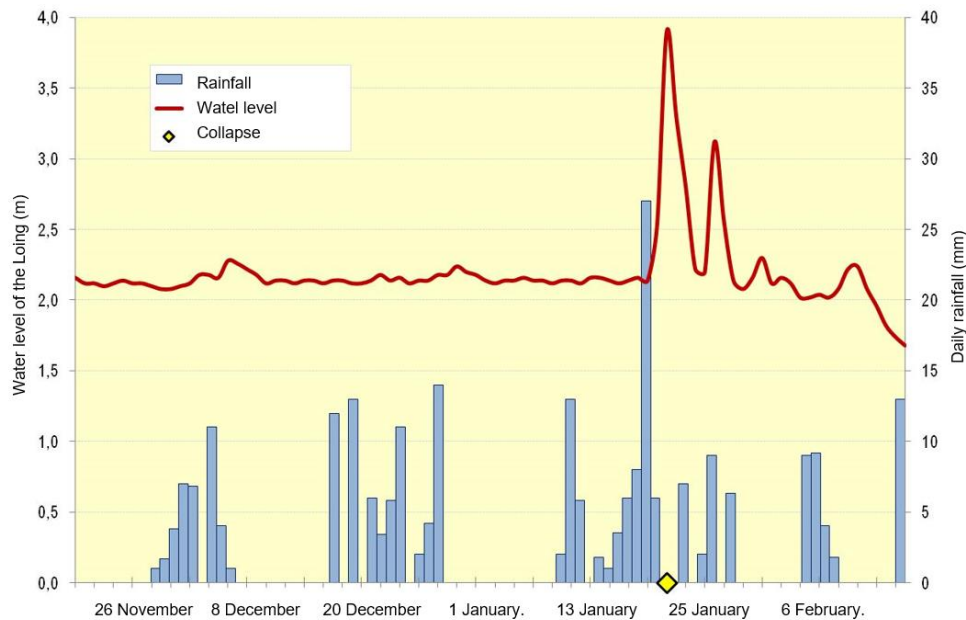
Figure 5. Daily rainfall and hydrology at Nemours during the two months preceding the collapse of 21/01/1910

Gombert & Cherkaoui (2011) propose the following stages of the disaster (see **Figure 5** and **Figure 6**):

- 1) After 10 days of important rainfall (48 mm) on ground made impermeable by frost, a new significant rainfall episode (27 mm) occurred on 19 January 1910;
- 2) The Loing was then heavily flooded the next day, with a peak of 3.90 m at the Nemours scale i.e. a rapid rise of water of about 1.8 m. The Fusain and the Betz local tributaries were also flooded, which contributed to the flooding of the alluvial plain located at the foot of Lorroy hamlet; however, witnesses

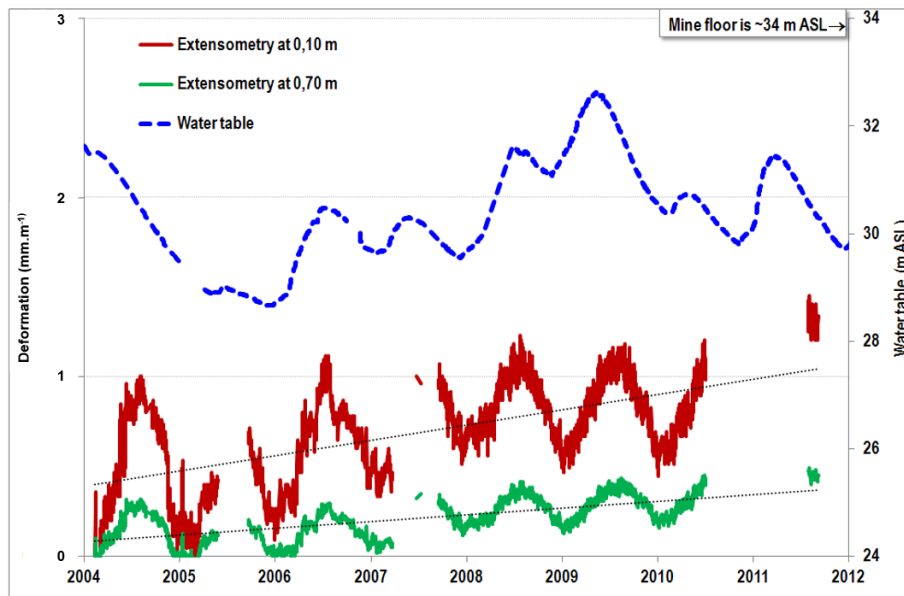
Figure 7. Evolution of the deformation ($\text{mm}\cdot\text{m}^{-1}$) of the pillar at two different depths as a function of the piezometric fluctuations at Estreux chalk mine (Gombert et al., 2013)

a convergence rod, and 3 pore pressure sensors. Additionally, the water table was monitored by a piezometer installed near the access shaft. The monitoring, which lasted 8 years from 2004 to 2012, mainly showed seasonal water table fluctuations marked by a lateral extension of the pillar that were related to piezometric cycles. The amplitude of these fluctuations reached 14% at 0.10 m depth and 5% at 0.70 m depth (Figure 7). In addition, the deformation due to the total extension of the pillar, which is greater in its peripheral zone ($1.34 \text{ mm}\cdot\text{m}^{-1}$) than in its central zone ($0.3 \text{ mm}\cdot\text{m}^{-1}$), shows that the geomechanical behaviour depends significantly on the differences in water content within the pillar, induced by water table fluctuations. However, during the observation period, the pillar deformation remained small in magnitude compared to a state of potential destruction.

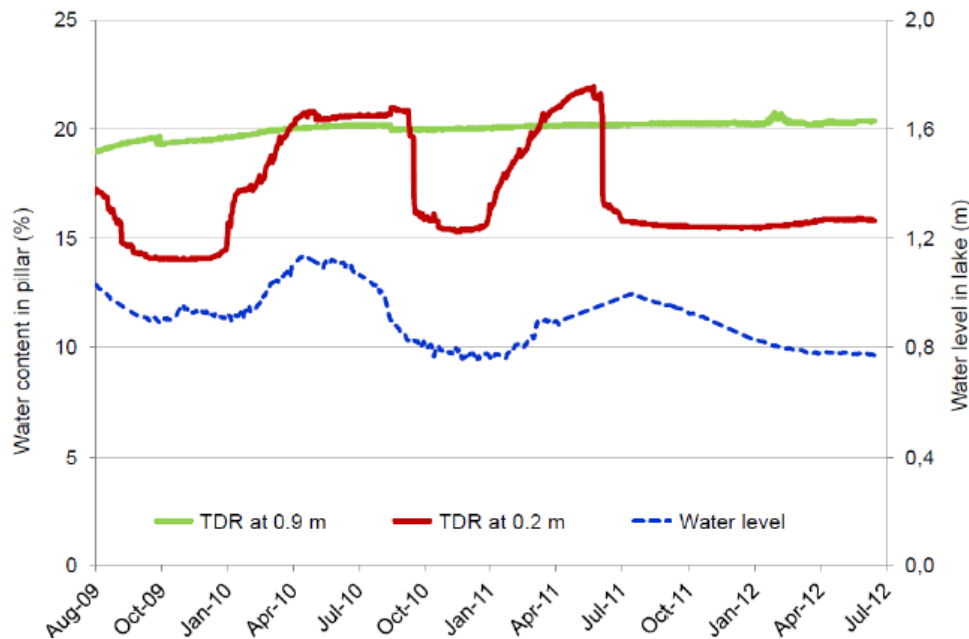
Figure 8. Evolution of the pillar water content at two different depths as a function of piezometric fluctuations at Saint-Martin-le-Nœud chalk mine (Gombert et al. 2013)

The second chalk mine is at Saint-Martin-le-Nœud (**Figure 3**). It has been partially submerged for over a century with water level fluctuations that may reach a metric amplitude (Gombert et al. 2013). Here, also one pillar was instrumented using 2 convergence rods, 2 double-anchored extensometers (0.50 m and 1.0 m), 1 suction sensor and 3 TDR probes to measure the water content of the pillar. In addition, 1 piezometric sensor measured the water level of the lake and its physic-chemical characteristics (temperature, conductivity, pH). Monitoring period was shorter than that of the Estreux mine as it lasted only 3 years from 2009 to 2012. The Saint-Martin-le-Nœud chalk turned out to be more resistant mechanically than expected and relatively less sensitive to water. These findings were consistent with the results obtained on core samples by Lafrance (2016). Besides, the monitoring period ended with a drop in the flooding level, interspersed with a period of slight rise (0.40 m maximum). The recorded deformations were consequently of little significance, but the data revealed the penetration of a moisture front within the pillar to at least 0.20 m depth, associated with hydrological cycles (**Figure 8**).

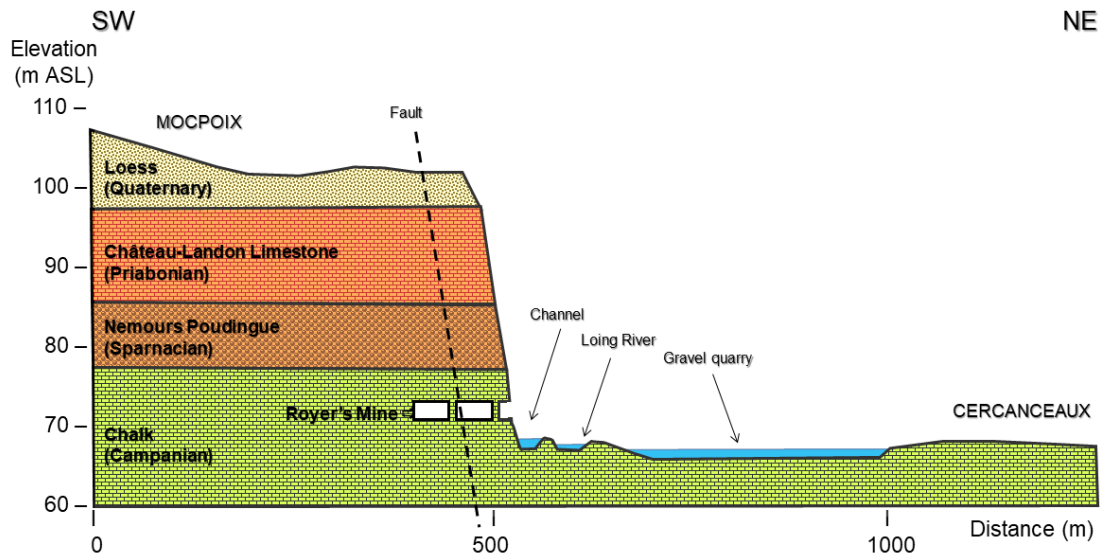
Figure 9. Geological section of the Château Landon site

The Gâtinais plateau is made of sedimentary rocks from the Tertiary era resting on Campanian chalk (c₆) and locally covered with quaternary loess (LP) (Figure 10). The chalk outcrops on the valley edges and bottoms, in a sometimes massive form with flint, sometimes loose and crumbly: it was under this latest facies that it was formerly exploited in mines under the name of "Blanc de Meudon". This formation is overlaid with a few metres of flint clay (RS) then by Tertiary layers which are from bottom to top (cf. Figure 9 and Figure 10):

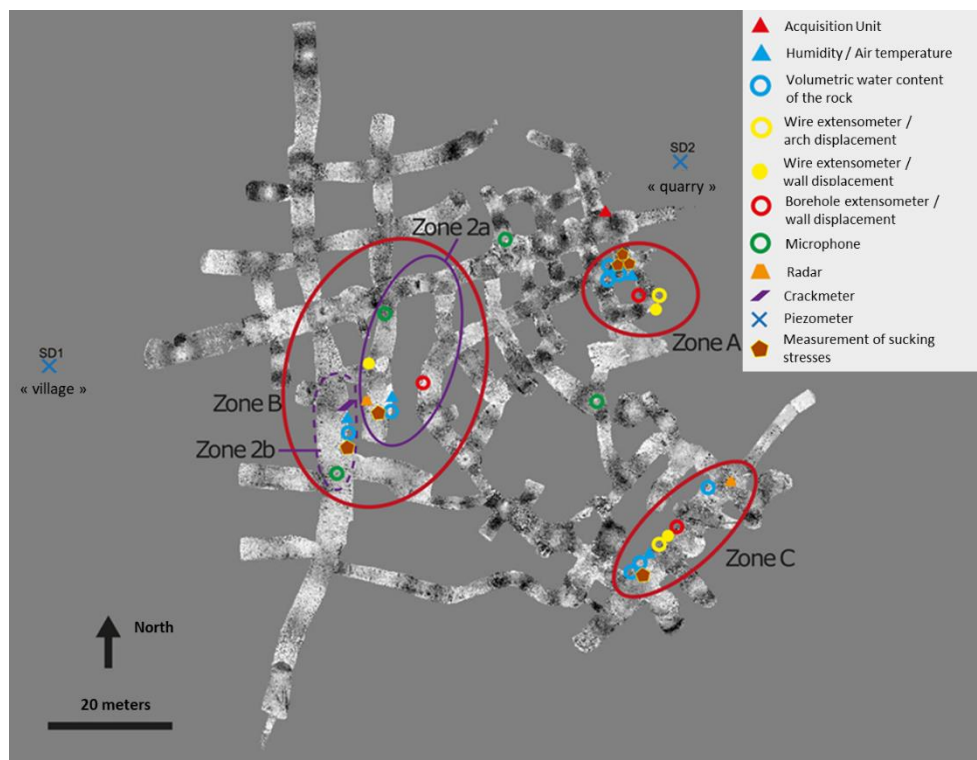
Figure 18. Location of the instrumentation set up in the Royer mine. More than 50 sensors have been installed in the three zones A, B, and C.

Based on these numerical results and on-site observations, two types of parallel monitoring were set up: monitoring of the “water” phase and monitoring of deformations of the rock mass. More than 50 sensors have been installed in areas A, B, and C (Table 2, Table 4) as well as outside the mine (Table 3, Figure 18).

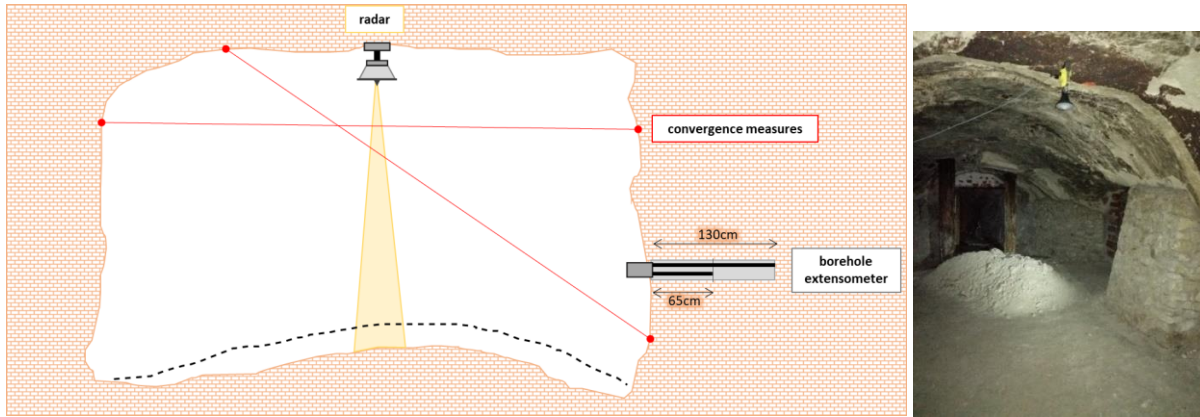
Figure 21. Schematic presentation of the location of the extensometers and radar measurement in the control zone - Zone C' (at left) and photo of the radar (at right)

Zone C, known as the control zone, has been highlighted by simulations (Figure 17), in particular because this part of the mine seems to deform very little in the event of a rise of the water table. Measurements coming from this zone can therefore be compared with zones that are potentially more unstable. Water content sensors have been set up in the embankment in the hope of obtaining an indication of the water table, particularly in the event of an unusual rise. A suction sensor has also been added to the wall. Convergences of the gallery as well as movements of the rock mass are monitored. Finally, a radar has been set up to monitor the movements of the embankment (**Figure 21**). Indeed, let us remember that we assume that the events of 2016 are at the origin of the damage noted in the brickwork which is located nearby (Figure 14).

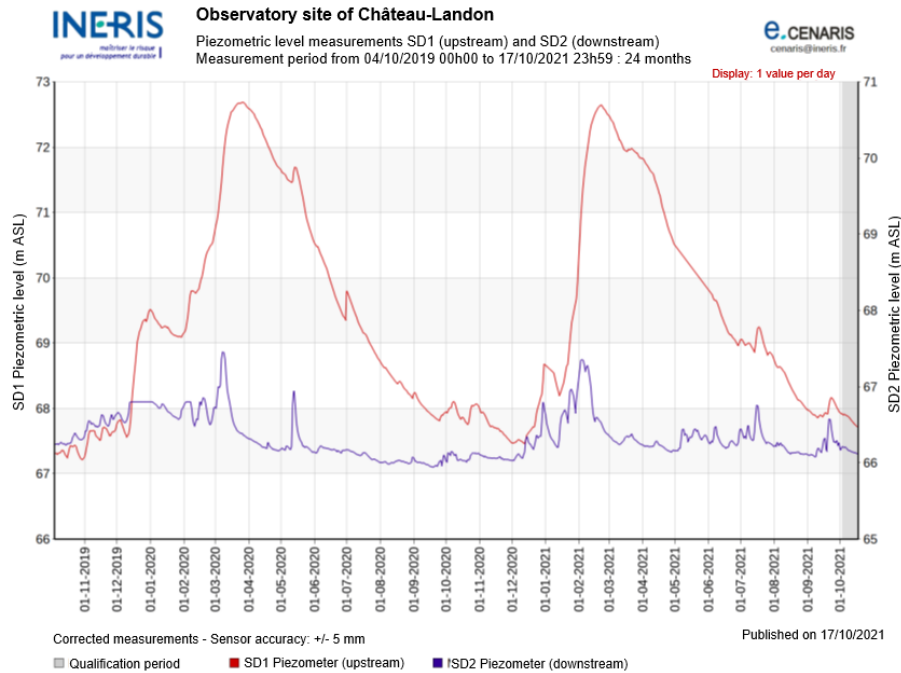
Figure 22. Water table level recorded by the two piezometers SD1 and SD2 since their installation

The first results of the continuous monitoring seem to indicate that while the climatic variations recorded over the year 2021 - particularly regarding the amount of rainfall - are not exceptional, they have clearly influenced the water table of the chalk aquifer (**Figure 22**). On the plateau (piezometer SD1), the average piezometric level of the chalk aquifer is 70 m ASL. Low water occurs in November-December with values below 67.4 m ASL. It is quickly followed by a replenishment which exceeds 72.6 m ASL, with a peak in February-March. The annual chalk water table fluctuation here is therefore of the order of 5.2 m. The behaviour differs significantly downstream of the mine (piezometer SD2), where, under the influence of the Loing, we observe a quasi-stabilisation of the

piezometric level at around 66,7 m ASL, from which some peaks emerge corresponding to the more significant rainy or hydrological episodes. High water levels are brief and also occur in February-March with values above 67.3 m ASL. The annual fluctuation of the chalk water table buffered by the alluvial water table is only 1.3 m here. The Loing canal runs along the foot of the landform where the mine is dug and is located between it and the Loing, about 2 m above the latter. The canal, however, does not seem to play any hydrogeological role next to the mine, because it is probably watertight. On the other hand, it forms an obstacle to the chalk aquifer, forcing it to pass underneath the anthropic channel in order to rejoin the Loing's alluvial aquifer. To complete this setup, and understand the impact of variations in the level of the Loing on that of the water table, a water level meter was recently installed directly in the Loing.
