Back analysis on the pillars behavior during the flooding of the Lorrain iron ore basin (France)

Christophe Didier, Nielen van Der Merwe, Frédéric Poulard

Back analysis on the Lorraine iron ore pillars behaviour.

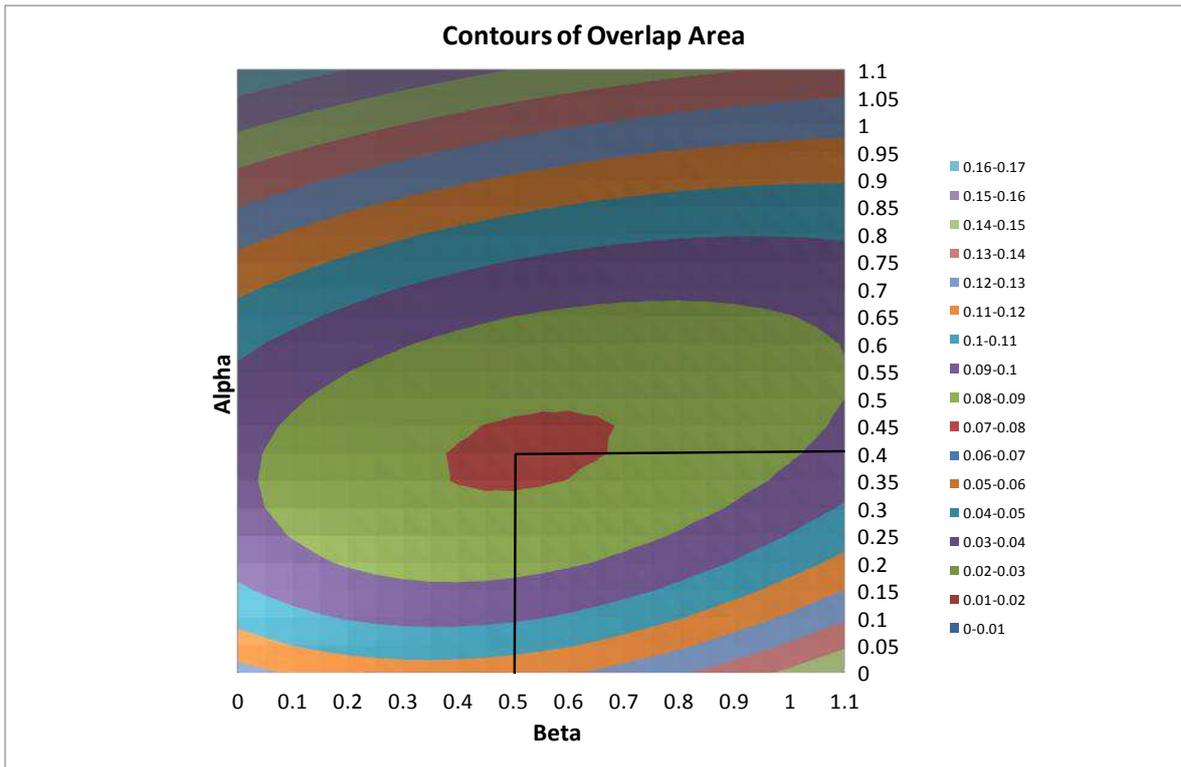
It shows a map of the overlap area value between the distributions of stable and failed safety coefficients. The centre of gravity of the minimum class (less than 8%) corresponds to the combination $\alpha = 0.4$ and $\beta = 0.5$. At this exact point, the overlap area is 7.9%.

Figure 2: Values of the "overlap areas" of the distributions of safety coefficients
for intact and failed pillars according to the values of α and β.

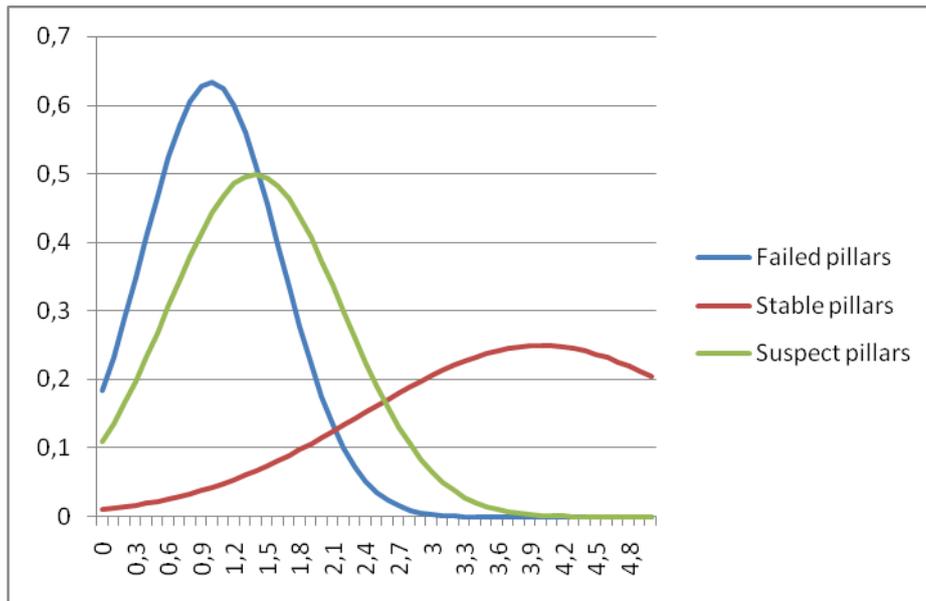
Figure 3 shows various distributions for categories of pillars, based on equation [8]. At this stage, safety factors for the sub set of data in the "Suspect" category were also calculated with Equation 8 and compared to the data sets for failed and intact cases. The three main categories used in constituting the (failed, suspect, stable) database are shown. We note that the area of overlap between the "failed" and "stable" categories is in fact relatively low.

Figure 3: Probability density distributions of safety factors for the stable, suspect and failed pillars.

Logically enough, the distribution for the pillars considered "suspect" shows a profile intermediate between the other two, although very appreciably closer to the "failed" category than the "stable" category. This confirms that the suspect pillars show characteristics that differentiate them very clearly from the long-term stable pillars. Moreover, although of concern, their stability characteristics turn out to be on the average slightly more favourable than those of the already failed pillars (mean safety factor of 1 for the failed and 1.4 for the suspect). This assessment is however only valid at a given time. Everything in fact leads one to expect that several "suspect" sectors will fail in the years to come, thus modifying the present distributions. It will then be particularly interesting to analyse the increase, according to time, in the mean safety factor of the failed pillars.

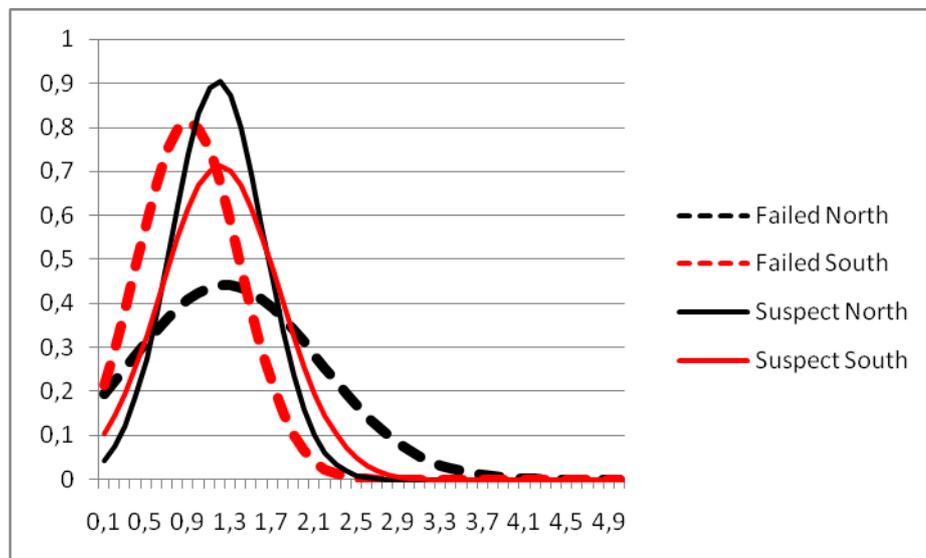
Figure 4 shows the distribution of the failed and suspect pillars for the south and north basins. An initial analysis reveals that the category of failed pillars in the southern sub-basin shows a noticeably less favourable stability configuration than the others. This may provide an initial factor in explaining the large number of failures that occurred during flooding of this part of the basin (presence of very fragile sectors).

Figure 4: Distributions of the safety factors for the pillars of the northern and southern basins.

Moreover, the "stability potential" of the suspect pillars seems very low (both for north and south), as they show a safety factor profile very similar to that of the failed sectors of the north basin. Everything thus leads one to believe that, given the ageing of the rock in addition, several sectors now considered suspect will fail in the years or decades to come.

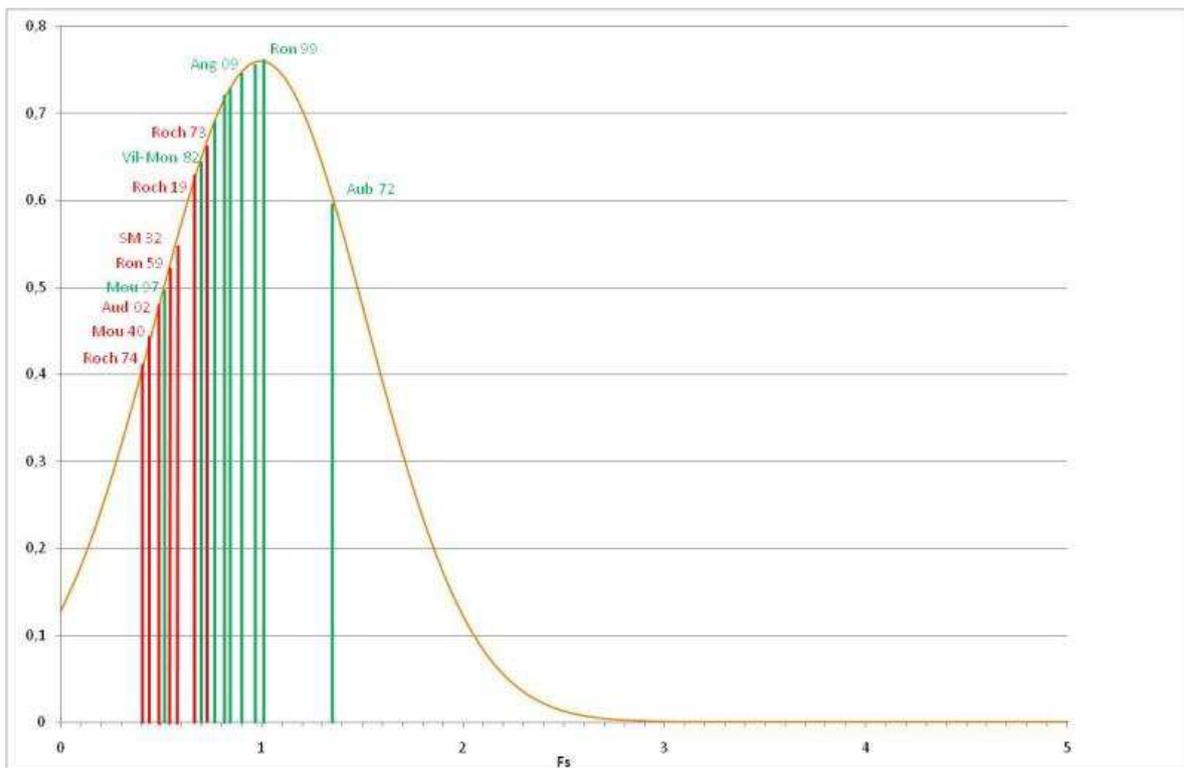
A specific methodology has been established by the group of experts led by Géoderis to identify the sectors at risk of sudden collapse, based on cross-analysis of the weakness of the underground works and the "rigidity" of the soil cover (Josien et al., 2010). Figure 5 gives rise to interesting prospects in terms of use of the approach described in the present paper to identify areas at risk of subsidence and those susceptible to collapse. It shows the location on the normal distribution of the failed pillars, the cases of sudden collapses (in red) and those of progressive subsidence (in green).

Figure 5: Location of past instabilities (in red collapses, in green subsidences).

From the analysis, it emerges that with one exception (Moutiers 97) the formula allows a very clear distinction: the lowest safety factors correspond to sudden events, the others to progressive subsidence. It appears that, in cases of progressive subsidence, the approach even allows the slowest events, hardly perceptible by the monitoring networks (Auboué 72, Roncourt 99, Angevillers), that correspond to the highest safety factors to be distinguished
