## **CNG buses fire safety : learnings from recent accidents in France and Germany**

Lionel Perrette, Helmut K. Wiedemann

# CNG buses fire safety: learnings from recent accidents in France and Germany

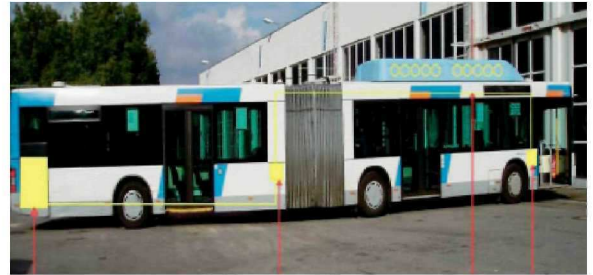
The fire started on a CNG articulated bus in the engine compartment (back of the bus). When the fire took off at 3:00 pm, the bus was parked in a depot along with other

CNG articulated buses. Each articulated bus was fitted with 10 CNG type III PRD protected tanks of 172 L each and filled with natural gas at a pressure of 200 bar.

Figure 2: Side picture of a bus similar the ones that burned (from [6])

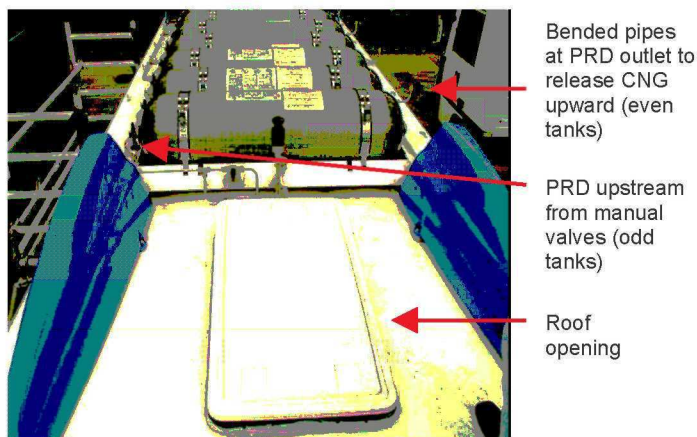
A 12 meter CNG bus was in daily commercial service on the 1<sup>st</sup> of August 2005. This bus was equipped with nine 126 L, 200 bar working pressure type IV CNG tanks. Each of the nine tanks was fitted with one thermal fuse located alternatively on the right or on the left side of the bus. There were two other thermal fuses located respectively ahead and behind the tank system. These two fuses are supposed to open before the fire reaches the tank system (from the front or the rear of the bus).

One single valve isolates the entire tank system from downstream components which means that when the valve is closed the tanks remained connected one to the others. The only way to isolate one tank from the others is to shut down its manual valve. Gas release deviators pointing upwards are mounted on the PRDs outlet in order to discharge CNG in the upward direction.

Figure 8: Top view of a CNG bus of a similar type to the one that caught fire (tank cover has been removed for taking the picture)
