## **CNG buses fire safety : learnings from recent accidents in France and Germany**

Lionel Perrette, Helmut K. Wiedemann

Institut National de l'Environnement Industriel et des Risques (INERIS) / France

TÜV Saarland Holding, Sulzbach Saar / Germany

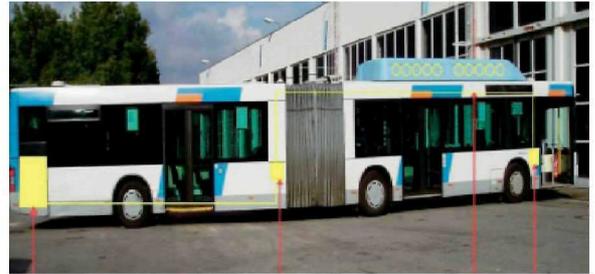
The fire started on a CNG articulated bus in the engine compartment (back of the bus). When the fire took off at 3:00 pm, the bus was parked in a depot along with other

CNG articulated buses. Each articulated bus was fitted with 10 CNG type III PRD protected tanks of 172 L each and filled with natural gas at a pressure of 200 bar.

Figure 2: Side picture of a bus similar the ones that burned (from [6])

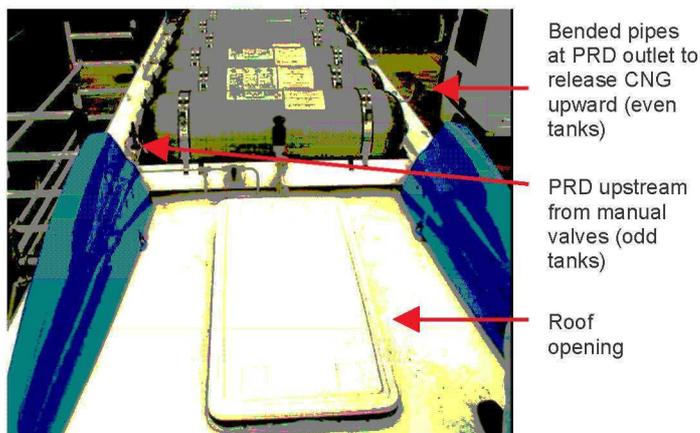
A 12 meter CNG bus was in daily commercial service on the 1<sup>st</sup> of August 2005. This bus was equipped with nine 126 L, 200 bar working pressure type IV CNG tanks. Each of the nine tanks was fitted with one thermal fuse located alternatively on the right or on the left side of the bus. There were two other thermal fuses located respectively ahead and behind the tank system. These two fuses are supposed to open before the fire reaches the tank system (from the front or the rear of the bus).

One single valve isolates the entire tank system from downstream components which means that when the valve is closed the tanks remained connected one to the others. The only way to isolate one tank from the others is to shut down its manual valve. Gas release deviators pointing upwards are mounted on the PRDs outlet in order to discharge CNG in the upward direction.

Figure 8: Top view of a CNG bus of a similar type to the one that caught fire (tank cover has been removed for taking the picture)
