# Multi-scale analysis of water alteration on the rockslope stability framework

Sandra Dochez, Farid Laouafa, Christian Franck, Sylvine Guedon, François Martineau, et al.. Multiscale analysis of water alteration on the rockslope stability framework. 16. French-Polish Colloquium of Soil and Rock Mechanics, Jul 2013, Montpellier, France. pp.NC. ineris-00973700

**ABSTRACT:** Water is an important weathering factor on rock discontinuities and in rock mass mechanical behavior. The increase of rainfall in frequency or in intensity highlights some problems on the rock slope stability analysis. The aim of this paper is the multi scale analysis of the chemical impact of water on rock (surface roughness and matrix). In this study we show how water induces degradation and thus may decreases the stability of the discontinuous rock mass. Water is known to have significant erosion and dissolution effects on rock surface or rock matrix. The chemical features of water such as temperature, pH or salinity make it a "good" candidate to rock degradation. This study has two main components. The first one is the study of water-solid chemical mechanisms and the other is the analysis of the mechanical r

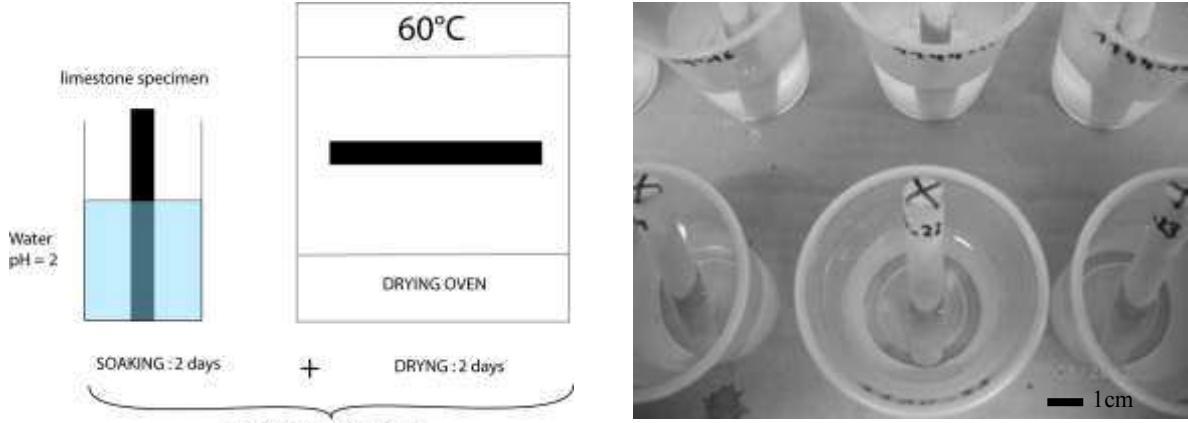
Figure 1: Schematic representation of the two steps of the experiment "alteration in quasi-static regime" which is composed of one cycle of weathering (left). Picture of the first phase of the experiment quasi-static regime limestone samples sticks are soaking in the acidic water (right).

This first experiment consists in leaving limestone's samples at rest in a fixed volume of acidic water (Figure 1). The evolution of weight of each samples during cycles of alteration are measured at different times. A cycle is composed of two steps. During the first step all samples are soaked 2 days in a sulfuric acid solution

at pH 2 then during the second step samples are dried at 60°C for 2 days (Figure 1). The acidic solution is renewed. Thanks to that change, the alteration is more effective by repetitions of these cycles, *in fine*, the samples degradation is increased.

The rock samples are cylindrical (diameter: 12 mm, high 100 mm) (Figure 1). A number of 24 sticks samples are used for each type of limestone. We used four types of limestone: Pierre de Caen (Caen Stone), Pierre de Lens (Lens Stone), Larrys and Comblanchien whose differ by their porosity. Limestones' porosity extend to a range from one to several tens percent. Caen Stone and Lens Stone have a high porosity respectively 20% and 17%, whereas the two others have a low one respectively 7% and 1%.

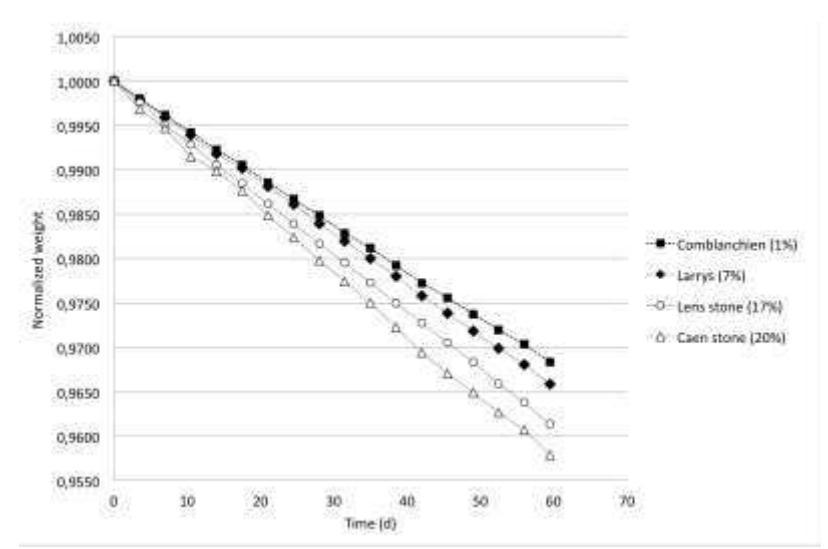
Figure 2: Evolution of sample weight during the experiment Alteration in static regime.

The evolution of each sample weight is measured during the dissolution process. A decrease of weight is measured for each type of limestone. Figure 2 represents normalized weight (weight (t)/weight (0)) versus time of degradation. We noticed linearity with time of the loss of weight for all the type of limestone (Figure 2). This indicates there is a constant rate of dissolution for limestone. In this figure below, we can observe that whatever the giving porosity the rate of decreasing weight is quite constant. However we can observe the higher the porosity, the higher the rate. This difference of rate means that the dissolution process also affects the pores of the matrix although the pore pressure is very small. Moreover the dissolution process has a higher influence on the more porous sample (Caen stone).

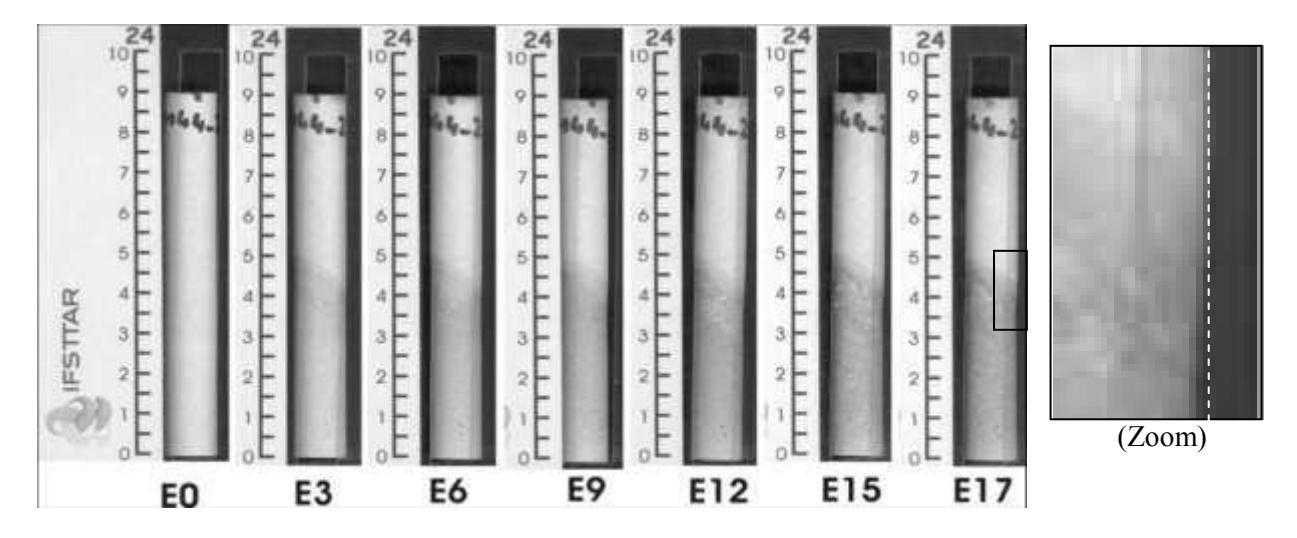
Figure 3: Pictures of Caen Stone samples: Initial state (E0), after 10 days (E3), 20 days (E6), 30 days (E9), 40 days (E12), 50 days (E15) and 60 days (E17).

At the fluid-air interface recognized by the different of coloring, a recession of the surface is observed for each sample of each limestone (Figure 3, Figure 4). This recession suggests a loss of material. The high degradation in this part of the sample is also attributed to the influence of the  $CO_2$  in ambient air. Actually,  $CO_2$  is considered as an important acidifying component of water. The interface is the place where the exchange between ambient air and the water near the surface is the most important, makes it a zone where degradation is improved.

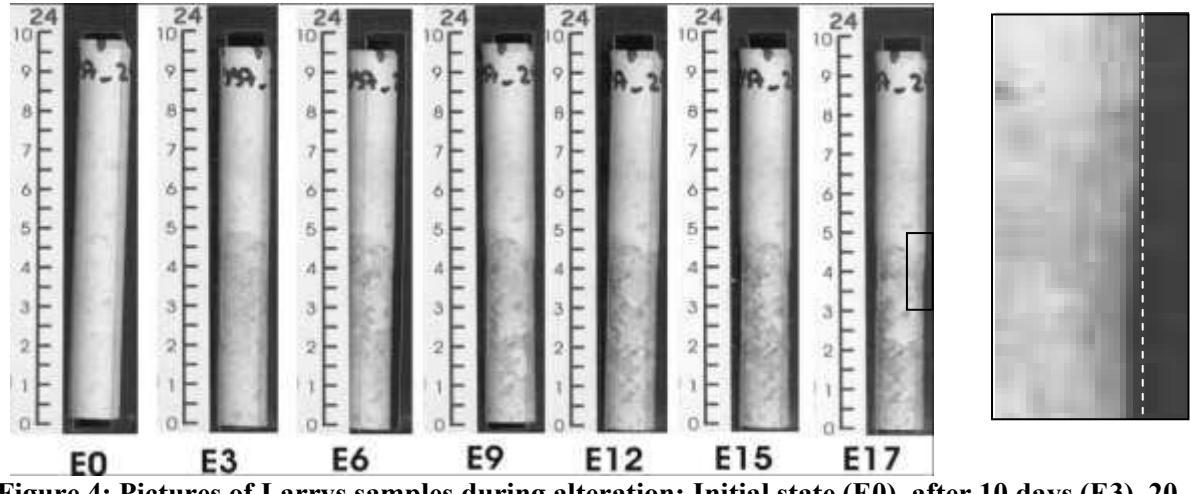
Figure 4: Pictures of Larrys samples during alteration: Initial state (E0), after 10 days (E3), 20 days (E6), 30 days (E9), 40 days (E12), 50 days (E15) and 60 days (E17).

We observe the same high degradation near the interface, for all types of limestone. This information suggests an influence of  $CO_2$  whatever the porosity.

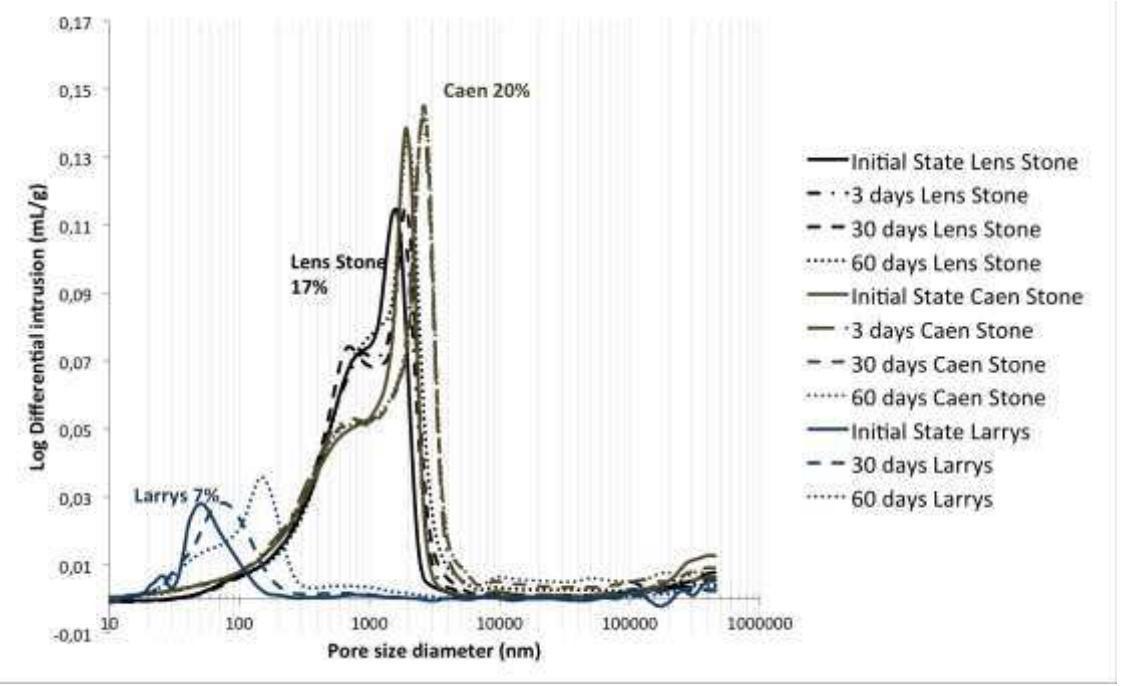
Figure 5: Volume of mercury intrusion versus pore size diameter for samples of Lens Stone, Caen Stone and Larrys and for several state of weathering

In order to evaluate the different states of alteration of the porous matrix evolution inside the sample, mercury intrusion porosimetry (MIP) measures have been done. This method is commonly used to evaluate the total porosity and the pore size distribution of different materials. MIP results are expressed as the total mercury volume intruded (log diffential intrusion) in a sample versus pore size (mean diameter pore). Measures were carried out after several cycles of degradation. The Figure 5 shows the volume of mercury intrusion versus the pore diameter. We represent on the graph three of the four limestone used for the study (Larrys (7%) Lens Stone (17%) and Caen Stone (20%)). First of all we can observe the mean pore diameter increases with the limestone's porosity. Then for each type of limestone there is an increase of the mean pore diameter between the initial state and 3 days of alteration. The alteration increase pore volume. Low porosity sample have little mean pore diameter whereas high porosity have their mean diameter higher. Matrix of Lens Stone and Caen Stone samples are modified after the first cycle. Indeed an aperture of the mean diameter pore is measured after the first cycle but the mean diameter doesn't increase for the other cycles. Nevertheless on Lens Stone, the volume of mercury increases between 30 days and 60 days of alteration. This reveals an increase of pores with same size. Larrys' samples show an increase of the mean diameter pore all along the state of degradation (Figure 5).

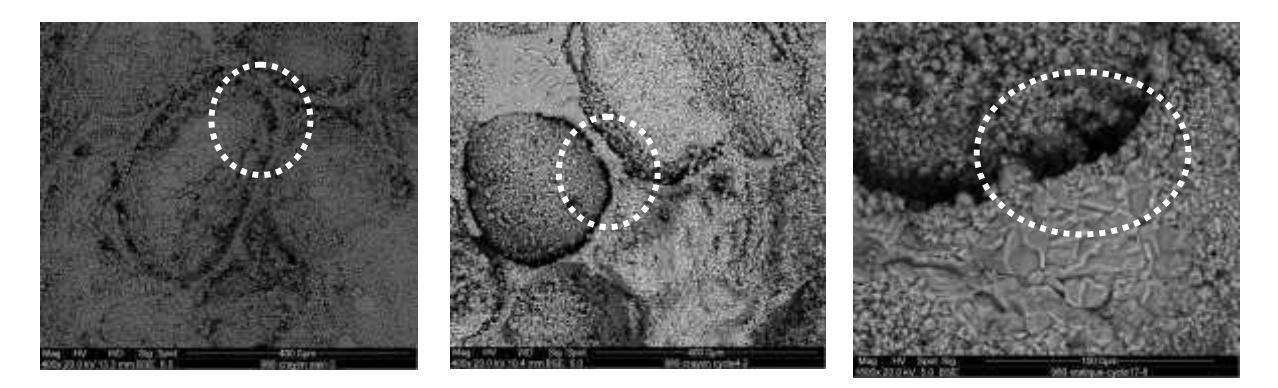
Figure 6: ESEM pictures from sample of Lens Stone at initial state (left) after 10 days (middle) and after 60 days (right). The dash line circles emphasize the gap between oolites; this gap was created during the alteration.

We observe sample of limestone named Lens Stone at micro-scale with an environmental scanning electron microscope (ESEM) (Figure 6). These three pictures show three states of limestone degradation's at different time, the first represents non-altered sample, the second at 10 days of alteration and the last one after 60 days of alteration. The limestone observed is Lens Stone, it is composed of ooids which are spherical grains composed of concentric layers. We observe along the period of alteration a digging around the ooids, which indicates dissolution of calcite. This kind of feature shows the non-homogeneous fact of dissolution either at space scale.

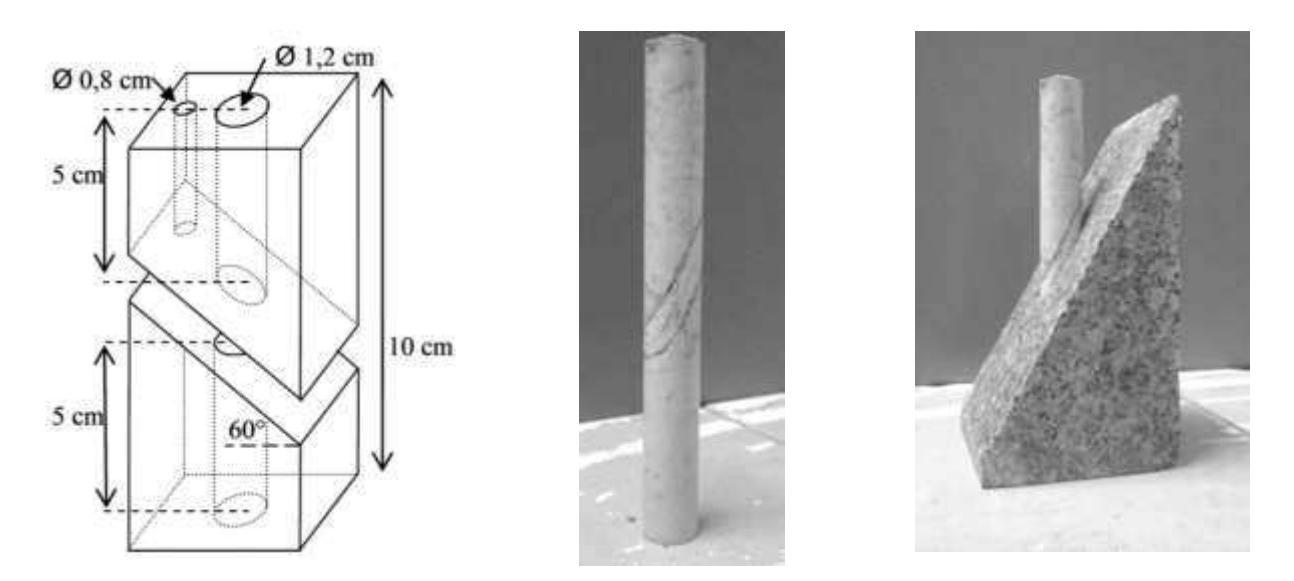
Figure 7: Shape of the granite base with dimension (left) the sample of limestone (middle) are inserted into the granite for the test (right) (after Druon)

In order to the observation and measurement of chemical degradation an evaluation of the mechanical response of the sample submitted to a shear loading is performed. The measurements are made with a uniaxial cell in order to evaluate the influence of alteration on the mechanical properties of limestone samples. We used cylindrical samples (Figure 7) as samples in the alteration in quasi-static experiment. Each sample is positioned in a shaped granite base (Figure 7) and put in the uniaxial cell (Figure 8).

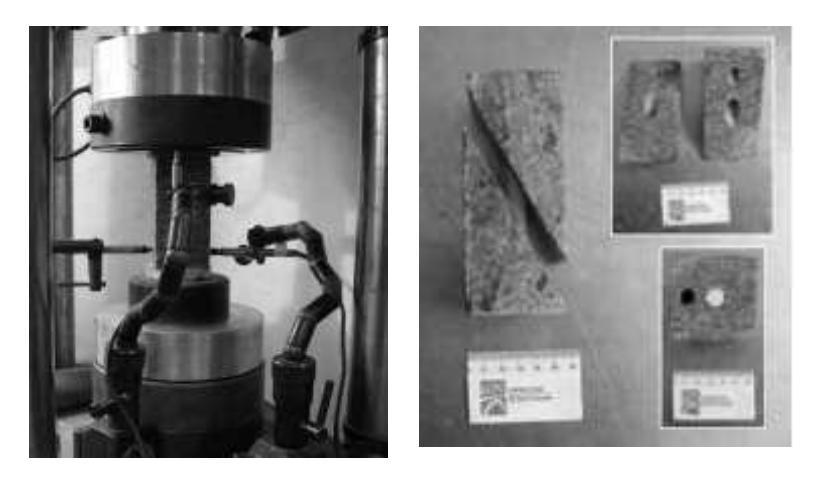
Figure 8: Picture of the uniaxial cell used for the experiment "alteration quasi-static" (left). Sample in the granite base (middle) and the broken sample after the test (right) (after Druon).

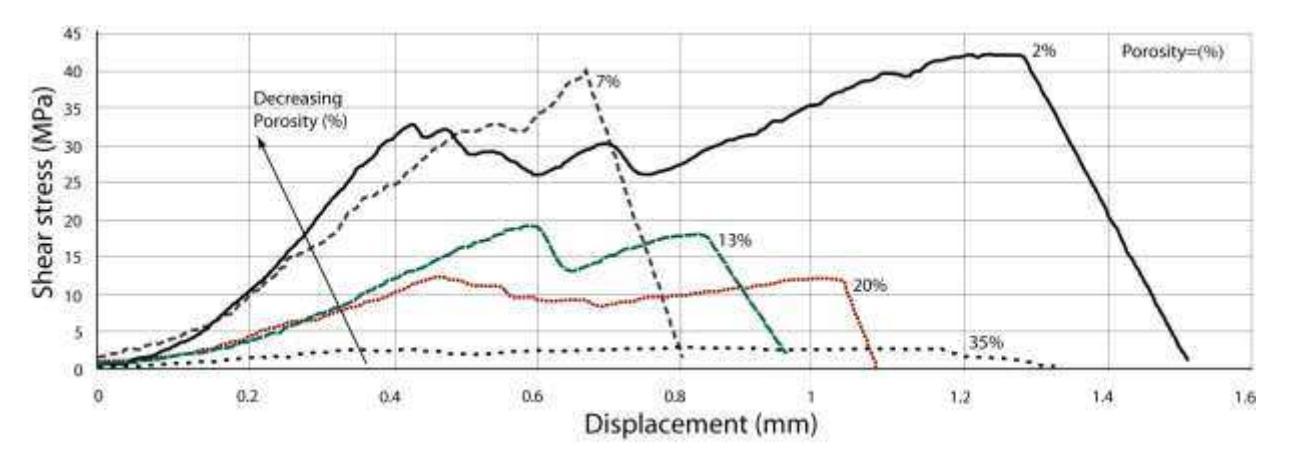
Figure 9: Shear stress versus tangential displacement for different limestone's porosity (modified from Druon, 2011 [10] ).

Shear strength measurements are performed on different non-altered limestone samples on a range of porosity 2% from 35 % (Figure 9). The different curves show an increase in the shear stress versus tangential displacement until a peak is reach and then a decrease followed by an increase to a maximum and then failed. The first stress drop is associated to micro-cracks of the sample and the final stress drop is related to the failure of the sample. All limestone samples seem to have the same behavior.

We noticed the smaller the porosity the stronger slope, this implies that the slope of curves is hardening with the decreasing porosity. It suggests porosity affects the mechanical response of samples.

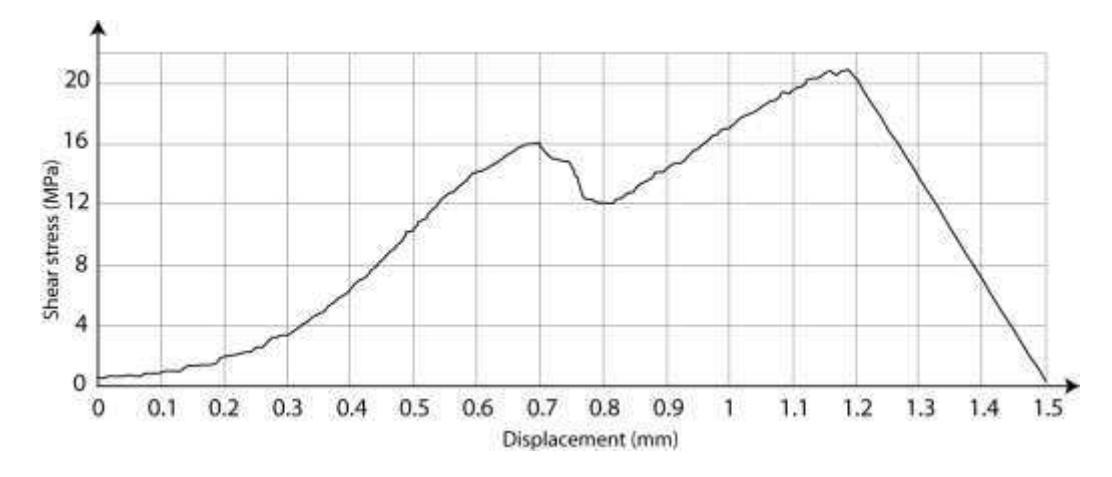
Figure 10: Evolution of shear stress versus tangential displacement for the limestone Larrys (modified from Druon, 2011).

The following experiment focused on non-altered Larrys (7%) sample. The Figure 10 shows the evolution of shear stress versus tangential displacement. The curve shows an increase to a peak at 16 MPa and a decrease to 12 MPa. This first part of the curve with the little peak, indicate a first micro-crack in the limestone sample. After that the shear stress rises to a maximum at 21 MPa and after the shear stress collapse. This part of the curve of the sample.

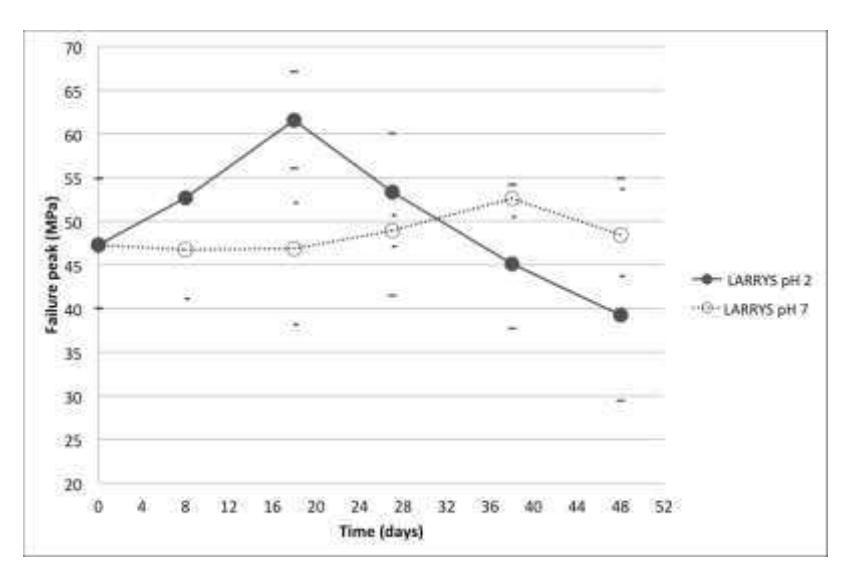
Figure 11: Evolution of the mean failure peak after period of alteration for Larrys limestones. A comparison between different water, acid (pH 2) and neutral (pH7). Dashes (above and below) represent respectively the standard deviations max and min. The small dashes for pH2, and the large dashes for pH 7(modified from Druon, 2011).

The Figure 11 shows the evolution of Larrys' samples mean failure peak during alteration period for two different pH degree of water (pH 2 and neutral water pH (7)). Which is surprising in that two curves show an increase of mean peak rupture to a maximum and a decrease. They have the same shape except the maximum for the acid water (pH 2) appears before that for rain water (pH 7). The difference between the curves points out the acceleration process of dissolution. The comparison between two different pH degrees of water shows how much the influence of pH water is relevant during the alteration process. Furthermore the slope before the peak for the pH 2 curve is stronger than the slope for pH 7.

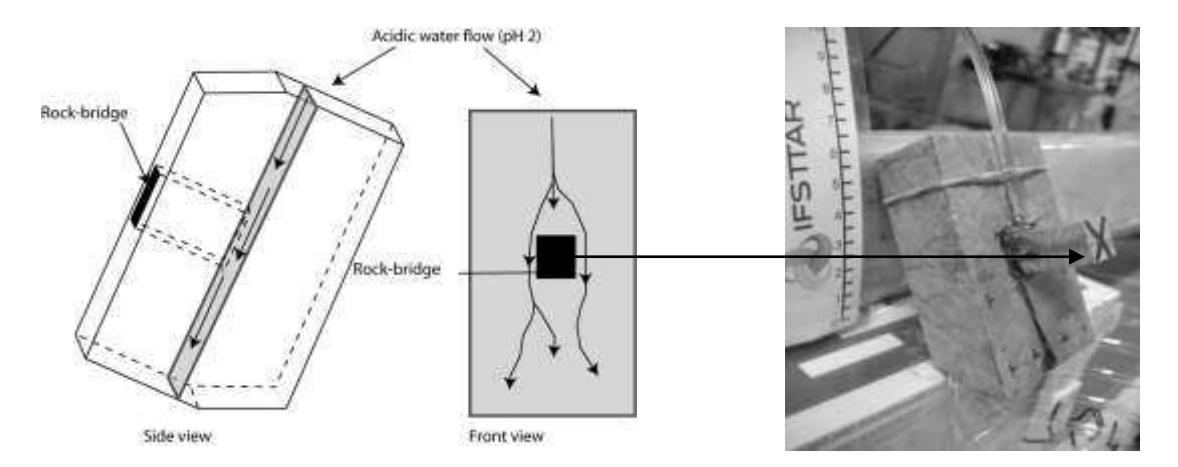
Figure 12: Schemes of the shape limestone samples for the experiment Alteration in the case of "flowing water", the acid solution is in drip system, the flow is one liter of solution per day, and run along the discontinuity and around the rock bridge (left). Picture of the runoff along the discontinuity and around the rock-bridge (right).

It exists [11] [12], part in the rock mass which is connected to the block ready to fall. These parts are called *rock-bridge* and they constitute the block stability. In this experiment, the shape of the sample and the water flow are different from the first one. Limestone's blocks are sawn so as to leave a continuous part, called rock bridge. The rectangular geometry of the bridge is connected to the surface of the block. The above part is taken off. The experiment is realized in open system where  $CO_2$  of the atmosphere can influence the interaction between the acidic solution and the surface of the block because  $CO_2$  is known to acidify water. The acidic solution is stored in tins and the solution flows via a drip system. The water flow is about one liter per day (Figure 12).

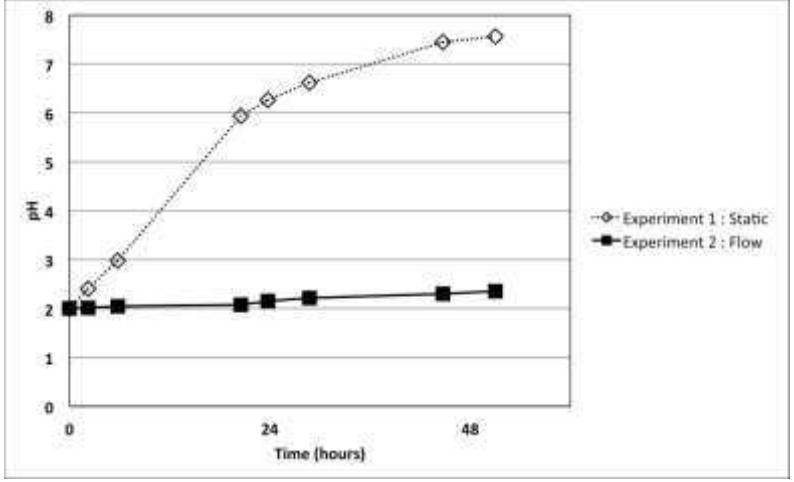
Figure 13: Representation of the evolution of pH as a function of time, the dotted curve with open symbols shows the evolution in the case of an alteration in static water regime: limestones (CaCO3) are soaking in an acidic solution (H<sub>2</sub>O; H<sub>2</sub>SO<sub>4</sub>). The solid curve and filled symbols shows the evolution in the case of an acidic solution flows along the limestone.

Figure 13 depicts the time evolution of water pH during two different experiments. A continuous flow on the limestone surface; maintains pH stability around 2 whereas limestone's sample immersion in an acidic solution buffers it at pH 7. This graph shows how time-contact between rock and solution is relevant.

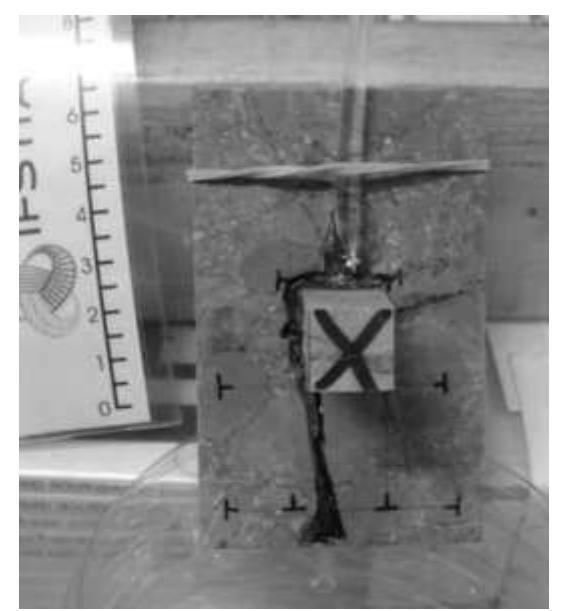
Figure 14: Picture of Montagnole limestone (CaCO<sub>3</sub>) sample surface degradation by acidic solution (H<sub>2</sub>O; H2SO4)

The experiment is performed in an open system, which means the sample in contact with ambient air. The interaction with the  $CO_2$  of the ambient air increases the phenomenon. The flow of water causes a material dissolution and destructuration (Figure 14). Fine particles are observed in the water of the recovery basin as

observed by Kupper [13]. The picture shows also an asymmetric flow of the solution. Indeed we observed during the period of runoff that water followed different paths. It is obvious that water prefers the easier path to dissolve crystals less competent that the rest of the rock sample.

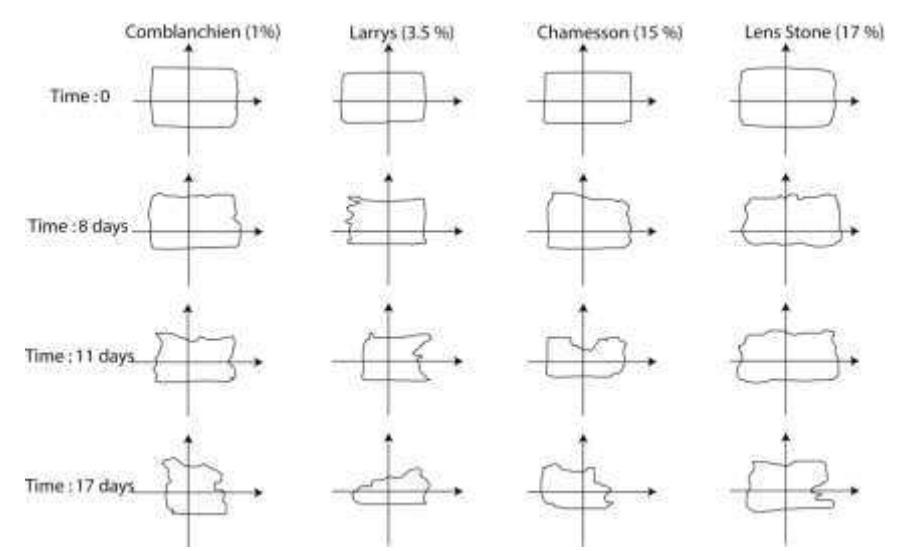
Figure 15: Comparison between the different states of alteration for each limestone of their rock bridges' perimeter measured with laser.

Each type of limestone received 12 liters of acid solution flowed for a period of 17 days. After 8, 11 and 17 days, a geometric analysis by laser is performed. Many profiles were done in order to show the influence of the alteration surface and to establish the decreasing of the rock bridge perimeter. This decreasing of the perimeter is observed during the water flowing for all samples (Figure 15). In addition we noticed an intact part of the rock bridge below. The recession of the rock-bridge perimeter may imply a decrease of the mechanical resistance of the rock bridge.

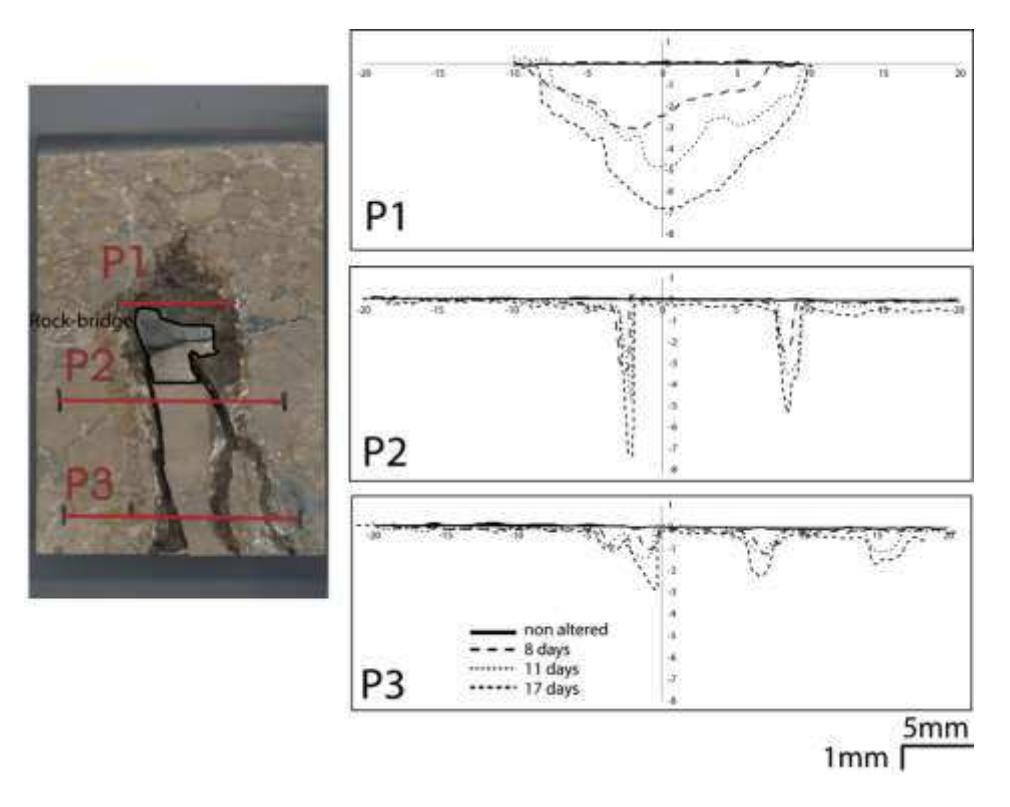
Figure 16: Montagnole sample after acidic water runoff, line P1, P2, P3 represent the place we take the profile by laser (left). These graphs represent the 3 profiles done by laser, the different curves show the evolution of the "topography" of the sample surface during alteration period (right)

We performed other laser profiles (Figure 16). Profile P1 was taken above the bridge then profile P2 just under the bridge, and the third P3 was measured on the below far from the bridge (Figure 16). These profiles were made at initial state, after 8 days of runoff, 11 days and at final state (17 days). Profile P1 is made near the place where the drop fell. It shows a digging which increases significantly over time. Profiles under the

bridge show two diggings (P2) then three (P3). These paths followed small fractures. These ones indicates preferential path of water circulation (P2 and P3).

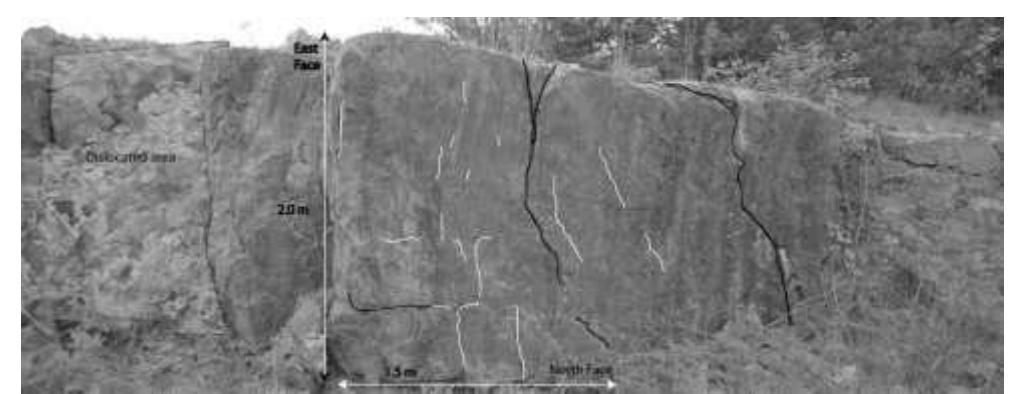
Figure 17: View of the rock mass, it presents a dislocated area on the left, and major discontinuities are in black and superficial are in white.

The site is located in Montagnole near Chambery (73) in France. The block is a triangle shaped dihedral with fractures and it is apparently ready to fall (Figure 17). This work aims to evaluate the potential of Ground Penetrating Radar (GPR) measurements to find and estimate the quantity of rock bridges into a block with a discontinuity.

The first observation in situ reveals many discontinuities; the major ones represented in black on Figure 17 are those where we suppose there are rock bridges to maintain the stability of the rock mass. The white ones appear to be just on the surface but they are important for the surface degradation. The GPR reveals the possibility to identify the surface discontinuity (Figure 19). As a matter of fact radar-gram present some weirdness, these ones are the proofs of different environment as air or rock mass. These are analyzed and after a treatment, a 3D view of the discontinuity surface could be made as Figure 20 shows.

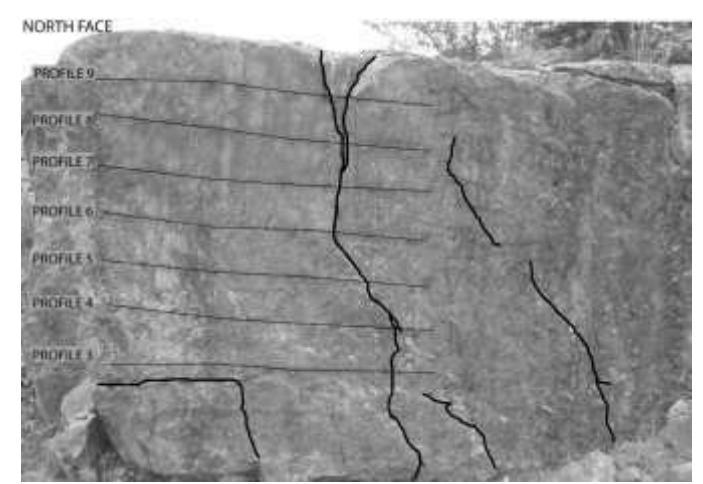
Figure 18: Depict of the North Face of the block in Chambery (73). The black lines reveal the different discontinuities observed. The black horizontal lines identified each radar profile, profile 3 to 9 from the bottom to the top.

GPR data were acquired using high frequency (1600 MHz) to estimate the presence of rock bridges (continuity in the rock mass). This high frequency is adapted to detect interfaces such as rock-air-rock in two meters thick. The air tends to disperse the signal, so we can deduce the rock bridge's presence or not. In this paper, GPR measurements consisted in profiles acquired from the block (Figure 18), in order to make a grid of the block and identify the presence of rock bridges.

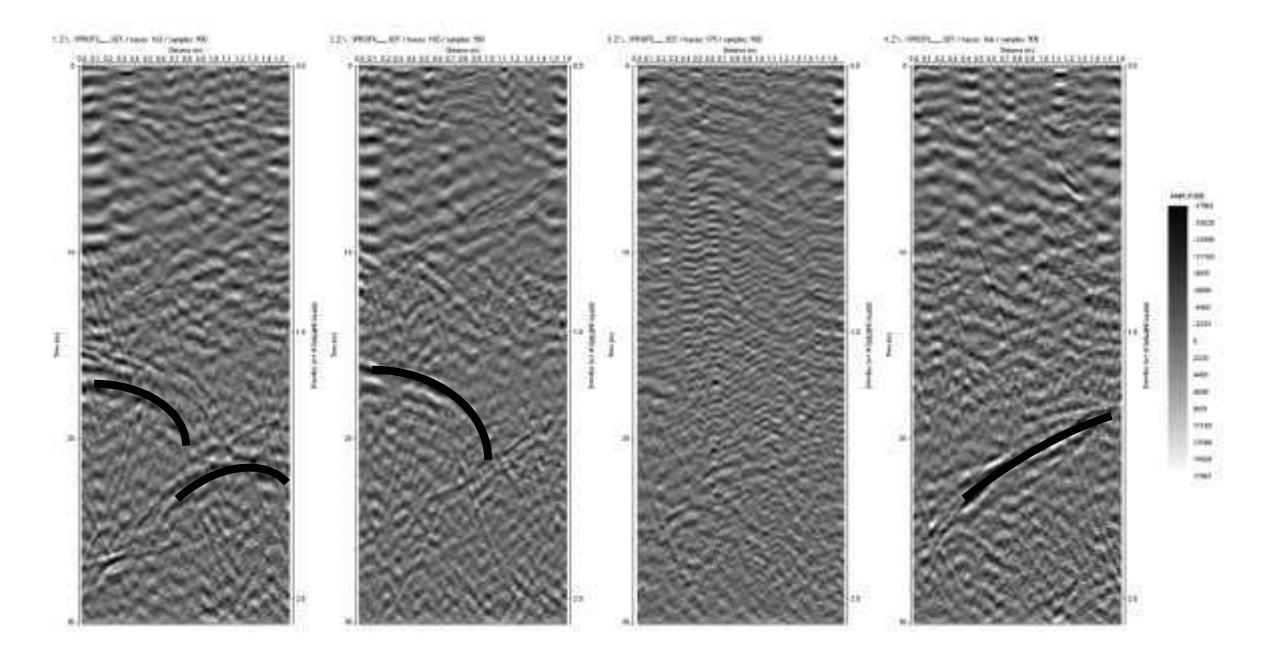
Figure 19: Radar gram acquired after profiles from the block, profile 3 to 6, the black lines represented the weirdness observed and used for the 3D representation.

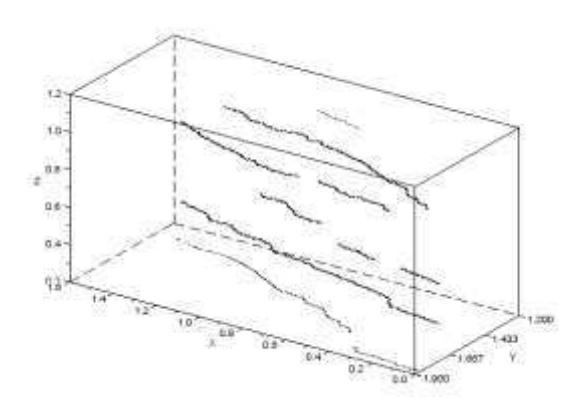
Figure 20 show horizontal dots, which represented the separation between rocks and void i.e. the discontinuity inside the block.

#### Figure 20: 3D view of the surface discontinuity after analyze and treatment of the data.
