Methods applied to investigate the major UVCE that occurred in the TOTAL refiner's Fluid Catalytic Cracking Unit at La Mède, France

Methods applied to investigate the major UVCE that occurred in the TOTAL refinery's Fluid Catalytic Cracking Unit at La Mède, France.

1. SUMMARY OF THE EVENT

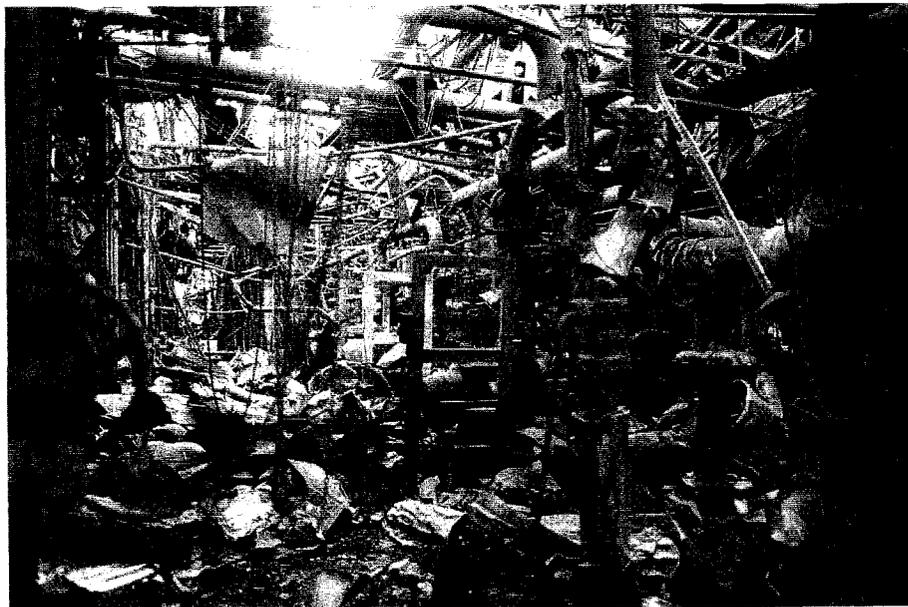
Figure 3. Gas Plant area after explosion and consecutive fires.

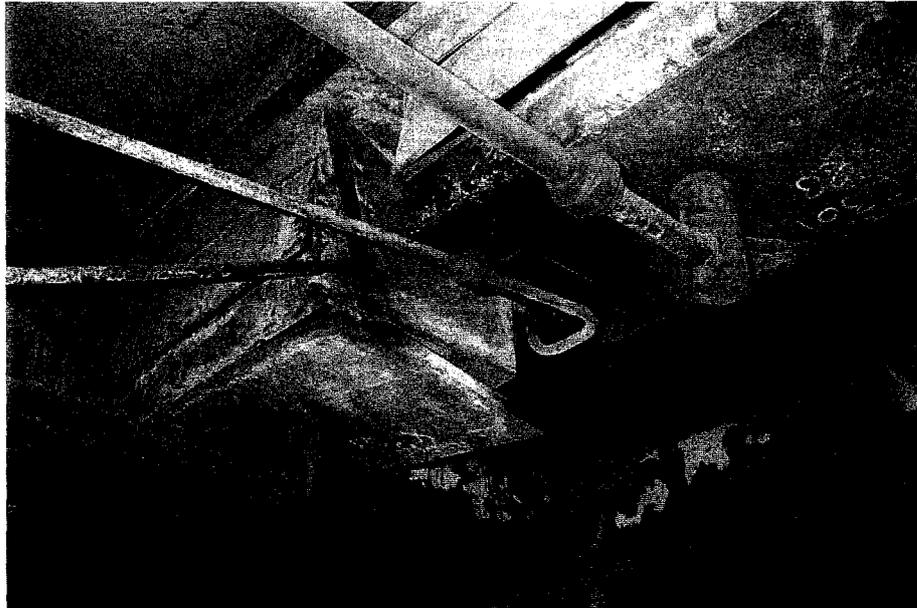
Figure 5. Ignition source: FCC main furnace.

On the other hand, several findings were made under the F301 furnace. The flammable cloud burnt up to the two thirds of the south part of the furnace. Traces of combustion were found on the external box of the third burner at east. More, in the direction of the Gas Plant, several burns, were found on the electrical cabinets and cables indicating the travel of a slow flame front. Several investigations on the electrical equipment were made in order to justify the exclusion of this kind of equipment.

Finally, the ignition on the F301 furnace was found to be the only solution that is consistent with evidence and with the observed traces of combustion. (see photograph of figure 5).
