## Qualification of the microseismic monitoring technique applied to the risk of collapse in iron ore mines

**ABSTRACT:** Experiments carried out in a working iron mine validated the microseismic monitoring technique as a means of detecting fracture noise emissions regarded as signals indicating an incipient collapse. In the experiment surface recordings were made of the microseismic signals corresponding to fractures and local collapse phenomena generated at the mine bottom by deliberately destroying pillars. The pillar removal operations and the collapse of the roof were systematically correlated with a series of microseismic events. The experiment served to validate the microseismic monitoring technique as a means of detecting surface precursors of a collapse, to demonstrate the effectiveness of the technique, and to calibrate the principal parameters of a microseismic monitoring system adapted to detection and monitoring in areas where there is a risk of collapse.

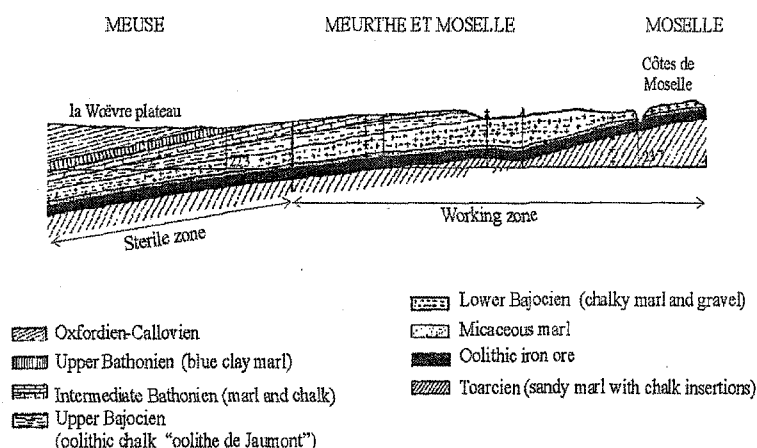
Figure 1: Simplified geological section of the Lorraine iron ore basin

The iron ore basin in Lorraine extends between the cities of Luxembourg in the north and Nancy (France) in the south. The iron ore deposit is sedimentary Aalenian and an insertion in the geological series between the Lias and the Jurassic (Tincelin, 1958). This deposit is virtually horizontal with a regular average slope of 3% and a mean thickness of 30 metres (figure 1). The sterile rocks lying above the iron-bearing formation known as "dead ground" have an average thickness of

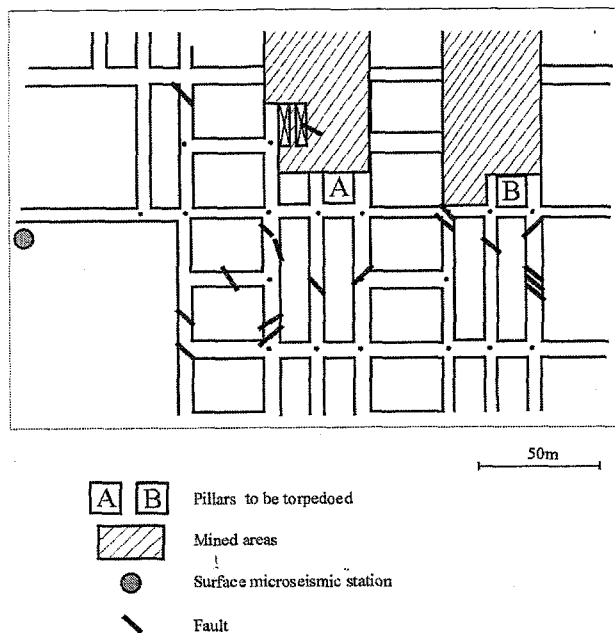
Figure 2: Plan view of the mine workings and location of the microseismic monitoring station at the surface

The geometry of the mining unit monitored by the microseismic technique is shown on figure 2. In this unit, the width of the islands is 40 metres, the strips between the islands are 30 metres wide and the mining height is 4 metres. The microseismic monitoring station was installed at the surface, in a borehole 30 metres in depth and about 300 metres from the mining operations. The microseismic station is a three-directional unit consisting of sensors of the accelerometer type with a pass band of 2 to 2300 Hz and a sensitivity of 500 mV/g. The signals are fed to a local computer with a sampling frequency of 10 kHz (figure 3).

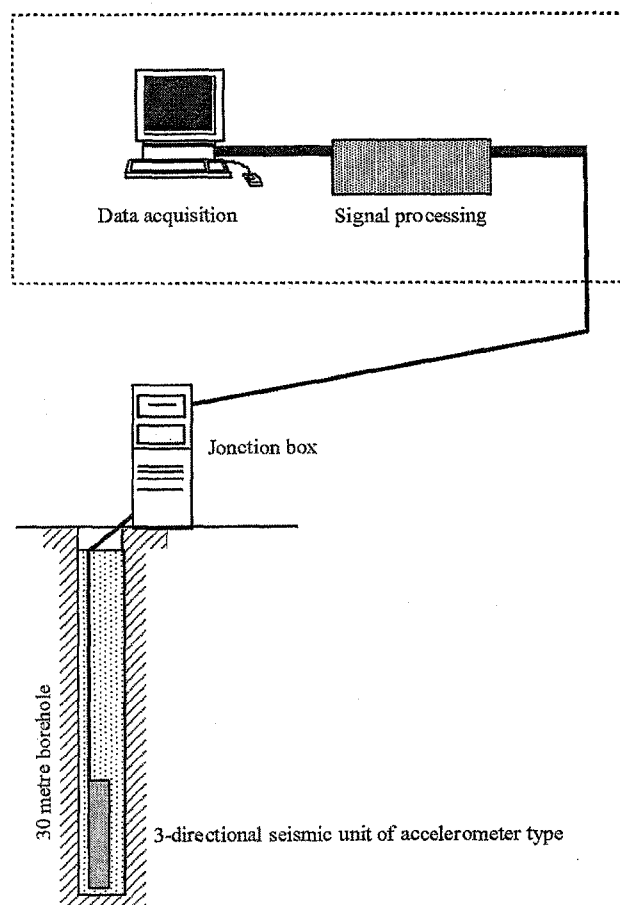
Figure 3: Microseismic measuring system

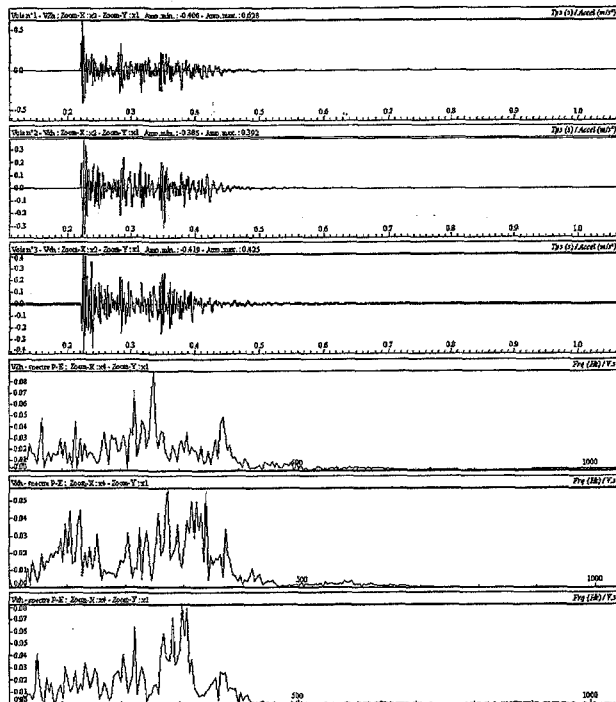
Figure 4: Examples of seismic signals and frequency spectra recorded during blasting operations some 300 metres from the seismic monitoring station on the surface.

All the blasting done during mining operations located 300 metres from the seismic station was systematically recorded by the seismic monitoring system. The signals recorded were of very high amplitude, leading to signal saturation. The signal frequency is about 200 Hz with peaks of up to 500 Hz.

Other blasts located about 600 metres from the monitoring station were also recorded. The maximum frequency of these events is lower (under 100 Hz) than the frequency of the events recorded during blasts located at 300 metres from the monitoring station. Finally, blasts some 900 metres from the monitoring station were not detected by the system. Figure 4 shows examples of seismic signals and of the frequency spectrum of the events recorded.

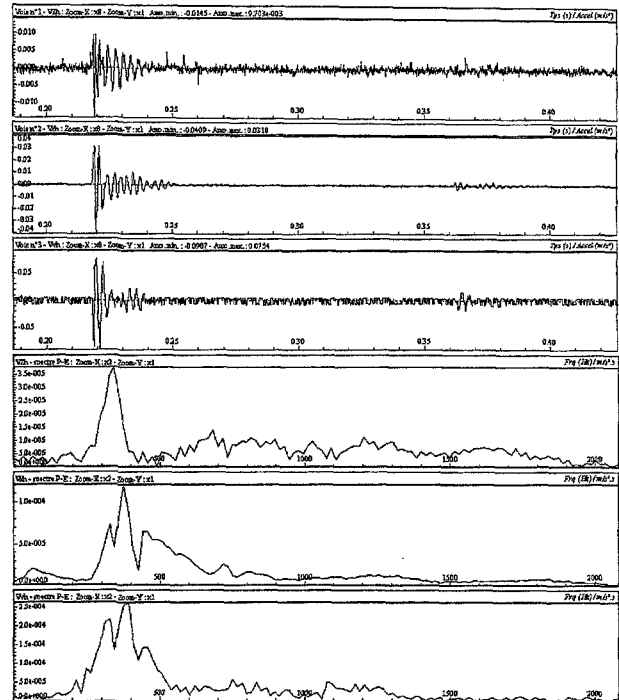
Figure 5: Examples of seismic signals recorded during the collapse of the roof. The difference with the signature of the seismic events associated with blasting can be clearly seen (see figure 4)

The collapse of the roof following the torpedoing of pillars A and B (see figure 3) generated 66 microseismic events. These events were characterised by their arrival in bursts, i.e., a number of events recorded in a short period of time. The signature of the signals and the spectral content of these events are appreciably different from those associated with blasting. They are very short events with maximum frequency peaks between 400 and 500 Hz (figure 5).
