Qualification of the microseismic monitoring technique applied to the risk of collapse in iron ore mines

G. Senfaute¹, M. Abdul Wahed², J.P. Piguet², J.P. Josien¹

ABSTRACT: Experiments carried out in a working iron mine validated the microseismic monitoring technique as a means of detecting fracture noise emissions regarded as signals indicating an incipient collapse. In the experiment surface recordings were made of the microseismic signals corresponding to fractures and local collapse phenomena generated at the mine bottom by deliberately destroying pillars. The pillar removal operations and the collapse of the roof were systematically correlated with a series of microseismic events. The experiment served to validate the microseismic monitoring technique as a means of detecting surface precursors of a collapse, to demonstrate the effectiveness of the technique, and to calibrate the principal parameters of a microseismic monitoring system adapted to detection and monitoring in areas where there is a risk of collapse.

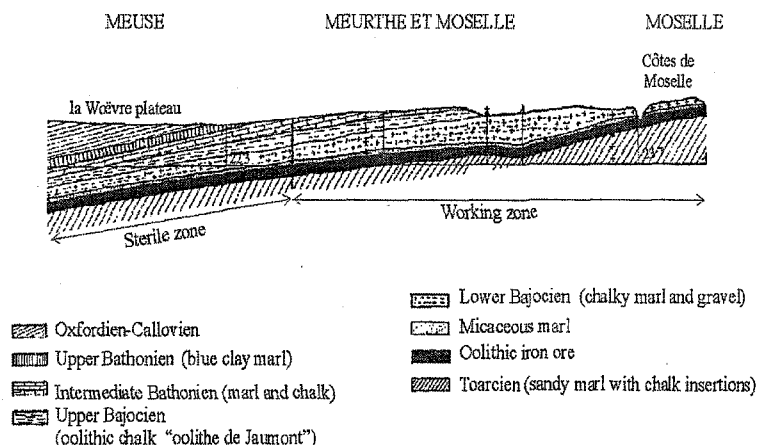
Figure 1: Simplified geological section of the Lorraine iron ore basin

The iron ore basin in Lorraine extends between the cities of Luxembourg in the north and Nancy (France) in the south. The iron ore deposit is sedimentary Aalenian and an insertion in the geological series between the Lias and the Jurassic (Tincelin, 1958). This deposit is virtually horizontal with a regular average slope of 3% and a mean thickness of 30 metres (figure 1). The sterile rocks lying above the iron-bearing formation known as "dead ground" have an average thickness of
