Qualification of the microseismic monitoring technique applied to the risk of collapse in iron ore mines

Gloria Senfaute, Mohamad Khir Abdul-Wahed, Jack-Pierre Piguet,
Jean-Pierre Josien

Gloria Senfaute, Mohamad Khir Abdul-Wahed, Jack-Pierre Piguet, Jean-Pierre Josien. Qualification of the microseismic monitoring technique applied to the risk of collapse in iron ore mines. International symposium of the international society for rock mechanics (EUROCK 2000), Mar 2000, Aachen, Germany. ineris-00972194

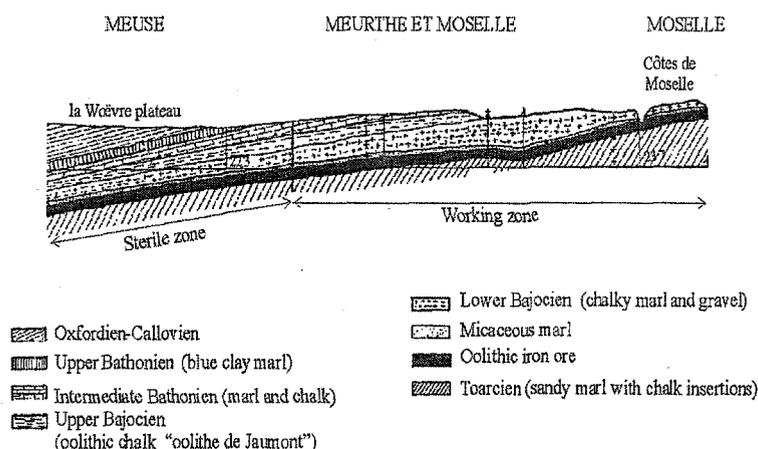
Figure 1: Simplified geological section of the Lorraine iron ore basin

The iron ore basin in Lorraine extends between the cities of Luxembourg in the north and Nancy (France) in the south. The iron ore deposit is sedimentary Aalenian and an insertion in the geological series between the Lias and the Jurassic (Tincelin, 1958). This deposit is virtually horizontal with a regular average slope of 3% and a mean thickness of 30 metres (figure 1). The sterile rocks lying above the iron-bearing formation known as "dead ground" have an average thickness of

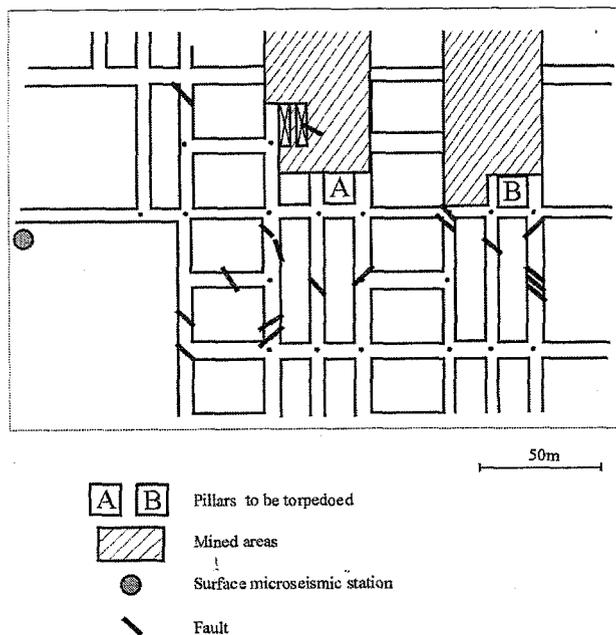
Figure 2: Plan view of the mine workings and location of the microseismic monitoring station at the surface

The geometry of the mining unit monitored by the microseismic technique is shown on figure 2. In this unit, the width of the islands is 40 metres, the strips between the islands are 30 metres wide and the mining height is 4 metres. The microseismic monitoring station was installed at the surface, in a borehole 30 metres in depth and about 300 metres from the mining operations. The microseismic station is a three-directional unit consisting of sensors of the accelerometer type with a pass band of 2 to 2300 Hz and a sensitivity of 500 mV/g. The signals are fed to a local computer with a sampling frequency of 10 kHz (figure 3).

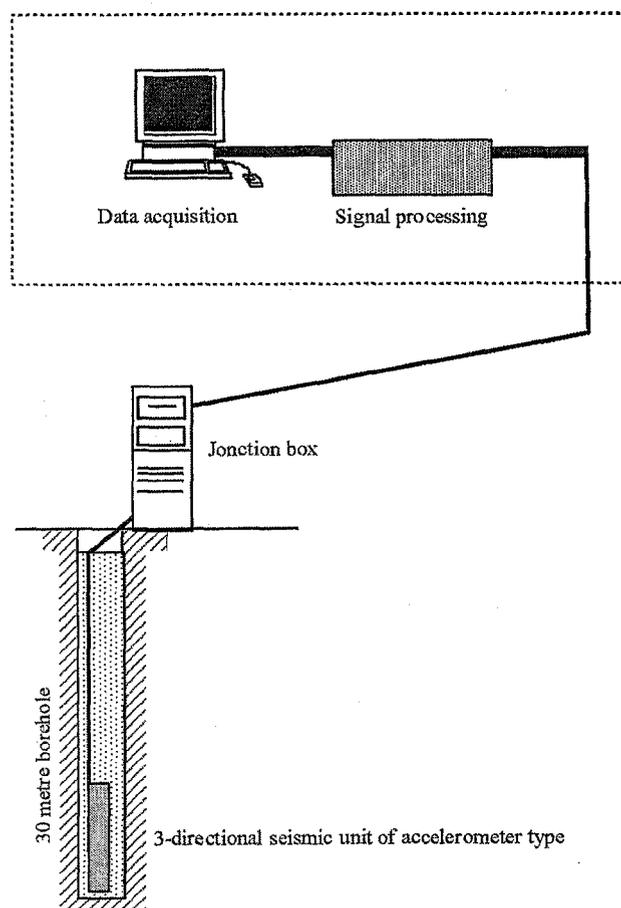
Figure 3: Microseismic measuring system

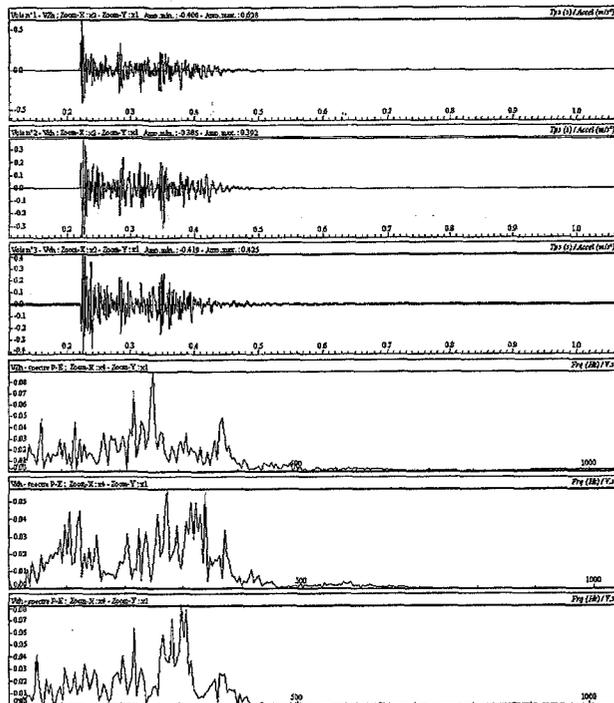
Figure 4: Examples of seismic signals and frequency spectra recorded during blasting operations some 300 metres from the seismic monitoring station on the surface.

All the blasting done during mining operations located 300 metres from the seismic station was systematically recorded by the seismic monitoring system. The signals recorded were of very high amplitude, leading to signal saturation. The signal frequency is about 200 Hz with peaks of up to 500 Hz.

Other blasts located about 600 metres from the monitoring station were also recorded. The maximum frequency of these events is lower (under 100 Hz) than the frequency of the events recorded during blasts located at 300 metres from the monitoring station. Finally, blasts some 900 metres from the monitoring station were not detected by the system. Figure 4 shows examples of seismic signals and of the frequency spectrum of the events recorded.

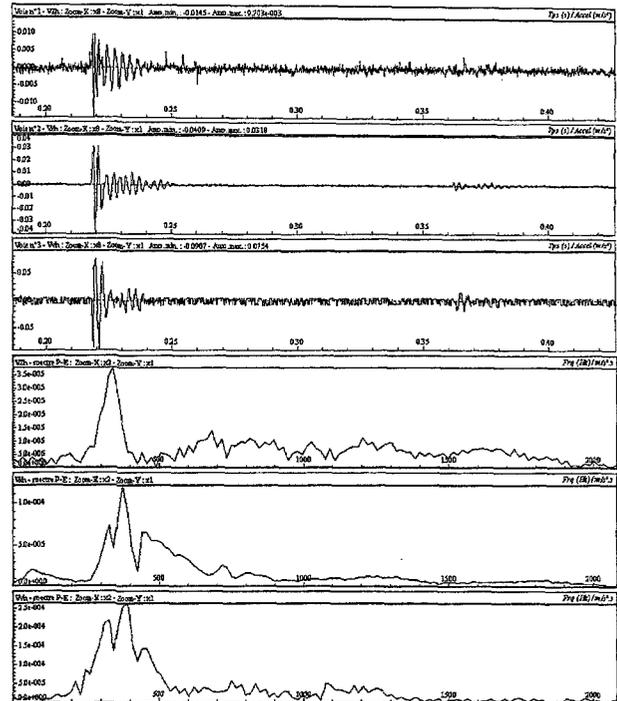
Figure 5: Examples of seismic signals recorded during the collapse of the roof. The difference with the signature of the seismic events associated with blasting can be clearly seen (see figure 4)

The collapse of the roof following the torpedoing of pillars A and B (see figure 3) generated 66 microseismic events. These events were characterised by their arrival in bursts, i.e., a number of events recorded in a short period of time. The signature of the signals and the spectral content of these events are appreciably different from those associated with blasting. They are very short events with maximum frequency peaks between 400 and 500 Hz (figure 5).
