## Behaviour of a highly pressurised tank of GH2 submitted to a thermal or mechanical impact

# BEHAVIOUR OF A HIGHLY PRESSURISED TANK OF GH<sub>2</sub>, SUBMITTED TO A THERMAL OR MECHANICAL IMPACT

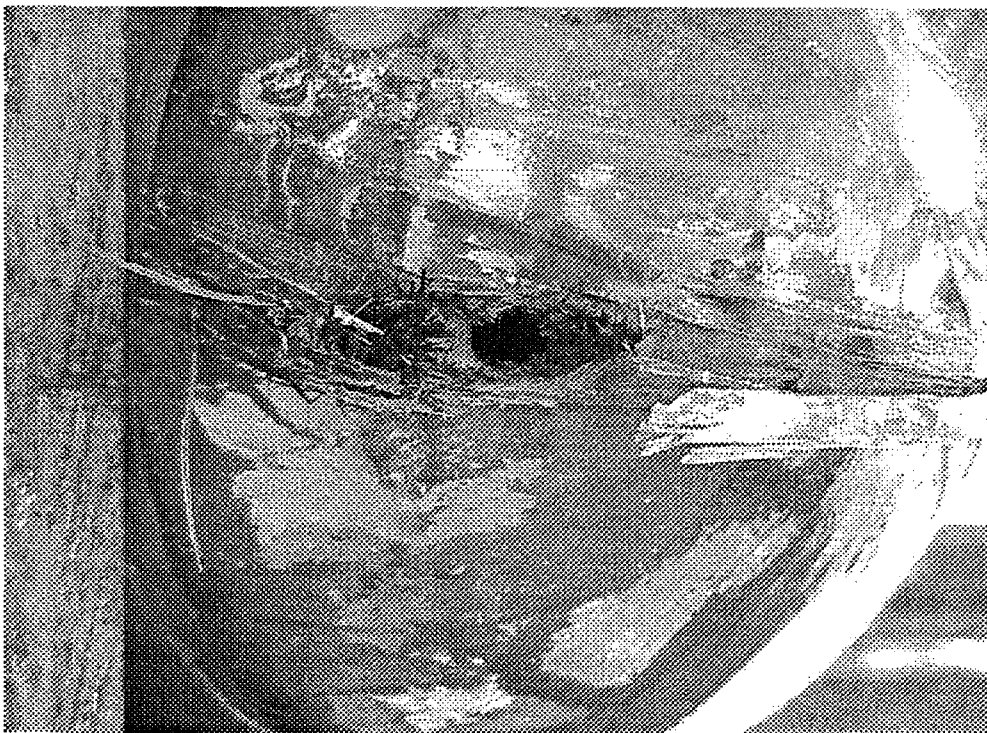
*Photo 4 : One of the bullet holes in the cylinder in test n°4*

The bullet has passed trough the cylinder, which did not burst (photo n°4). Hydrogen discharged through both holes as two jets, but did not ignite.
