## Back-analysis of the rockburst in Frieda 5 and design program for panel in seam 6 (HBL-France)

Vincent Renaud, Lynda Driad, Marwan Al Heib, J.-F. Noirel

## BACK-ANALYSIS OF THE ROCKBURST IN FRIEDA 5 AND DESIGN PROGRAM FOR PANEL IN SEAM 6 (HBL – FRANCE)

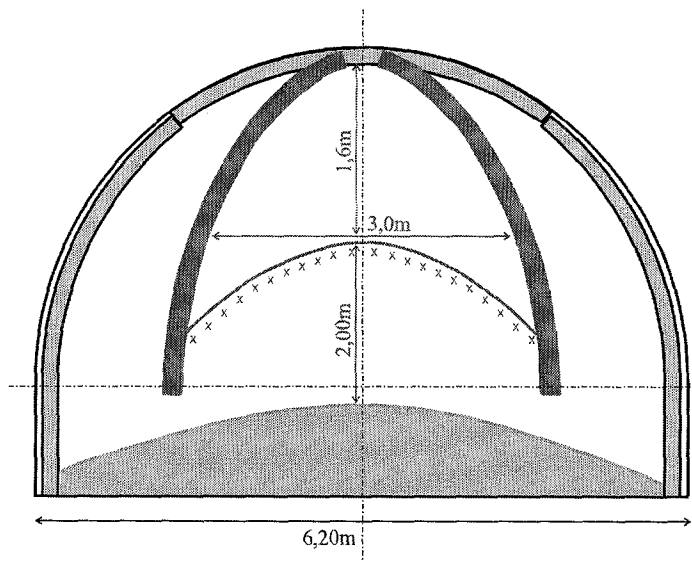
On June 21 2001, a fatal rock burst affected the main gate of the Frieda 5-1250 panel in the Merlebach Mine (HBL). The rock burst was extremely violent (magnitude 3.6). The heave exceeded 2 m (figures 1 and 2, HBL note number 384/01-JPA/ND [3]). The damaged zone was 250 m long and was located at between 100 m and 350 m in front of the face (between the sides).

Fig. 1: Diagram showing bottom level blow off.

The seismic focus of the 21/06/01 event is located on the Frieda5 main gate 100 m in front of the face (figure 1). The location in depth shows that the depth of the focus of this event is about 1400 m (estimated depth below the surface, figure 2) at 200 m from the Frieda5 cutting face.

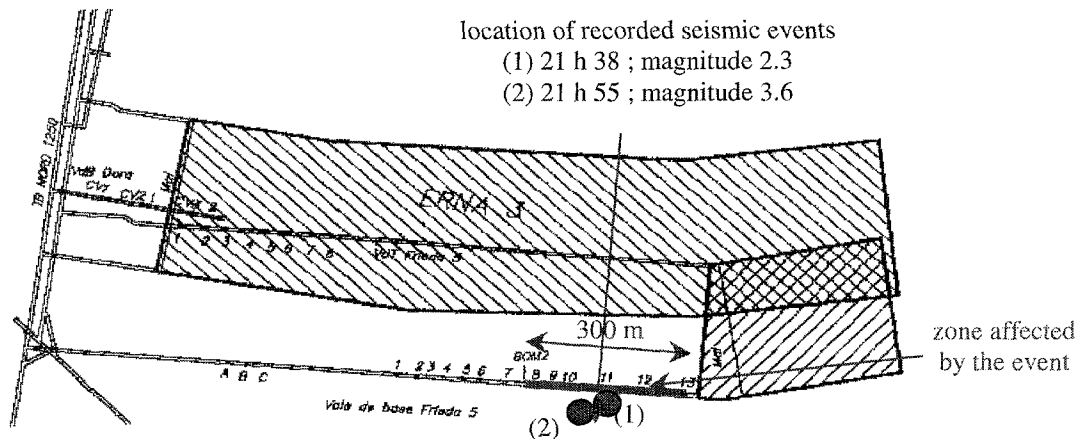
Fig. 2: View of the damaged zone and location of seismic events.

In the case of the June 21 2001 event, the analysis of the direction of the first movement demonstrated an explosive rupture mechanism. More explicitly, the movement of the wave was a pure compression. Events recorded before the accident, and particularly the 21/06/2001 event at 19h 38 (~ 20 min before the accident), show a shear mechanism (figure 2).

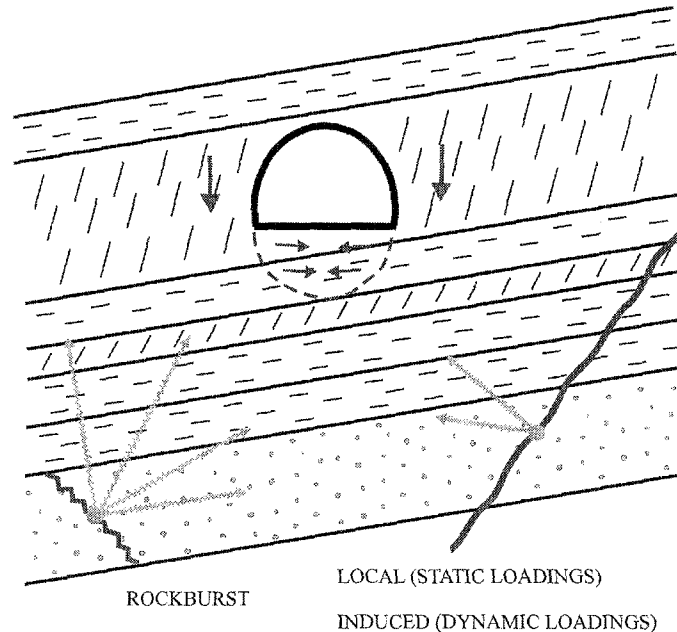
Fig. 3: The identified rupture mechanism

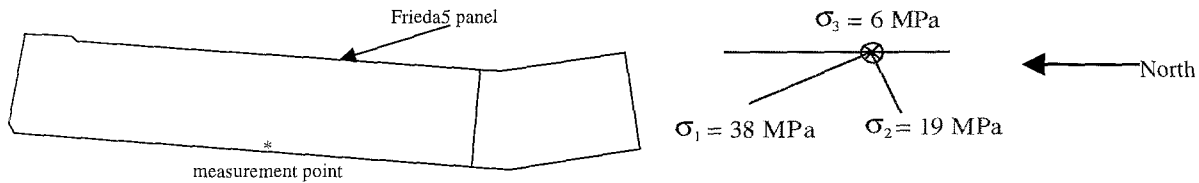
Stress measurements show that horizontal stresses are very high and the vertical stress is less than the weight of the ground (figure 4).

Fig. 4: Stress diagram in accident zone

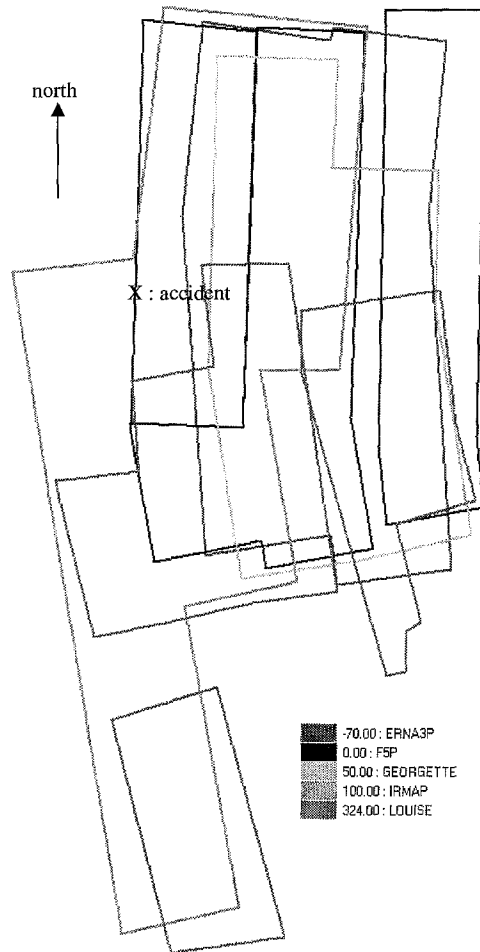
The model using the SUIT3D program ([8], figure 5) was intended to achieve two objectives, firstly to find the initial tensor before mining started, and variations in the stress tensor close to the area of the accident [2]. The calculation was made assuming linear elasticity, with an isotropic stress tensor over the scale of the deposit. The seams considered in the calculation are shown in table 1.

Fig. 5: Modeled seams with SUIT3D

Seam	Distance/Frieda5-1250	Number of panels
Louise	324 m	3
Irma	100 m	2
Georgette	50 m	2
Frieda5	0 m	1 + final advance
Erna3	-70 m	2

- mining operations in the Irma-1250 panel considerably modified the distribution of normal, horizontal and axial stresses. The influence of Erna3 and Frieda5 operations is lower and never exceeds 20%;
- overstress areas correspond to the Louise TB zone and the zone ahead of the Irma-1250 face;
- in the intermediate zone (where the part of the Frieda5-1250 panel on which mining operations are taking place is located, and the part of the bottom level affected during the accident); the vertical stress in these zones is relieved;
- furthermore, the influence of mining operations in the Frieda5-1250 panel is limited to zones close to the part of the panel from which coal has been extracted, and in particular it appears weak in the part of the level affected by the accident.

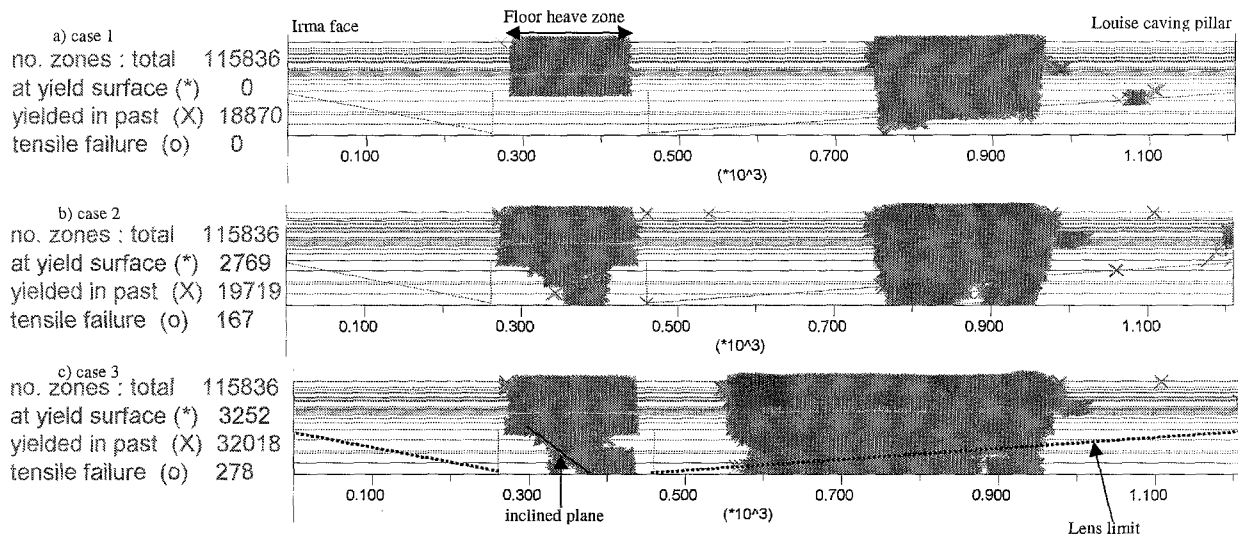
The mechanism studied would appear to be capable of reproducing total deconsolidation of the bed under some conditions (figure 6):

- the vertical stress relief in the accident zone must be less than or equal to 4 MPa;
- the North-South horizontal stresses must be high (higher than 60 MPa and therefore higher than the measurements made in situ);
- East-West horizontal stresses, and particularly shear stresses, are design parameters that are less sensitive than the previous two;
- the compression strength ( $R_c$ ) of the sandstone bed had to be halved so that the second sandstone bench could be fractured.

Fig. 6: Overview: distribution of plasticity

Case 1: 200 m advance

Case 2: 200 m advance, effect of the axial horizontal stress

Case 3: 400 m advance, effect of stress gradients

- 1) a bottom case with a variable thickness sandstone bed (between 0 m and 20 m) and a 125 m wide zone in which vertical stresses were relieved;
- 2) a bottom case mode with N-S horizontal stresses increased by 25 %;
- 3) same mode as above (case 2) but with the Frieda 5 face advanced by 400 m, which is close to the accident configuration.

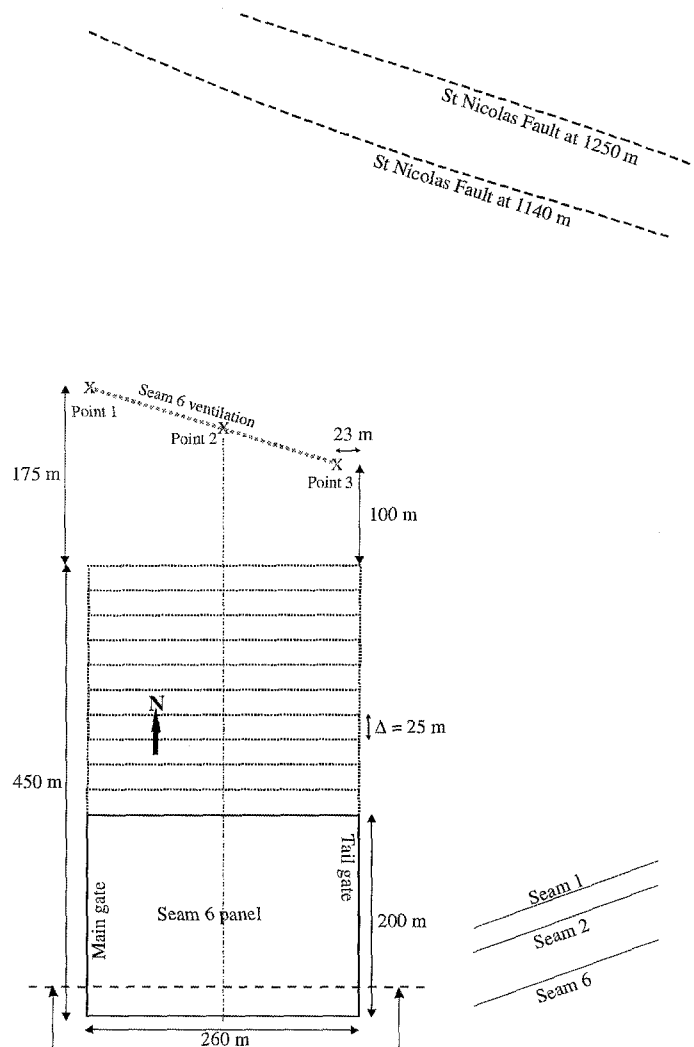
The advance of the panel between 200 m and 470 m (maximum length) is simulated in 12 steps (figure 5). The model includes all mined panels of the Reumaux Mines (HBL).

The results were analyzed considering the variation of the state of stress with the advance of panel 1140-1250 (figure 5). The comments can be made on this model:

Fig. 5: Different steps in modeling the advance on the Seam 6 panel.

- operation of the Seam 6 panel will have an influence ahead of the faces of the Seam 1 and 2 panels starting from an advance of 325 m. This is a very small modification compared with the initial state before operation of the panel;

- starting from 400 m, the influence becomes more significant. It corresponds to an increase in the normal stress (zones close to the roof track increase by 2 MPa, the 28 MPa contours move by 110 m ahead of the face on the bottom level) and an increase in the east-west horizontal stress at the face of the 1st panel in Seam 1 (increase of 2 MPa);

- in the ventilation zone, the greatest increase concerns the east-west horizontal stress, which is 15% of the initial value. The normal stress only increases by 5%. No modification is observed for the north-south horizontal stress;

- the front ends of Seams 1, 2 and 6 do not intersect until the advance reaches 450 m (the planned length).

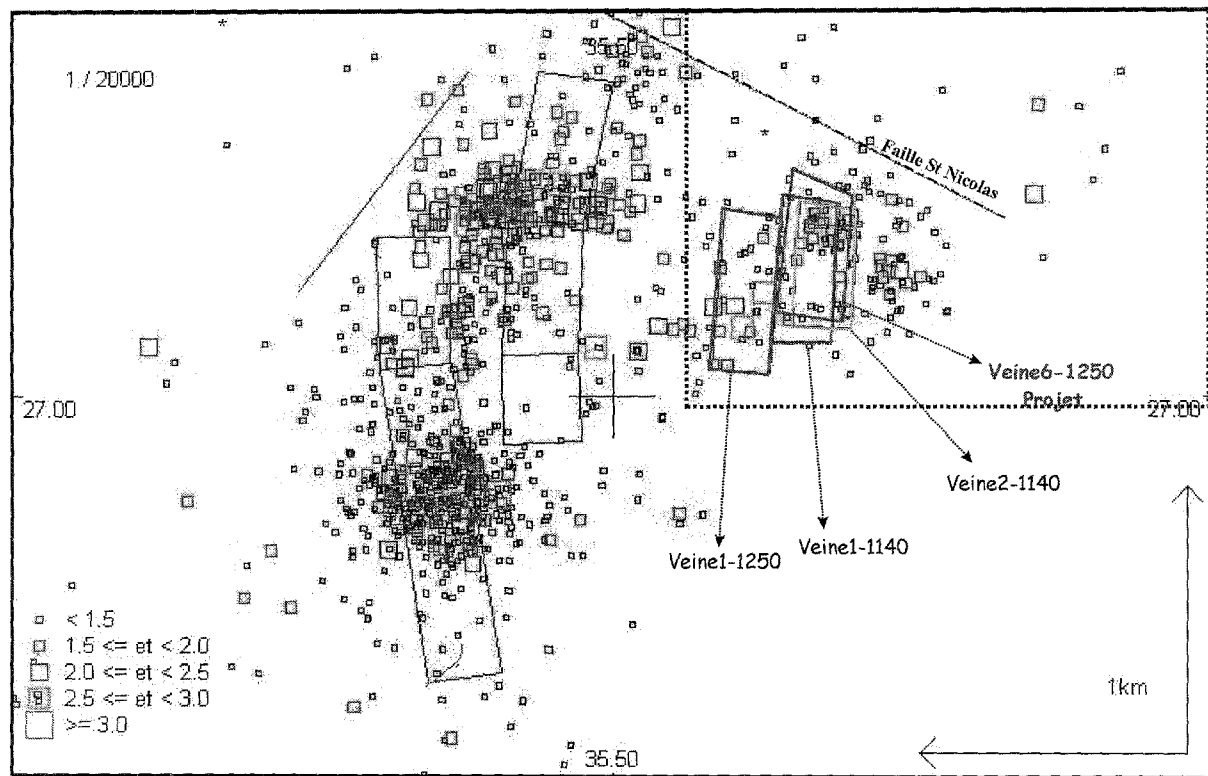
Seismic activity related to all mining operations carried out between 1995-2001 is represented by the spatial distribution of focuses of events recorded in the HBL regional listening network. Based on the distribution of focuses in the zone limited to Seams 1 (panels 1140, 1250) and 2 (panel 1250), it is quite obvious that seismic activity is much lower (209 events) than was observed in the West sector (Irma, Erna and Frieda, 1500 events). A distinction is made between three activity distributions (figure 6):

1. minor rock bursts, most with a magnitude of less than 1.5, related to ruptures close to the St Nicolas fault;
2. a cluster of focuses located at about a hundred meters to the East of the panels in the preferred NS direction. A single rock burst with a magnitude of more than 2 is identified;

Fig. 6: Seismic activity of Seams 1 sector (1140, 1250 panels), Seam 2 (1140 panel), 1995-2001 period

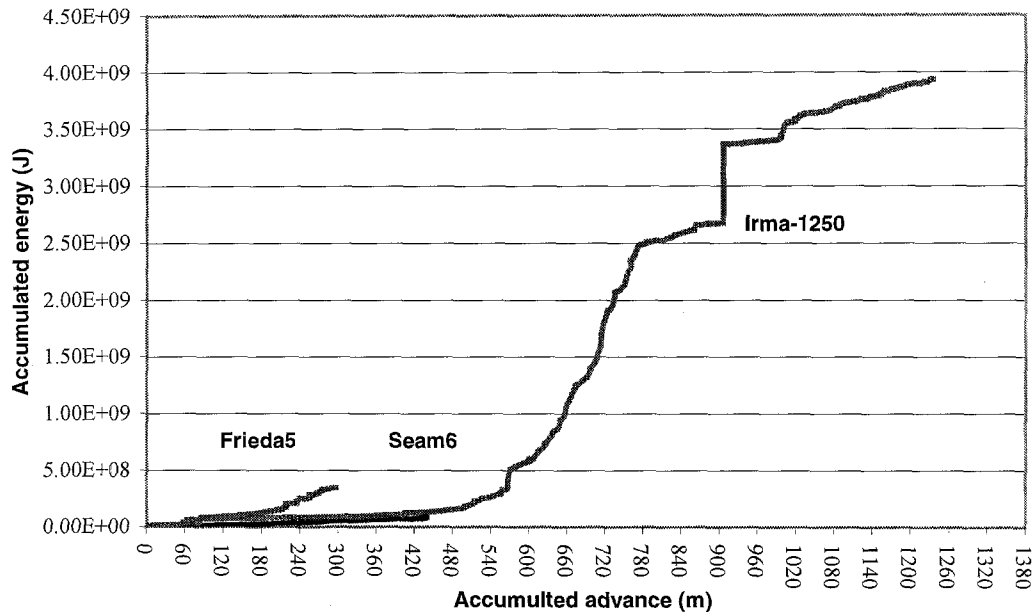
Figure 7 shows curves of the energy dissipated during operation of the Irma-1250, Frieda5-1250 and Seam 6 fronts as a function of the advance. For the three fronts, the energy is calculated starting from the seismoacoustic data. Irma-1250 was exploited over the longest length (1300 m), and advance of the Frieda5 and Seam 6 fronts was 300 m and 444 m, respectively. Thus, a comparison can be made between the three energy variation curves for an advance of up to 444 meters. An analysis of the three curves shown in figure 6 shows that the energy level released by the Frieda5 front is the highest and that the relief speed increases quickly after 180 m advance. For the Irma-1250 front, the dissipated energy is low until 420 m and then increases gradually. Note that the energy released by the front in Seam 6 is the lowest throughout the entire mining operation period.

Fig. 7: Curves of energy dissipated during mining operations of the Frieda5, Seam6 and Irma-1250 cuts
