Vincent Renaud, Lynda Driad, Marwan Al Heib, J.-F. Noirel

Vincent Renaud, Lynda Driad, Marwan Al Heib, J.-F. Noirel. Back-analysis of the rockburst in Frieda 5 and design program for panel in seam 6 (HBL-France). ROCKBURSTS International Symposium 2002, Nov 2002, Ustron, Poland. pp.313-326. ineris-00972385

## BACK-ANALYSIS OF THE ROCKBURST IN FRIEDA 5 AND DESIGN PROGRAM FOR PANEL IN SEAM 6 (HBL – FRANCE)

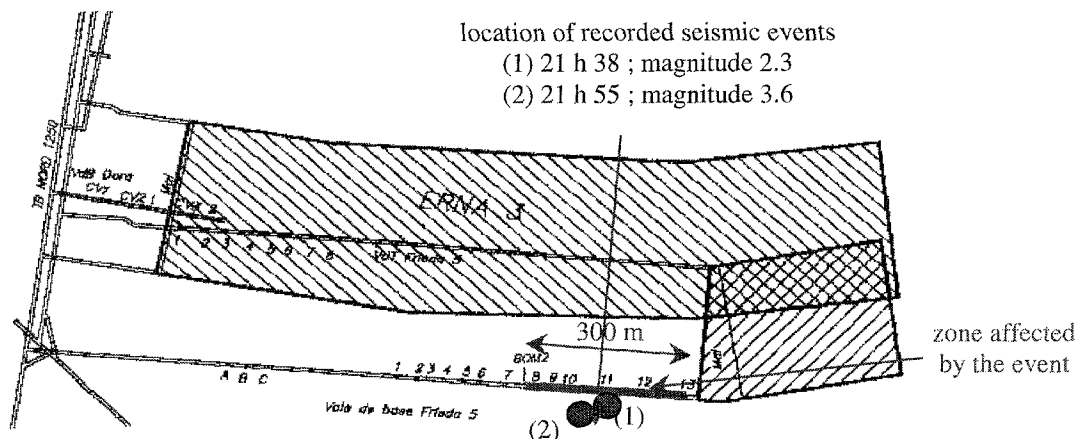
Fig. 2: View of the damaged zone and location of seismic events.

The seismic focus of the 21/06/01 event is located on the Frieda5 main gate 100 m in front of the face (figure 1). The location in depth shows that the depth of the focus of this event is about 1400 m (estimated depth below the surface, figure 2) at 200 m from the Frieda5 cutting face.

In the case of the June 21 2001 event, the analysis of the direction of the first movement demonstrated an explosive rupture mechanism. More explicitly, the movement of the wave was a pure compression. Events recorded before the accident, and particularly the 21/06/2001 event at 19h 38 (~ 20 min before the accident), show a shear mechanism (figure 2).

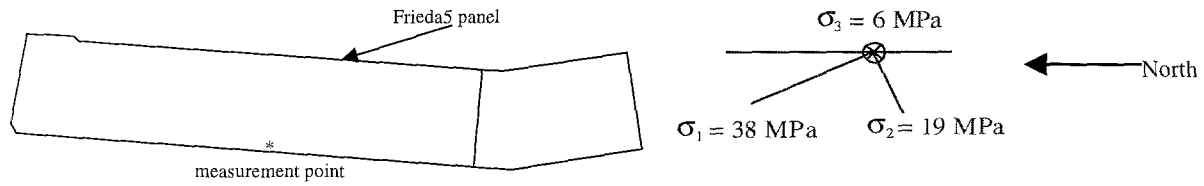
Stress measurements show that horizontal stresses are very high and the vertical stress is less than the weight of the ground (figure 4).

Fig. 4: Stress diagram in accident zone

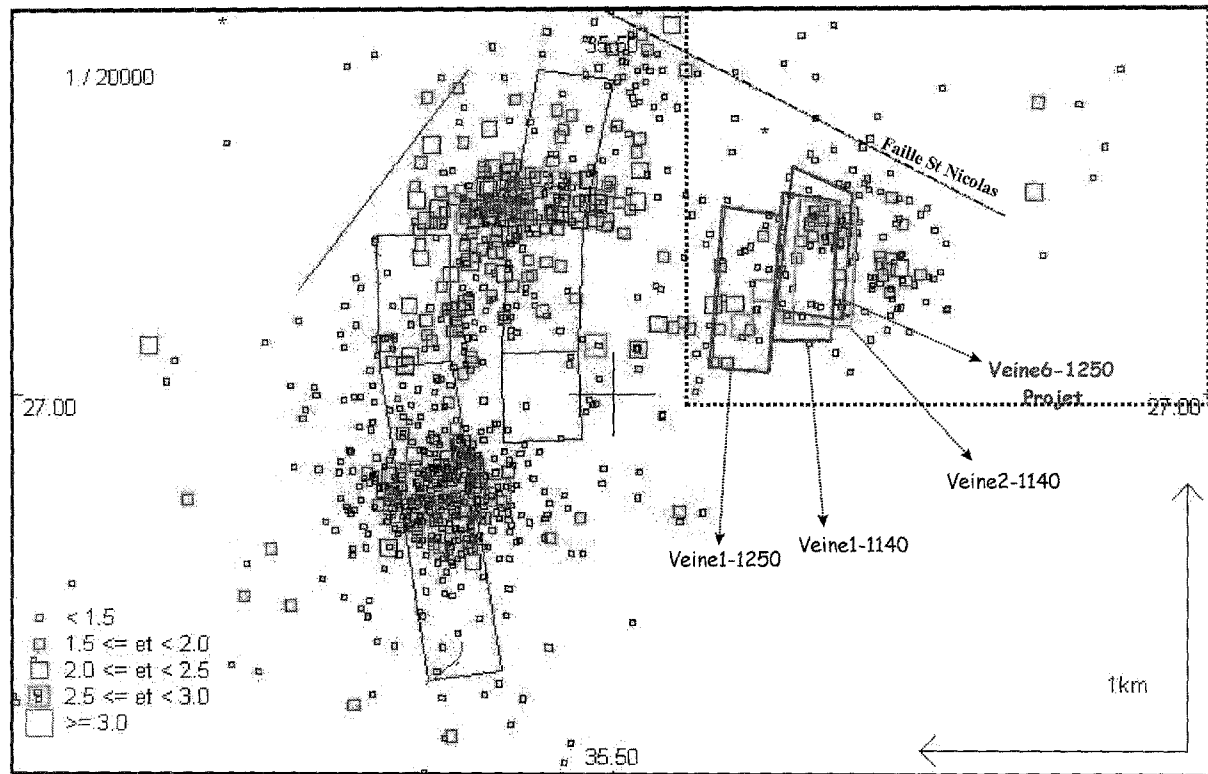
Seismic activity related to all mining operations carried out between 1995-2001 is represented by the spatial distribution of focuses of events recorded in the HBL regional listening network. Based on the distribution of focuses in the zone limited to Seams 1 (panels 1140, 1250) and 2 (panel 1250), it is quite obvious that seismic activity is much lower (209 events) than was observed in the West sector (Irma, Erna and Frieda, 1500 events). A distinction is made between three activity distributions (figure 6):

1. minor rock bursts, most with a magnitude of less than 1.5, related to ruptures close to the St Nicolas fault;
2. a cluster of focuses located at about a hundred meters to the East of the panels in the preferred NS direction. A single rock burst with a magnitude of more than 2 is identified;

Fig. 6: Seismic activity of Seams 1 sector (1140, 1250 panels), Seam 2 (1140 panel), 1995-2001 period

- the seismic activity related to mining operations on Seams 1 and 2 is particularly weak compared with the activity in the sector of the Frieda5 cut;
- only 7 of the 209 recorded events have a magnitude of more than 2.0.
- identified mechanisms at the focus associate these events with shear type failures.
