Multi-scale analysis of water alteration on the rockslope stability framework

Sandra Dochez, Farid Laouafa, Christian Franck, Sylvine Guedon, François Martineau, Julie d'Amato, Albane Saintenoy

Sandra Dochez, Farid Laouafa, Christian Franck, Sylvine Guedon, François Martineau, et al.. Multi-scale analysis of water alteration on the rockslope stability framework. 16. French-Polish Colloquium of Soil and Rock Mechanics, Jul 2013, Montpellier, France. pp.NC. ineris-00973700

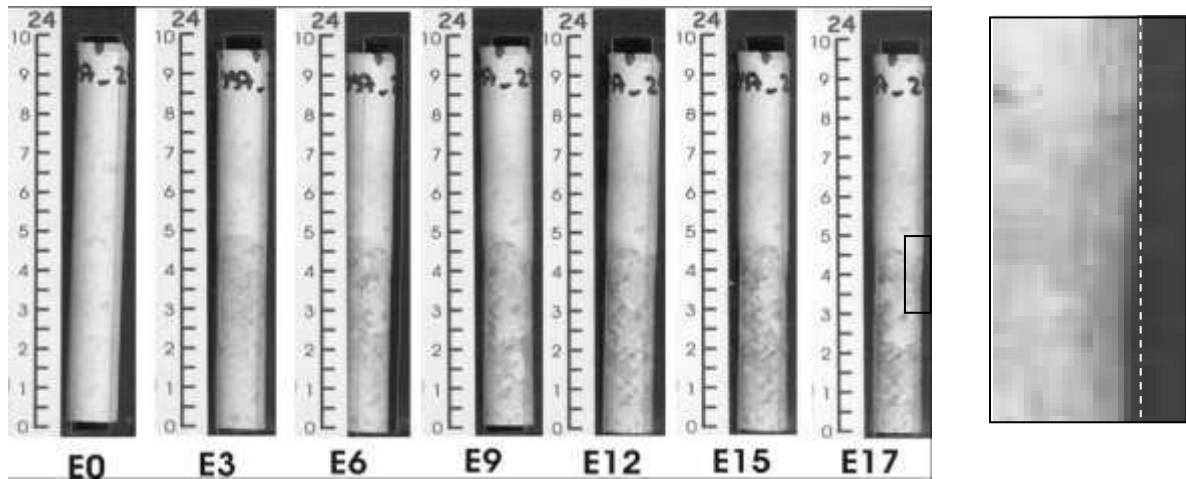
Figure 4: Pictures of Larrys samples during alteration: Initial state (E0), after 10 days (E3), 20 days (E6), 30 days (E9), 40 days (E12), 50 days (E15) and 60 days (E17).

We observe the same high degradation near the interface, for all types of limestone. This information suggests an influence of CO₂ whatever the porosity.

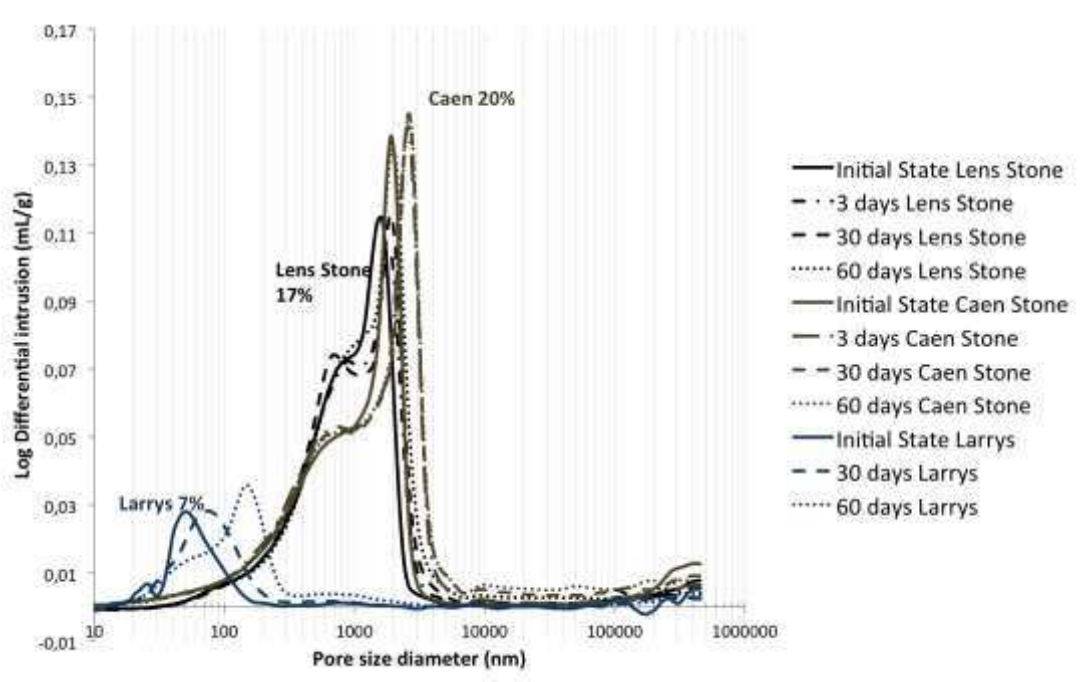
Figure 5: Volume of mercury intrusion versus pore size diameter for samples of Lens Stone, Caen Stone and Larrys and for several state of weathering

In order to evaluate the different states of alteration of the porous matrix evolution inside the sample, mercury intrusion porosimetry (MIP) measures have been done. This method is commonly used to evaluate the total porosity and the pore size distribution of different materials. MIP results are expressed as the total mercury volume intruded (log differential intrusion) in a sample versus pore size (mean diameter pore). Measures were carried out after several cycles of degradation. The Figure 5 shows the volume of mercury intrusion versus the pore diameter. We represent on the graph three of the four limestone used for the study (Larrys (7%) Lens Stone (17%) and Caen Stone (20%)). First of all we can observe the mean pore diameter increases with the limestone's porosity. Then for each type of limestone there is an increase of the mean pore diameter between the initial state and 3 days of alteration. The alteration increase pore volume. Low porosity sample have little mean pore diameter whereas high porosity have their mean diameter higher. Matrix of Lens Stone and Caen Stone samples are modified after the first cycle. Indeed an aperture of the mean diameter pore is measured after the first cycle but the mean diameter doesn't increase for the other cycles. Nevertheless on Lens Stone, the volume of mercury increases between 30 days and 60 days of alteration. This reveals an increase of pores with same size. Larrys' samples show an increase of the mean diameter pore all along the state of degradation (Figure 5).

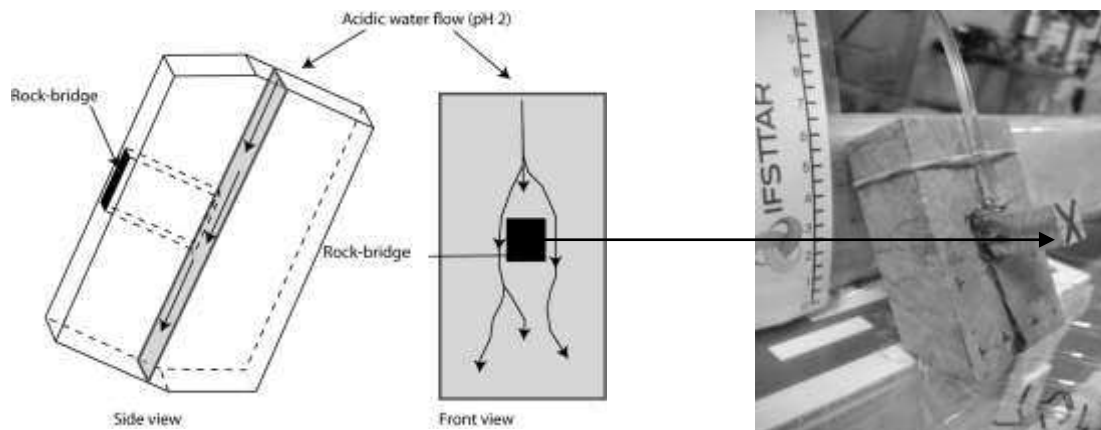
Figure 12: Schemes of the shape limestone samples for the experiment Alteration in the case of “flowing water”, the acid solution is in drip system, the flow is one liter of solution per day, and run along the discontinuity and around the rock bridge (left). Picture of the runoff along the discontinuity and around the rock-bridge (right).

It exists [11] [12], part in the rock mass which is connected to the block ready to fall. These parts are called *rock-bridge* and they constitute the block stability. In this experiment, the shape of the sample and the water flow are different from the first one. Limestone's blocks are sawn so as to leave a continuous part, called rock bridge. The rectangular geometry of the bridge is connected to the surface of the block. The above part is taken off. The experiment is realized in open system where CO_2 of the atmosphere can influence the interaction between the acidic solution and the surface of the block because CO_2 is known to acidify water. The acidic solution is stored in tins and the solution flows via a drip system. The water flow is about one liter per day (Figure 12).

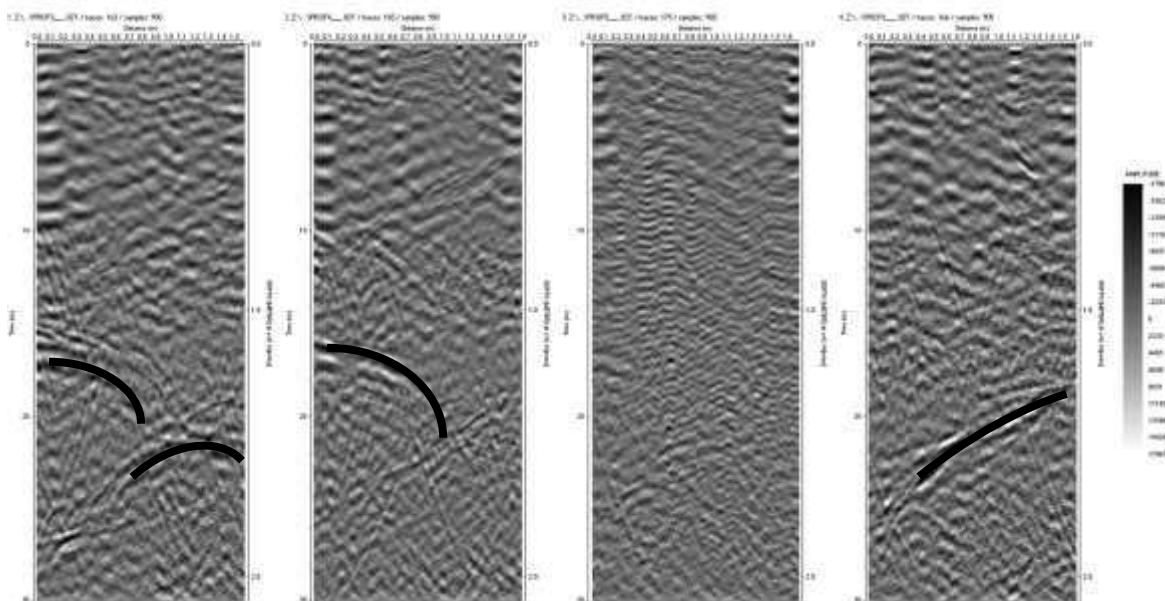
Figure 19: Radar gram acquired after profiles from the block, profile 3 to 6, the black lines represented the weirdness observed and used for the 3D representation.

The first observation in situ reveals many discontinuities; the major ones represented in black on Figure 17 are those where we suppose there are rock bridges to maintain the stability of the rock mass. The white ones appear to be just on the surface but they are important for the surface degradation. The GPR reveals the possibility to identify the surface discontinuity (Figure 19). As a matter of fact radar-gram present some weirdness, these ones are the proofs of different environment as air or rock mass. These are analyzed and after a treatment, a 3D view of the discontinuity surface could be made as Figure 20 shows.
