## Multi-scale analysis of water alteration on the rockslope stability framework

Sandra Dochez, Farid Laouafa, Christian Franck, Sylvine Guedon, François Martineau, et al.. Multi-scale analysis of water alteration on the rockslope stability framework. 16. French-Polish Colloquium of Soil and Rock Mechanics, Jul 2013, Montpellier, France. pp.NC. ineris-00973700

# MULTI-SCALE ANALYSIS OF WATER ALTERATION ON THE ROCKSLOPE STABILITY FRAMEWORK

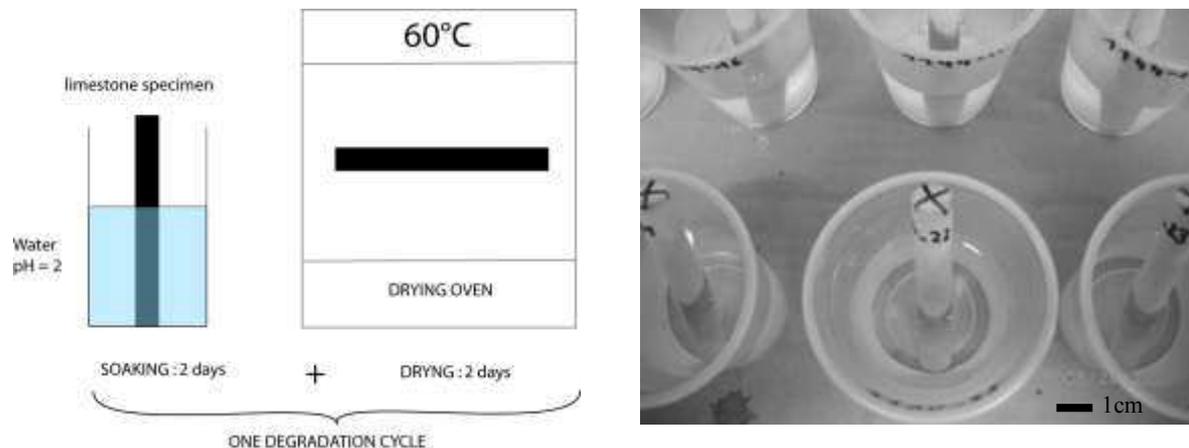
**Figure 1: Schematic representation of the two steps of the experiment “alteration in quasi- static regime” which is composed of one cycle of weathering (left). Picture of the first phase of the experiment quasi-static regime limestone samples sticks are soaking in the acidic water (right).**

This first experiment consists in leaving limestone's samples at rest in a fixed volume of acidic water (Figure 1). The evolution of weight of each samples during cycles of alteration are measured at different times. A cycle is composed of two steps. During the first step all samples are soaked 2 days in a sulfuric acid solution

at pH 2 then during the second step samples are dried at 60°C for 2 days (Figure 1). The acidic solution is renewed. Thanks to that change, the alteration is more effective by repetitions of these cycles, *in fine*, the samples degradation is increased.

The rock samples are cylindrical (diameter: 12 mm, high 100 mm) (Figure 1). A number of 24 sticks samples are used for each type of limestone. We used four types of limestone: Pierre de Caen (Caen Stone), Pierre de Lens (Lens Stone), Larrys and Comblanchien whose differ by their porosity. Limestones' porosity extend to a range from one to several tens percent. Caen Stone and Lens Stone have a high porosity respectively 20% and 17%, whereas the two others have a low one respectively 7% and 1%.

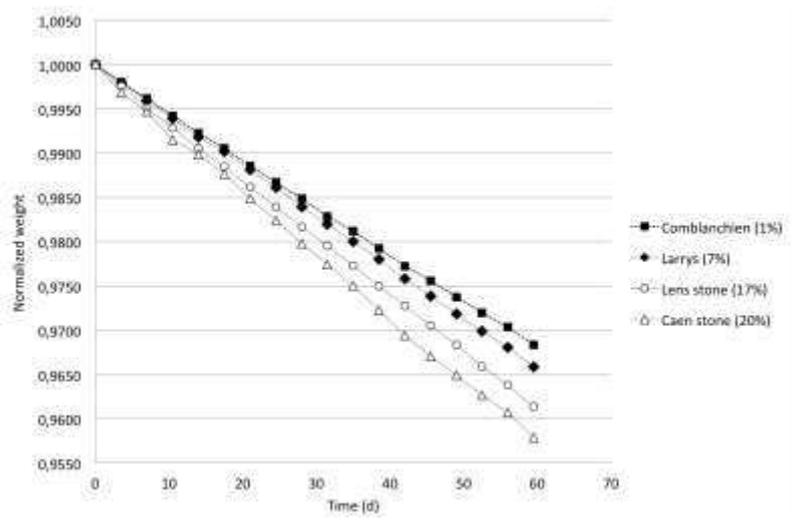
**Figure 2: Evolution of sample weight during the experiment Alteration in static regime.**

The evolution of each sample weight is measured during the dissolution process. A decrease of weight is measured for each type of limestone. Figure 2 represents normalized weight (weight (t)/weight (0)) versus time of degradation. We noticed linearity with time of the loss of weight for all the type of limestone (Figure 2). This indicates there is a constant rate of dissolution for limestone. In this figure below, we can observe that whatever the giving porosity the rate of decreasing weight is quite constant. However we can observe the higher the porosity, the higher the rate. This difference of rate means that the dissolution process also affects the pores of the matrix although the pore pressure is very small. Moreover the dissolution process has a higher influence on the more porous sample (Caen stone).

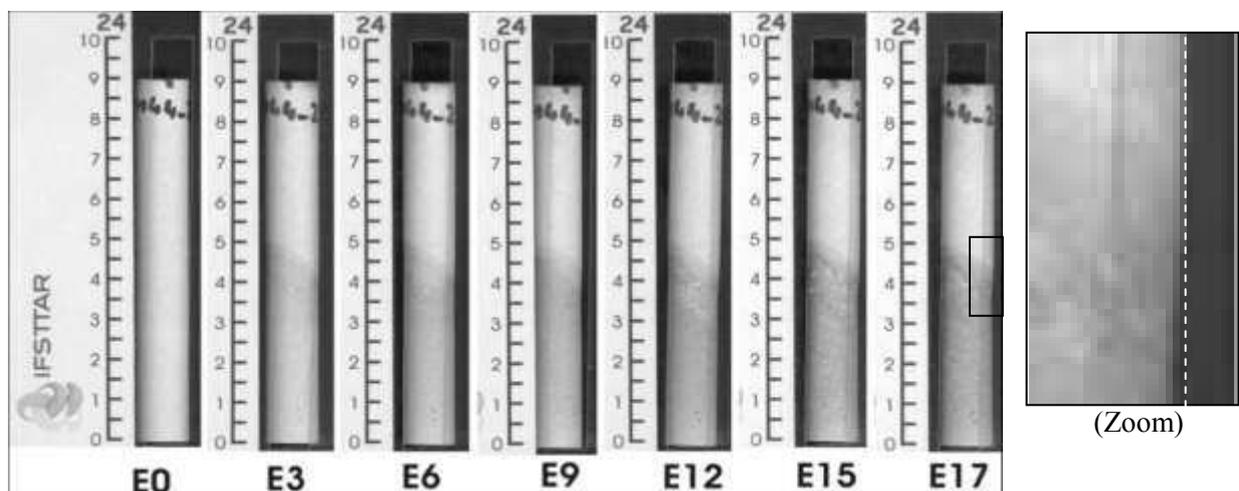
**Figure 3: Pictures of Caen Stone samples: Initial state (E0), after 10 days (E3), 20 days (E6), 30 days (E9), 40 days (E12), 50 days (E15) and 60 days (E17).**

At the fluid-air interface recognized by the different of coloring, a recession of the surface is observed for each sample of each limestone (Figure 3, Figure 4). This recession suggests a loss of material. The high degradation in this part of the sample is also attributed to the influence of the CO<sub>2</sub> in ambient air. Actually, CO<sub>2</sub> is considered as an important acidifying component of water. The interface is the place where the exchange between ambient air and the water near the surface is the most important, makes it a zone where degradation is improved.

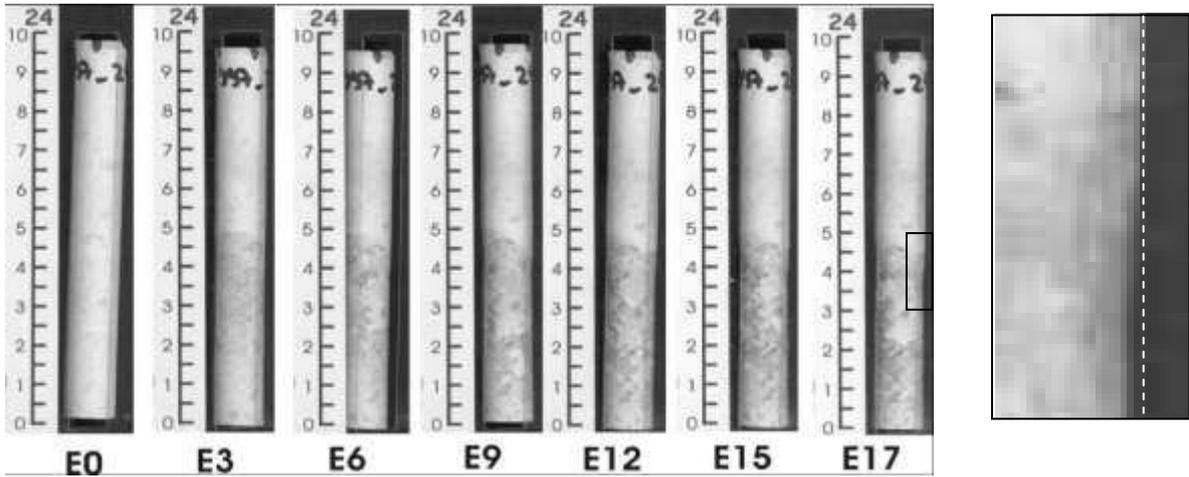
**Figure 4: Pictures of Larrys samples during alteration: Initial state (E0), after 10 days (E3), 20 days (E6), 30 days (E9), 40 days (E12), 50 days (E15) and 60 days (E17).**

We observe the same high degradation near the interface, for all types of limestone. This information suggests an influence of CO<sub>2</sub> whatever the porosity.

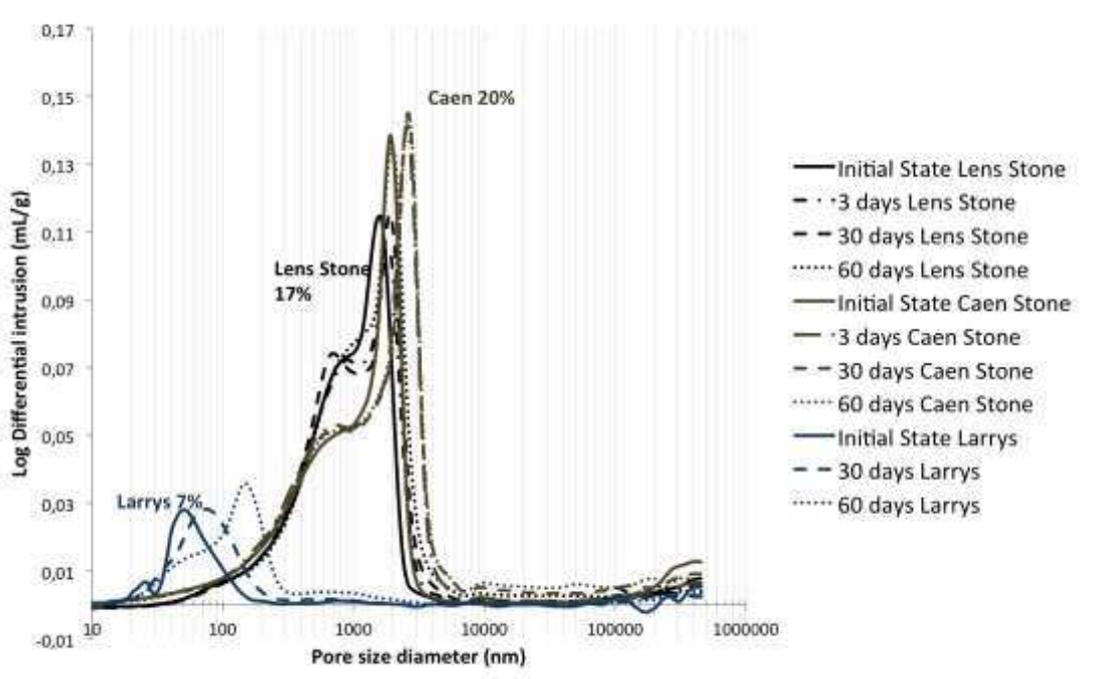
**Figure 5: Volume of mercury intrusion versus pore size diameter for samples of Lens Stone, Caen Stone and Larrys and for several state of weathering**

In order to evaluate the different states of alteration of the porous matrix evolution inside the sample, mercury intrusion porosimetry (MIP) measures have been done. This method is commonly used to evaluate the total porosity and the pore size distribution of different materials. MIP results are expressed as the total mercury volume intruded (log differential intrusion) in a sample versus pore size (mean diameter pore). Measures were carried out after several cycles of degradation. The Figure 5 shows the volume of mercury intrusion versus the pore diameter. We represent on the graph three of the four limestone used for the study (Larrys (7%) Lens Stone (17%) and Caen Stone (20%)). First of all we can observe the mean pore diameter increases with the limestone's porosity. Then for each type of limestone there is an increase of the mean pore diameter between the initial state and 3 days of alteration. The alteration increase pore volume. Low porosity sample have little mean pore diameter whereas high porosity have their mean diameter higher. Matrix of Lens Stone and Caen Stone samples are modified after the first cycle. Indeed an aperture of the mean diameter pore is measured after the first cycle but the mean diameter doesn't increase for the other cycles. Nevertheless on Lens Stone, the volume of mercury increases between 30 days and 60 days of alteration. This reveals an increase of pores with same size. Larrys' samples show an increase of the mean diameter pore all along the state of degradation (Figure 5).

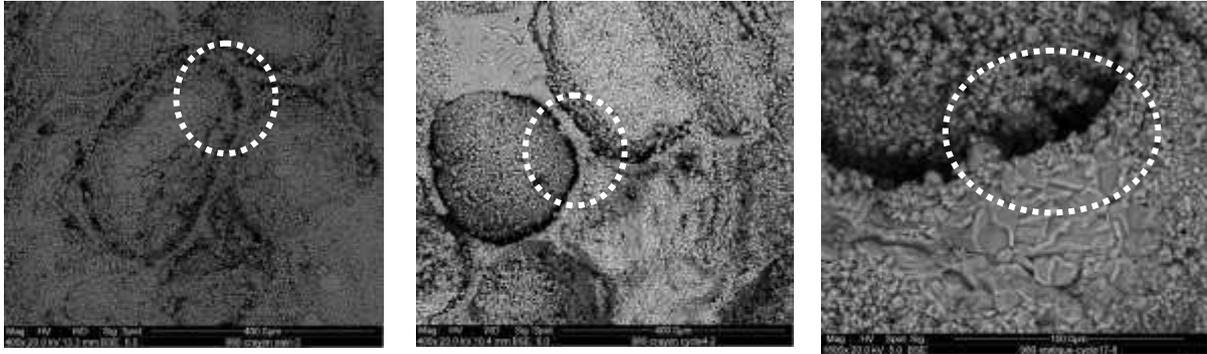
**Figure 6: ESEM pictures from sample of Lens Stone at initial state (left) after 10 days (middle) and after 60 days (right). The dash line circles emphasize the gap between oolites; this gap was created during the alteration.**

We observe sample of limestone named Lens Stone at micro-scale with an environmental scanning electron microscope (ESEM) (Figure 6). These three pictures show three states of limestone degradation's at different time, the first represents non-altered sample, the second at 10 days of alteration and the last one after 60 days of alteration. The limestone observed is Lens Stone, it is composed of ooids which are spherical grains composed of concentric layers. We observe along the period of alteration a digging around the ooids, which indicates dissolution of calcite. This kind of feature shows the non-homogeneous fact of dissolution either at space scale.

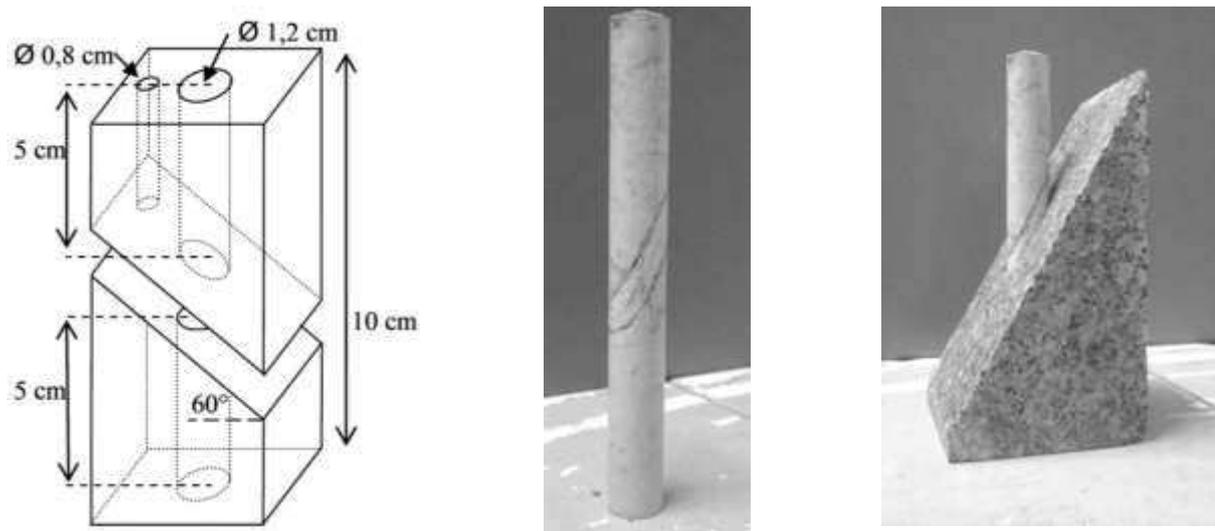
**Figure 7: Shape of the granite base with dimension (left) the sample of limestone (middle) are inserted into the granite for the test (right) (after Druon)**

In order to the observation and measurement of chemical degradation an evaluation of the mechanical response of the sample submitted to a shear loading is performed. The measurements are made with a uniaxial cell in order to evaluate the influence of alteration on the mechanical properties of limestone samples. We used cylindrical samples (Figure 7) as samples in the alteration in quasi-static experiment. Each sample is positioned in a shaped granite base (Figure 7) and put in the uniaxial cell (Figure 8).

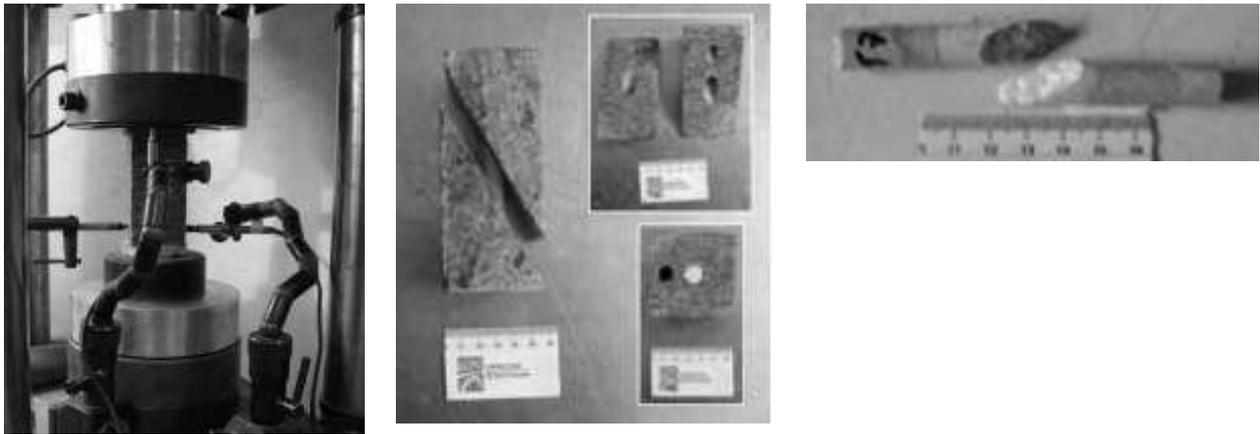
**Figure 8: Picture of the uniaxial cell used for the experiment “alteration quasi-static” (left). Sample in the granite base (middle) and the broken sample after the test (right) (after Druon).**

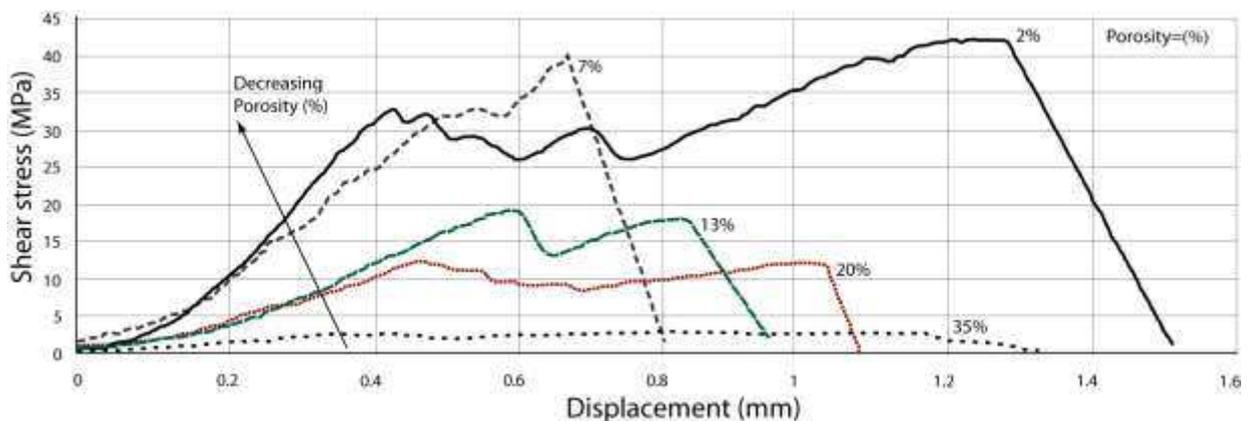
**Figure 9: Shear stress versus tangential displacement for different limestone’s porosity (modified from Druon, 2011 [10] ).**

Shear strength measurements are performed on different non-altered limestone samples on a range of porosity 2% from 35 % (Figure 9). The different curves show an increase in the shear stress versus tangential displacement until a peak is reached and then a decrease followed by an increase to a maximum and then failed. The first stress drop is associated to micro-cracks of the sample and the final stress drop is related to the failure of the sample. All limestone samples seem to have the same behavior.

We noticed the smaller the porosity the stronger slope, this implies that the slope of curves is hardening with the decreasing porosity. It suggests porosity affects the mechanical response of samples.

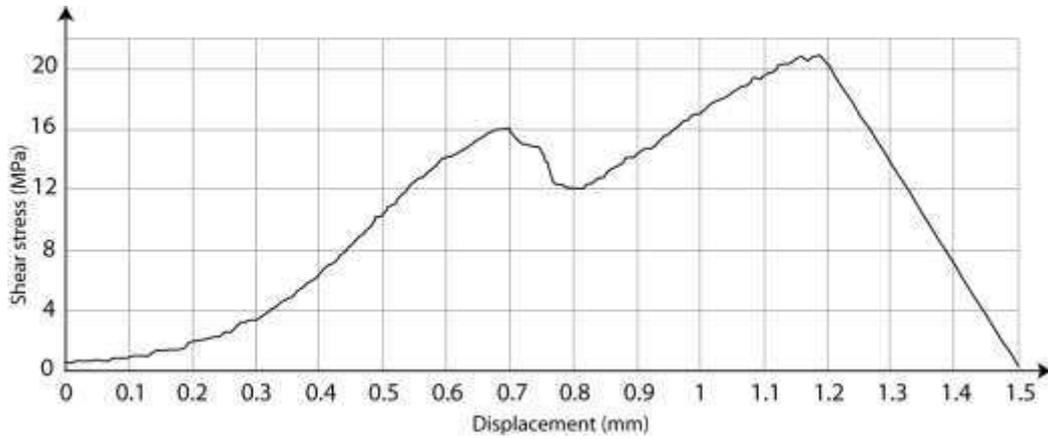
**Figure 10: Evolution of shear stress versus tangential displacement for the limestone Larrys (modified from Druon, 2011).**

The following experiment focused on non-altered Larrys (7%) sample. The Figure 10 shows the evolution of shear stress versus tangential displacement. The curve shows an increase to a peak at 16 MPa and a decrease to 12 MPa. This first part of the curve with the little peak, indicate a first micro-crack in the limestone sample. After that the shear stress rises to a maximum at 21 MPa and after the shear stress collapse. This part of the curve represents the rupture of the sample.

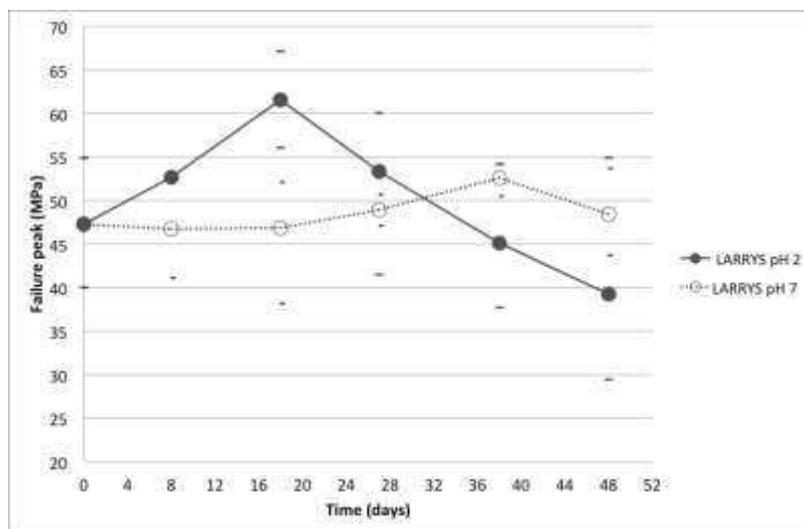
**Figure 11: Evolution of the mean failure peak after period of alteration for Larrys limestones. A comparison between different water, acid (pH 2) and neutral (pH7). Dashes (above and below) represent respectively the standard deviations max and min. The small dashes for pH2, and the large dashes for pH 7(modified from Druon, 2011).**

The Figure 11 shows the evolution of Larrys' samples mean failure peak during alteration period for two different pH degree of water (pH 2 and neutral water pH (7)). Which is surprising in that two curves show an increase of mean peak rupture to a maximum and a decrease. They have the same shape except the maximum for the acid water (pH 2) appears before that for rain water (pH 7). The difference between the curves points out the acceleration process of dissolution. The comparison between two different pH degrees of water shows how much the influence of pH water is relevant during the alteration process. Furthermore the slope before the peak for the pH 2 curve is stronger than the slope for pH 7.

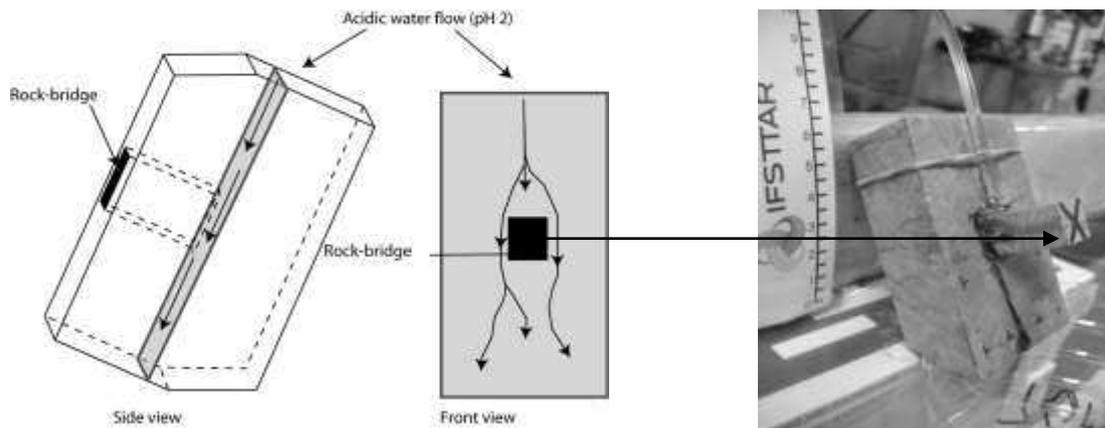
**Figure 12: Schemes of the shape limestone samples for the experiment Alteration in the case of “flowing water”, the acid solution is in drip system, the flow is one liter of solution per day, and run along the discontinuity and around the rock bridge (left). Picture of the runoff along the discontinuity and around the rock-bridge (right).**

It exists [11] [12], part in the rock mass which is connected to the block ready to fall. These parts are called *rock-bridge* and they constitute the block stability. In this experiment, the shape of the sample and the water flow are different from the first one. Limestone's blocks are sawn so as to leave a continuous part, called rock bridge. The rectangular geometry of the bridge is connected to the surface of the block. The above part is taken off. The experiment is realized in open system where  $\text{CO}_2$  of the atmosphere can influence the interaction between the acidic solution and the surface of the block because  $\text{CO}_2$  is known to acidify water. The acidic solution is stored in tins and the solution flows via a drip system. The water flow is about one liter per day (Figure 12).

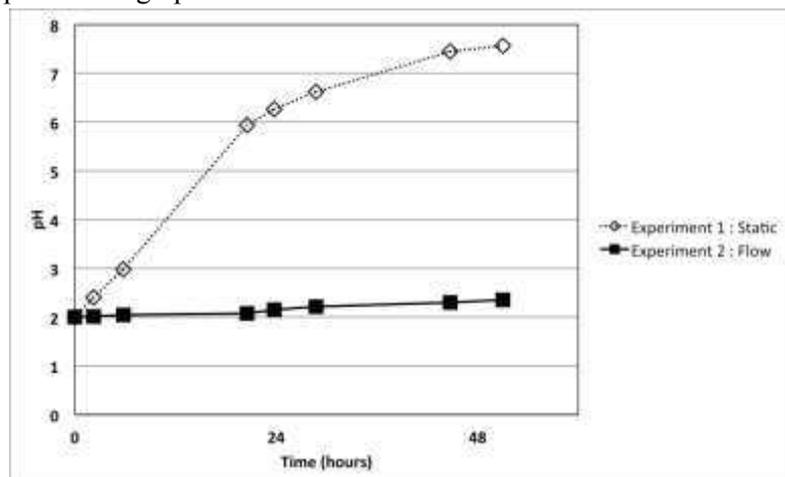
**Figure 13: Representation of the evolution of pH as a function of time, the dotted curve with open symbols shows the evolution in the case of an alteration in static water regime: limestones ( $\text{CaCO}_3$ ) are soaking in an acidic solution ( $\text{H}_2\text{O}$ ;  $\text{H}_2\text{SO}_4$ ). The solid curve and filled symbols shows the evolution in the case of an acidic solution flows along the limestone.**

Figure 13 depicts the time evolution of water pH during two different experiments. A continuous flow on the limestone surface; maintains pH stability around 2 whereas limestone's sample immersion in an acidic solution buffers it at pH 7. This graph shows how time-contact between rock and solution is relevant.

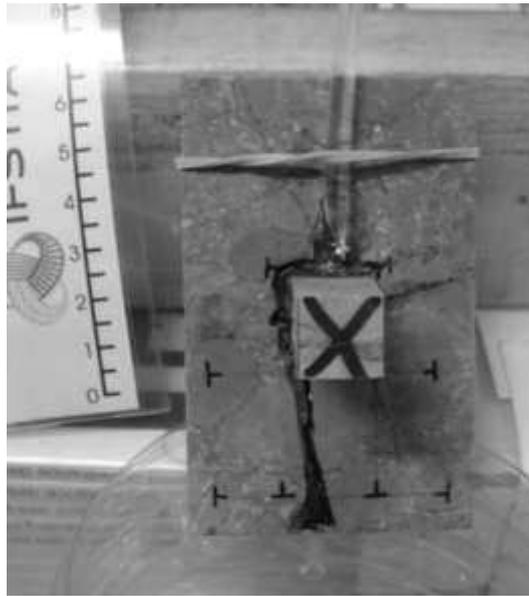
**Figure 14: Picture of Montagnole limestone ( $\text{CaCO}_3$ ) sample surface degradation by acidic solution ( $\text{H}_2\text{O}$ ;  $\text{H}_2\text{SO}_4$ )**

The experiment is performed in an open system, which means the sample in contact with ambient air. The interaction with the  $\text{CO}_2$  of the ambient air increases the phenomenon. The flow of water causes a material dissolution and deconstruction (Figure 14). Fine particles are observed in the water of the recovery basin as

observed by Kupper [13]. The picture shows also an asymmetric flow of the solution. Indeed we observed during the period of runoff that water followed different paths. It is obvious that water prefers the easier path to dissolve crystals less competent than the rest of the rock sample.

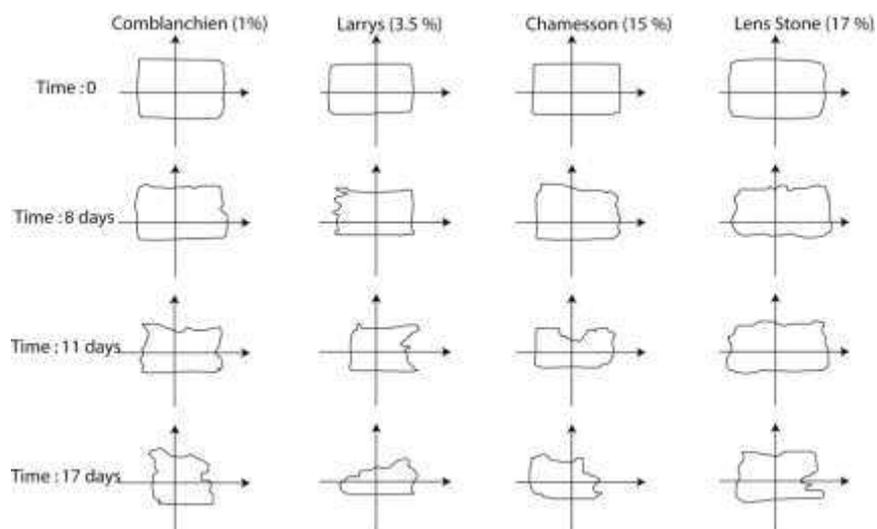
**Figure 15: Comparison between the different states of alteration for each limestone of their rock bridges' perimeter measured with laser.**

Each type of limestone received 12 liters of acid solution flowed for a period of 17 days. After 8, 11 and 17 days, a geometric analysis by laser is performed. Many profiles were done in order to show the influence of the alteration surface and to establish the decreasing of the rock bridge perimeter. This decreasing of the perimeter is observed during the water flowing for all samples (Figure 15). In addition we noticed an intact part of the rock bridge below. The recession of the rock-bridge perimeter may imply a decrease of the mechanical resistance of the rock bridge.

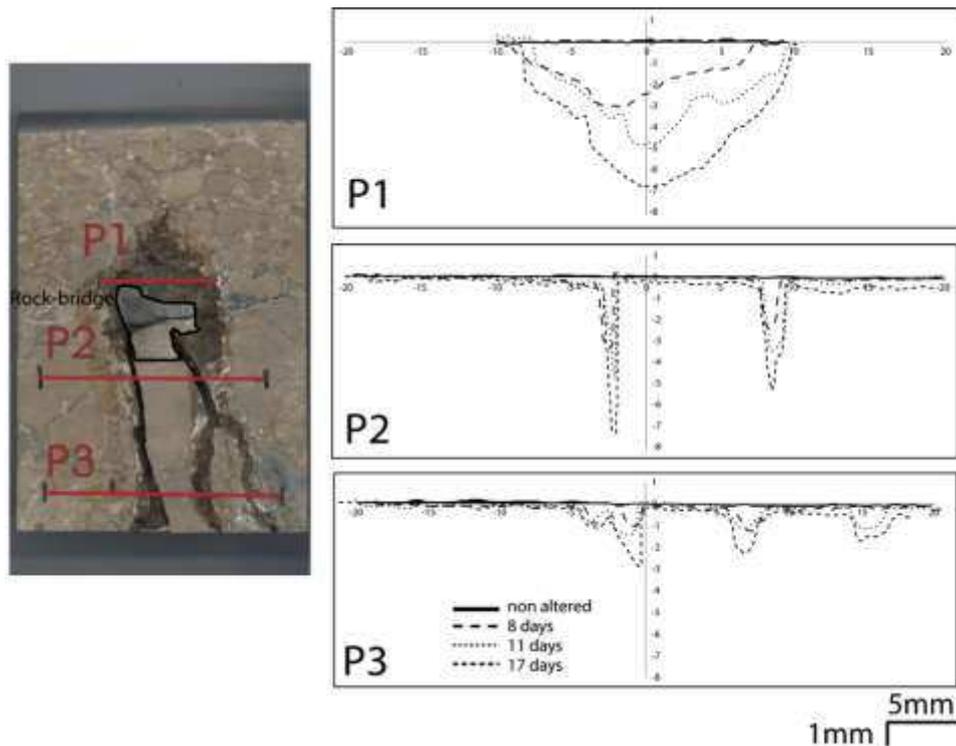
**Figure 16: Montagnole sample after acidic water runoff, line P1, P2, P3 represent the place we take the profile by laser (left). These graphs represent the 3 profiles done by laser, the different curves show the evolution of the “topography” of the sample surface during alteration period (right)**

We performed other laser profiles (Figure 16). Profile P1 was taken above the bridge then profile P2 just under the bridge, and the third P3 was measured on the below far from the bridge (Figure 16). These profiles were made at initial state, after 8 days of runoff, 11 days and at final state (17 days). Profile P1 is made near the place where the drop fell. It shows a digging which increases significantly over time. Profiles under the

bridge show two diggings (P2) then three (P3). These paths followed small fractures. These ones indicates preferential path of water circulation (P2 and P3).

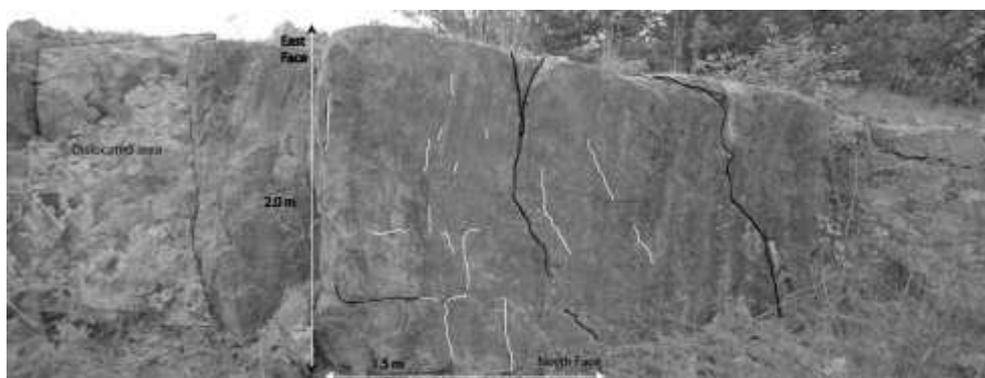
**Figure 17: View of the rock mass, it presents a dislocated area on the left, and major discontinuities are in black and superficial are in white.**

The site is located in Montagnole near Chambéry (73) in France. The block is a triangle shaped dihedral with fractures and it is apparently ready to fall (Figure 17). This work aims to evaluate the potential of Ground Penetrating Radar (GPR) measurements to find and estimate the quantity of rock bridges into a block with a discontinuity.

The first observation in situ reveals many discontinuities; the major ones represented in black on Figure 17 are those where we suppose there are rock bridges to maintain the stability of the rock mass. The white ones appear to be just on the surface but they are important for the surface degradation. The GPR reveals the possibility to identify the surface discontinuity (Figure 19). As a matter of fact radar-gram present some weirdness, these ones are the proofs of different environment as air or rock mass. These are analyzed and after a treatment, a 3D view of the discontinuity surface could be made as Figure 20 shows.

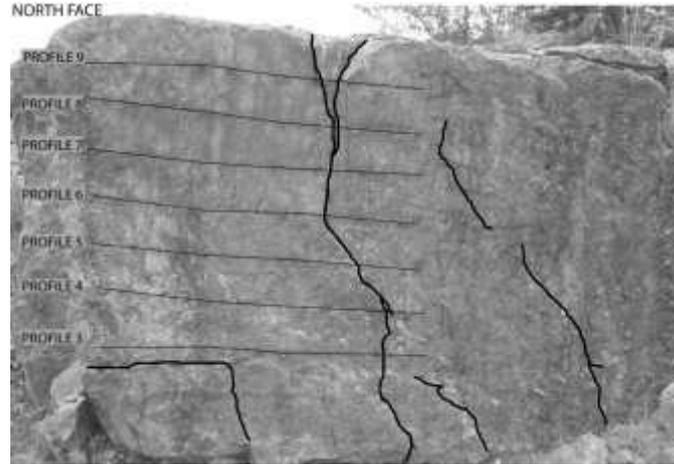
**Figure 18: Depict of the North Face of the block in Chambéry (73). The black lines reveal the different discontinuities observed. The black horizontal lines identified each radar profile, profile 3 to 9 from the bottom to the top.**

GPR data were acquired using high frequency (1600 MHz) to estimate the presence of rock bridges (continuity in the rock mass). This high frequency is adapted to detect interfaces such as rock-air-rock in two meters thick. The air tends to disperse the signal, so we can deduce the rock bridge's presence or not. In this paper, GPR measurements consisted in profiles acquired from the block (Figure 18), in order to make a grid of the block and identify the presence of rock bridges.

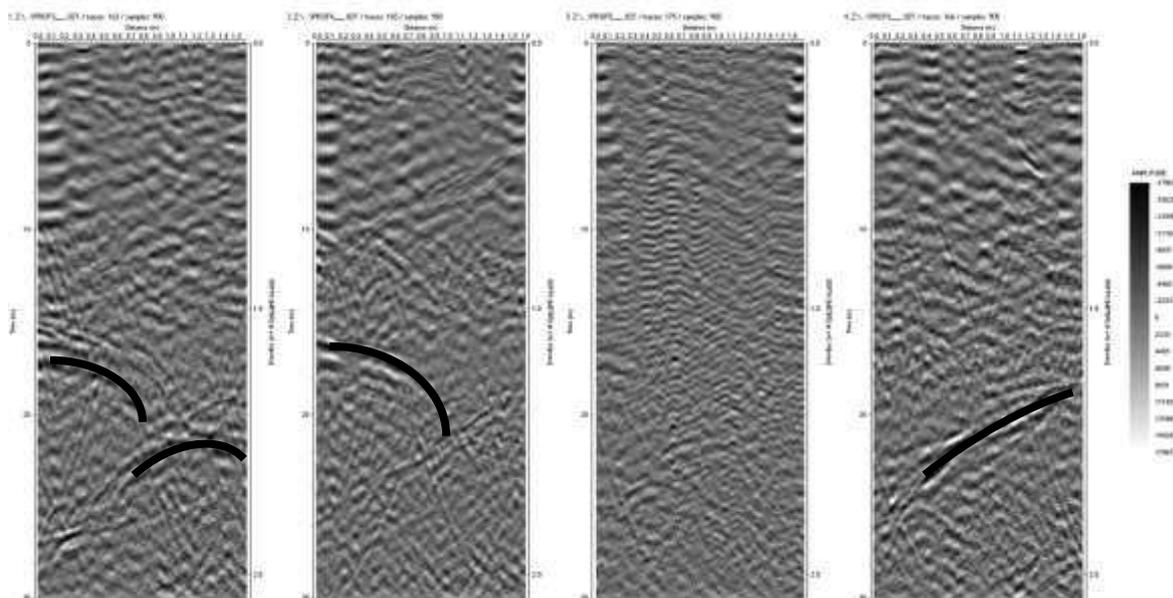
**Figure 19: Radar gram acquired after profiles from the block, profile 3 to 6, the black lines represented the weirdness observed and used for the 3D representation.**

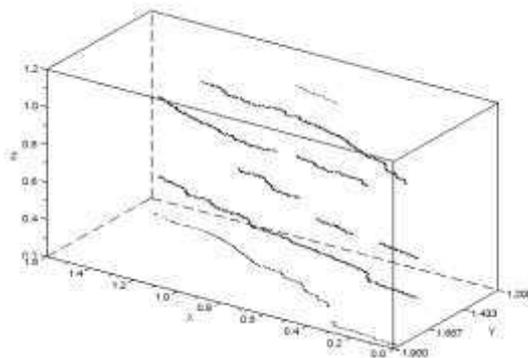
**Figure 20: 3D view of the surface discontinuity after analyze and treatment of the data.**

Figure 20 show horizontal dots, which represented the separation between rocks and void i.e. the discontinuity inside the block.
