Detection of underground Marlpit mine using high resolution seismic

Detection of Underground Marlpit Quarries Using High Resolution Seismic

B. Piwakowski* (Ecole Centrale de Lille), L. Drad-Lebeau (Institut National de l'Environnement Industriel), A. Kosecki (Ecole Centrale de Lille) & P. Safinowski (Ecole Centrale de Lille)

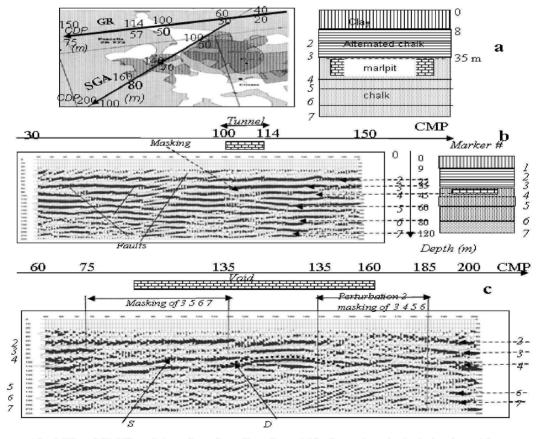
Fig.1.Site of St Gilles a) Location of profiles, the void limits and geological structure; b) Section GA and interpretation c) Section SGA and interpretation

<u>Site of St Gilles de la Neuville (Fig.1)</u> The section (a) shows the locations of profiles in relation the positions of voids and the general geological setting. The voids occur at dept of 35 m in chalk layer, covered by alternated chalk and clay.

<u>The profile GR</u> is the reference section situated within the void-free zone and crosses a small tunnel of 7 m width (its AN=0.34). The obtained section shows numerous markers: 2, 3, ... 7 and it can be observed that the obtained resolution is relatively low (i.e. f_e too low). Notice also the important natural irregularities of the structure. The expected masking caused by the tunnel is practically not seen; indeed, taking into account its AN=0.35 the tunnel is close to the detection limit.

<u>The profile SGA</u> includes the void-free zones (CMP < 90 and CMP > 160) and the zone including the void (90 < CMP < 160). The void manifests itself by the following phenomena:

- Within interval 75 < CMP < 120 & 150 < CMP < 185: perturbations of the marker 3 and nearly total masking of markers 4, 5, 6, 7.
- Within interval 75 < CMP < 135 we can observe the quite strange seismic behaviour S and diffraction D which might be interpreted respectively as the effect of a local fill of an old subsidence and the presence of filled in well.
- In the contrary the effects seen within interval 150 < CMP < 185 are rather evident. The perturbations of 2 suggest that the void is collapsing there and reaches depth of 25 m <u>Site of Goderville</u> (Fig.2) This study compares the results obtained with the explosive and vibratory source.

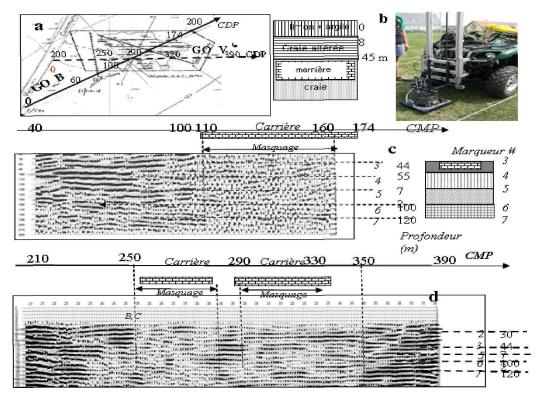
Fig.2.Site of Godedrville **a)** positions of profiles et and void limits; **b)** P vibrator mounted on an all terrain vehicle (quad) **c)** Section GO_B and interpretation **d)** Section GO_V and interpretation.

<u>GO-B profile</u>: The presence of the void is clearly seen for CMP > 105 by means of the perturbations of upper marker 3 and the masking of deeper markers 4, 5, 6, 7. The precision of location of the void limit (2.5 m) is much better than expected ($\delta_x = 16$ m). <u>GO-V profile</u>. This profile is longer then the profile GO-B since the non-destructive source was used. It reveals the same markers 3 à 7 seen already in GO-B. Notice that the quarry effect is now in the middle part of profile (250 < CMP < 330) giving better imaging. The natural geological structure is located symmetrically on its both sides. **Site of Eturqueraye** (Fig.3). This study is carried out without a priori knowledge of the marlpit position. The extremely high ground absorption, implied to use a very low fe (such as used in deep seismic!) which resulted in very low resolution seismic image. The proximity of a motorway and of the high voltage power line caused additional difficulties.

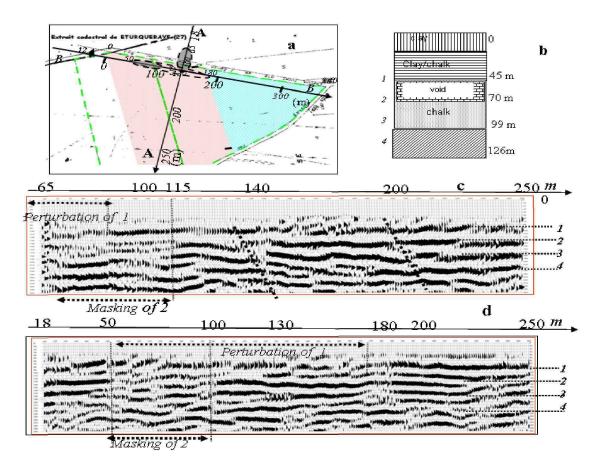
Fig.3.Site of Eturqueraye **a)** Locations of profiles and void limits (perturbations of 2:filled ellipses perturbation of 1 :dotted ellipses);, **b)** geological structure **c)**Profile AA **d)** Profile BB

<u>The profile AA</u> manifests a masking of marker 2 within the interval (65 - 115) m. and less evident perturbations of 1. Thus this zone is interpreted as the effect of marlpit gallery. <u>The profile BB</u> indicates the similar results within the interval (50 - 100) m. but perturbation of 1 zone is much larger (position of gallery probable but less evident)

The positions of presumed voids are shown in Fig.3.a The found positions agree with the known position of the void given (after interpretation) by the owner of the investigated site.
