Natech accidents at industrial facilities. The case of the Wenchuan earthquake

Natech Accidents at Industrial Facilities – the Case of the Wenchuan Earthquake

Abstract

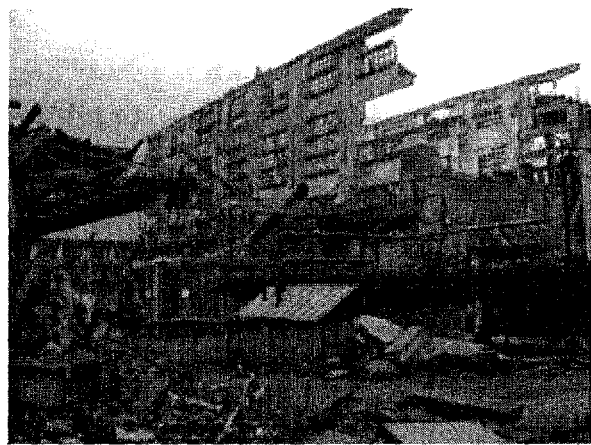
Fig. 1: Destroyed building at a chemical facility.

During our site visits we noticed widespread building damage and collapse, in particular in installations located in areas subject to high peak ground acceleration values. Our findings suggest that the damage severity is directly correlated to the age of the installation, and older facilities not built according to the latest design codes suffered more severe and extensive damage. Moreover, the construction type significantly influenced a building's resistance to the earthquake loads with masonry and un- or poorly reinforced concrete structures being the most vulnerable (Figs. 1 and 2).

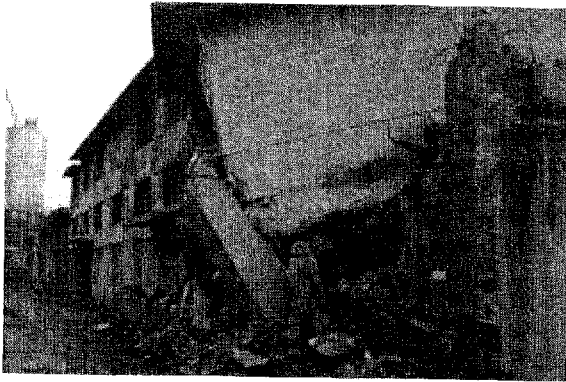
Fig. 2: Building collapse due to insufficient reinforcement.

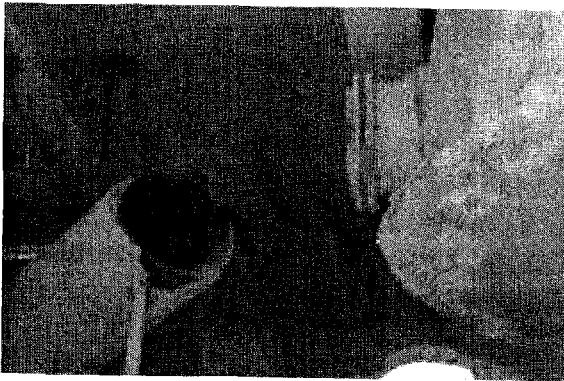
Fig. 3: Severed pipe.

Falling debris from collapsing buildings and other structures resulted in major equipment damage. Debris impact also severed and crushed pipes both inside buildings and outside. In many cases we observed bending or severing of external pipes when connected tanks or

buildings were displaced or collapsed (Fig. 3 and 4).
