Natech accidents at industrial facilities. The case of the Wenchuan earthquake

Natech Accidents at Industrial Facilities – the Case of the Wenchuan Earthquake

Natural disasters can trigger chemical accidents (so-called Natech accidents) with severe consequences on man or the environment. This work highlights the main characteristics of earthquake-triggered Natechs by describing our insights from a field trip to chemical facilities in the area affected by the 12 May, 2008, Wenchuan earthquake in China. Our preliminary results indicate that damage was most severe in older facilities with masonry and un- or poorly reinforced concrete structures being the most vulnerable. Debris impact and the shaking loads caused damage to and loss of equipment and pipes where hazardous-materials releases occurred. Emergency response on-site was hampered by a loss of lifelines.

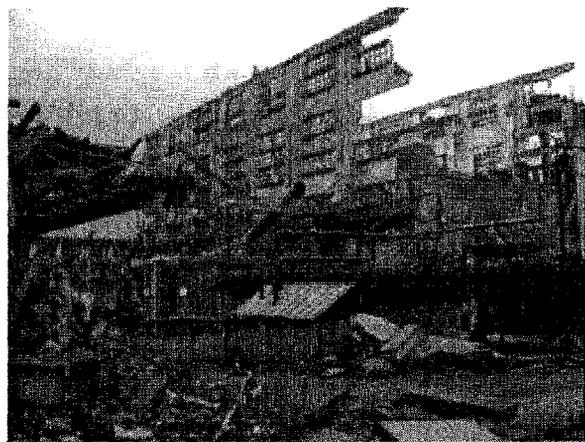
Fig. 1: Destroyed building at a chemical facility.

During our site visits we noticed widespread building damage and collapse, in particular in installations located in areas subject to high peak ground acceleration values. Our findings suggest that the damage severity is directly correlated to the age of the installation, and older facilities not built according to the latest design codes suffered more severe and extensive damage. Moreover, the construction type significantly influenced a building's resistance to the earthquake loads with masonry and un- or poorly reinforced concrete structures being the most vulnerable (Figs. 1 and 2).

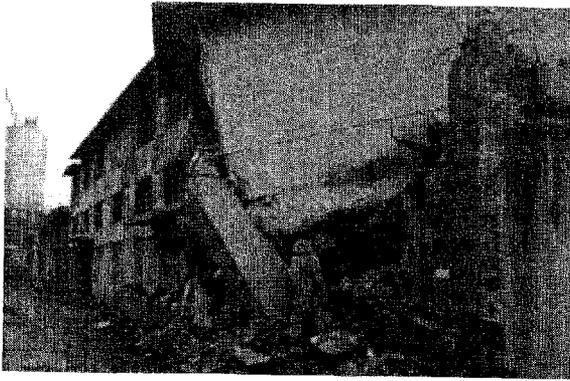
Fig. 2: Building collapse due to insufficient reinforcement.
