# Impact of climate change on the collapse of shallow mines – feedback from France

**ABSTRACT:** For many years, Ineris has been conducting research on the impact of climate change on the stability of abandoned mines. In this context, work has been initiated to reference cases of shallow mine collapses. So far, 480 cases have been identified and described. Preliminary analysis of the information gathered shows that 50% of the cases correspond relate to chalk mines, 32% to limestone mines, and 16% to gypsum mines. Two case studies presented in the paper were also analyzed in more detail. Complexity of the water-rock interaction and the importance of studying more precisely the various parameters impacted and their relationships are highlighted. Therefore, a chalk mine located in Seine-et-Marne (France) was instrumented to monitor the evolution of the structure over time and analyze the different causes of degradation. The objectives are to better understand the behavior of these structures to be able to detect precursor signs to these collapses.

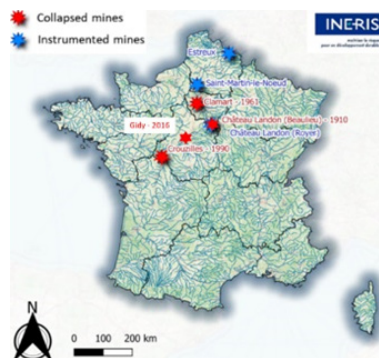
Figure 2. Ineris instrumented sites (in blue) - collapsed mines selected as case studies (in red).

To verify the correlation between rainfall events and the collapse of underground cavities, 2 case studies were selected: Château-Landon in Seine et Marne and Clamart in Hauts de Seine. Their location is shown in Figure 2.

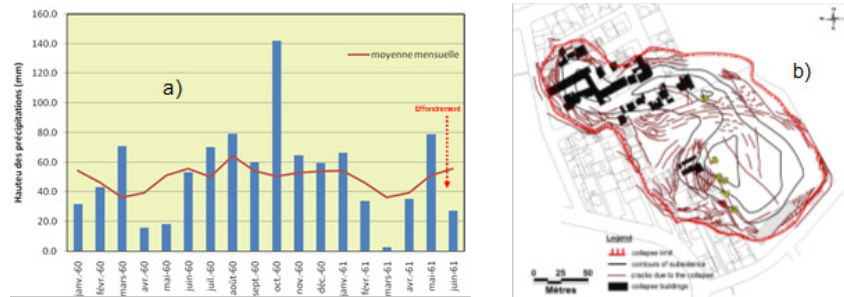
Figure 3. (a) Monthly rainfall from 1960 to June 1961 and (b) Clamart collapse on June 1st, 1961.

Having been studied extensively, the causes of this mine collapse have never been established with certainty, but experience-based feedback on the possible role of water has been considered. For several years, the lower level of the mine had been flooded by the chalk water table, but its level did not vary before the collapse, just as with the level of the Seine, which was low. However, precipitation was contrasted during the 8 years preceding the collapse with the driest year (400 mm in 1953) and the wettest year (812 mm in 1958) for the entire period 1941-1960. In the month

preceding the collapse, significant precipitation concentrated in a small number of days was recorded: there was more precipitation during the week preceding the collapse than in a normal month, in particular with 48 mm on May 25. Although no exceptional hydroclimatic event occurred, this elevated rainfall a week before the collapse could have played a role, as well as the two water system leaks reported to the right of the mine during the days leading up to it (Figure 3).

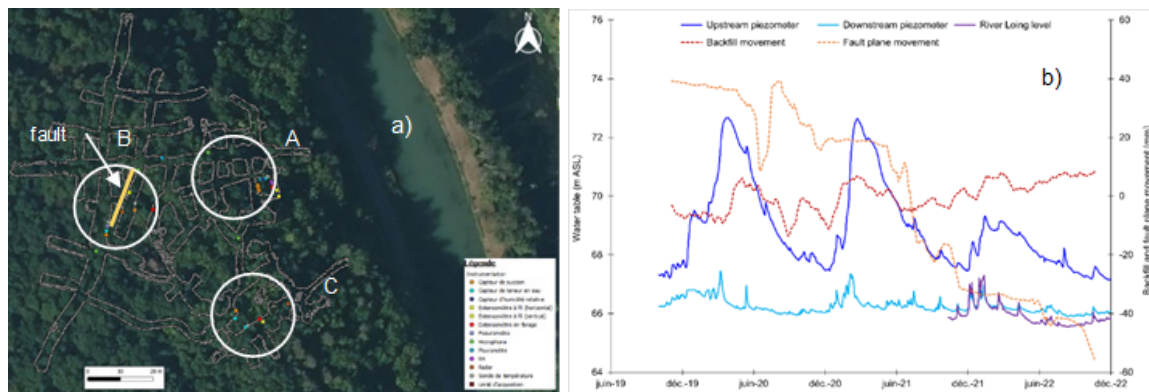
Figure 5. (a) Instrumentation of the Royer mine and (b) comparative evolution of the mean movements of the backfill and the fault plane with the daily heights of the water table and the river.

Two types of parallel monitoring were set up at the end of 2019 to correlate water data (variations in water table, water content of the chalk, and hygrometry) and acquired geotechnical data (deformation and failure of a pillar, a roof, and a fault). More than 50 sensors are installed in 3 different areas called A, B, and C as well as outside the mine (Figure 5a): A is the small pillars area, B is the fault area, and C is the control area. All the data are shared through a dedicated web-monitoring page on the e.cenaris (<https://cenaris.ineris.fr>) web portal.

Fluctuations in the level of the chalk water table, which correspond to the high water / low water cycles, reach  $\pm 2.77$  m upstream and  $\pm 0.78$  m downstream where they are buffered by those of the Loing river ( $\pm 0.87$  m) which forms the base level of the aquifer (Figure 5a). The figure also includes the distance variation measurements from the vault of the gallery to the embankment (zone C) and at the level of the fault plane (zone B). A correlation is observed between the piezometric cycles and the level of the embankment as well as the displacements of the fault plane (Figure 5b).
